Project Number: 1-14129.02

Kaipara Moana

KDC Marine Asset Condition Assessments

21 April 2020

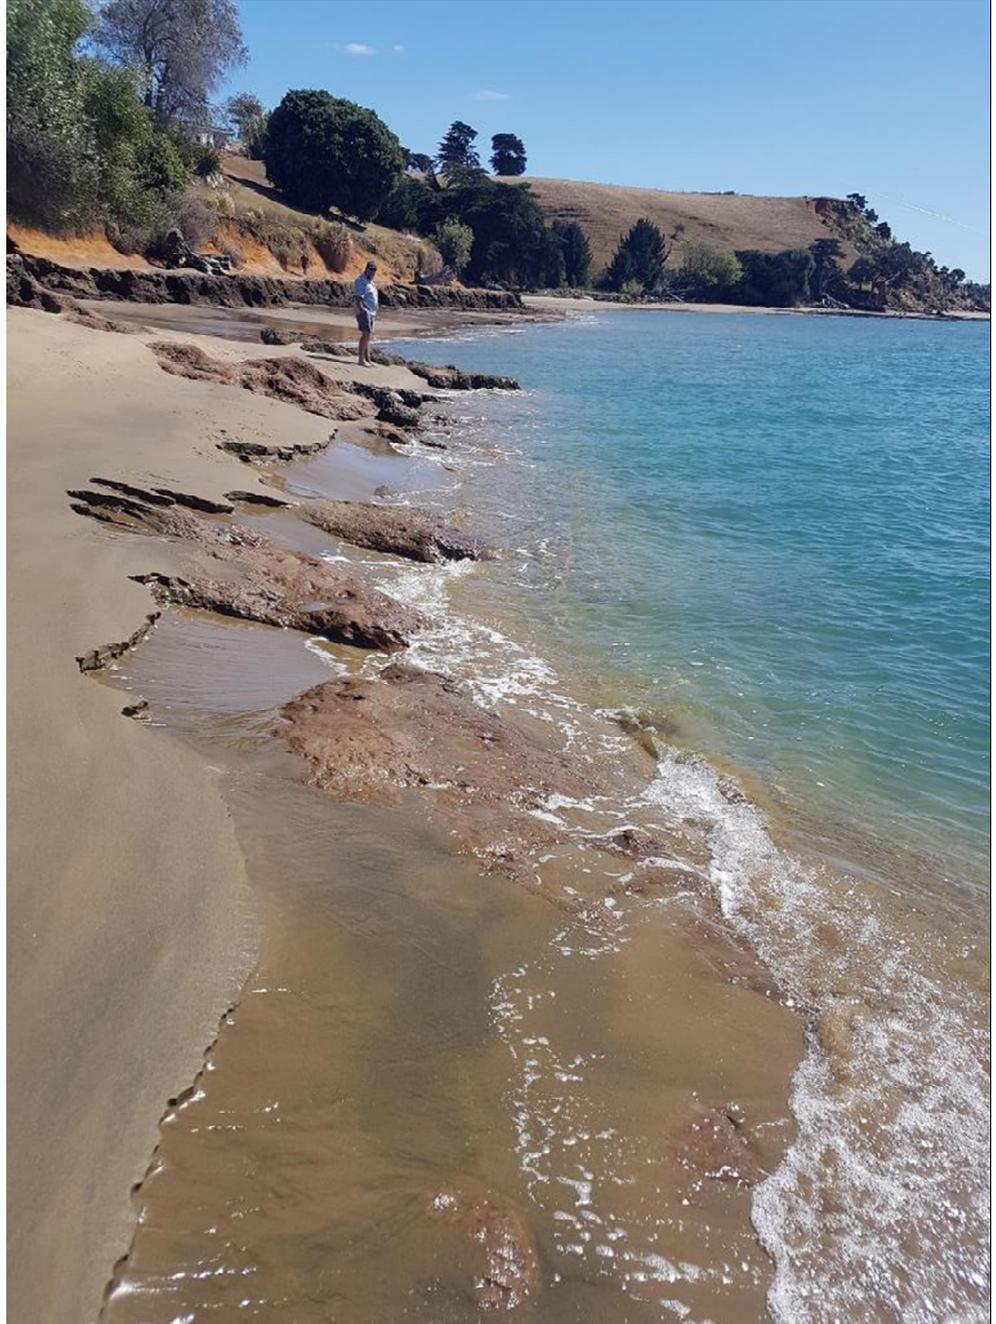
The rock shelves observed in the “Northern Bay” are examples of wave cut platforms, suggesting this area is frequently exposed to wave action. The ad-hoc armouring attempts in the bay at the cliffs and banks in front of properties, also indicate erosion due to frequent wave exposure.

Cliff at Site 2
Campground –
Note ad-hoc
erosion protection
at base of cliff for
properties above
(stone rip-rap,
concrete
demolition rubble
and gabion
baskets)

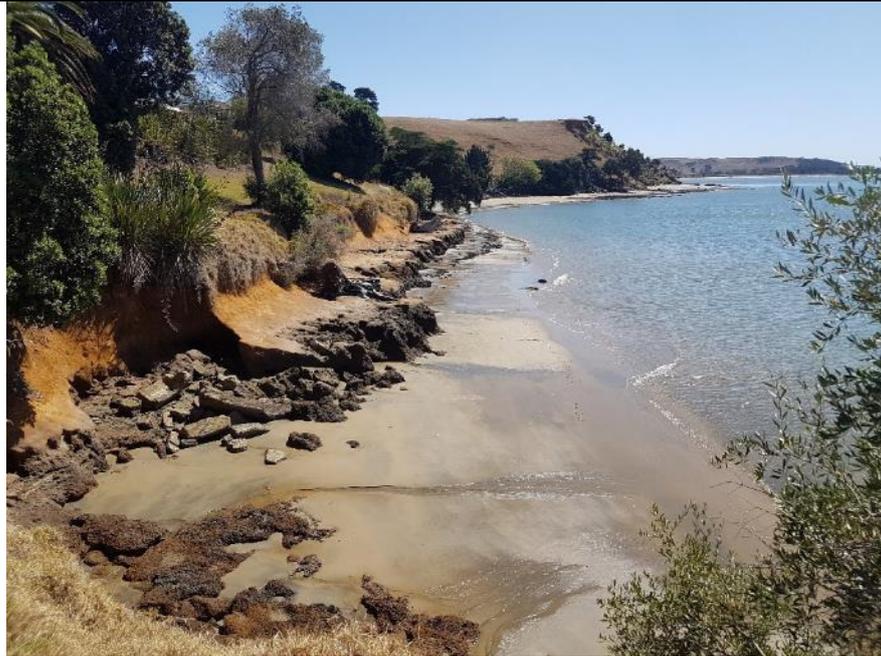
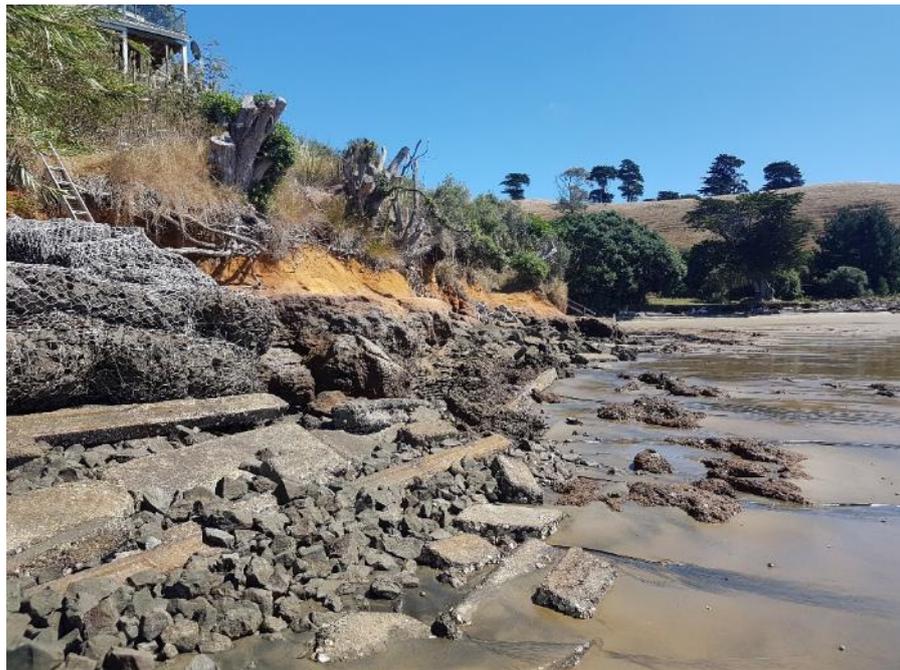
Campground site 2
- too steep for
vehicle access

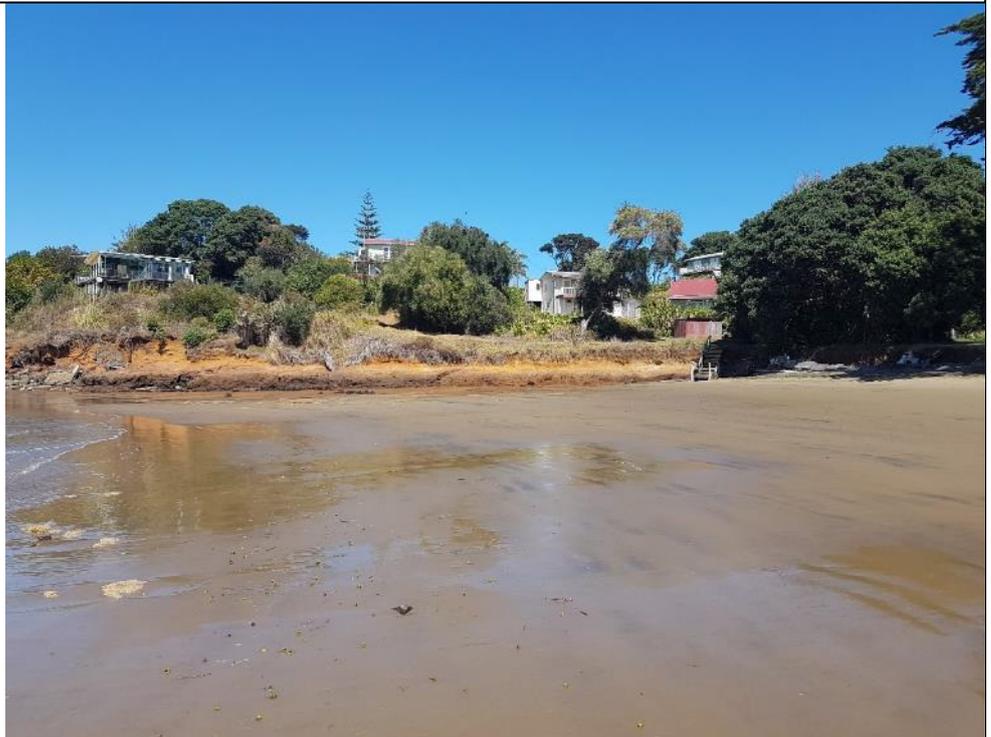
Site 3 - Bedrock and wave cut platforms visible at foot of cliffs

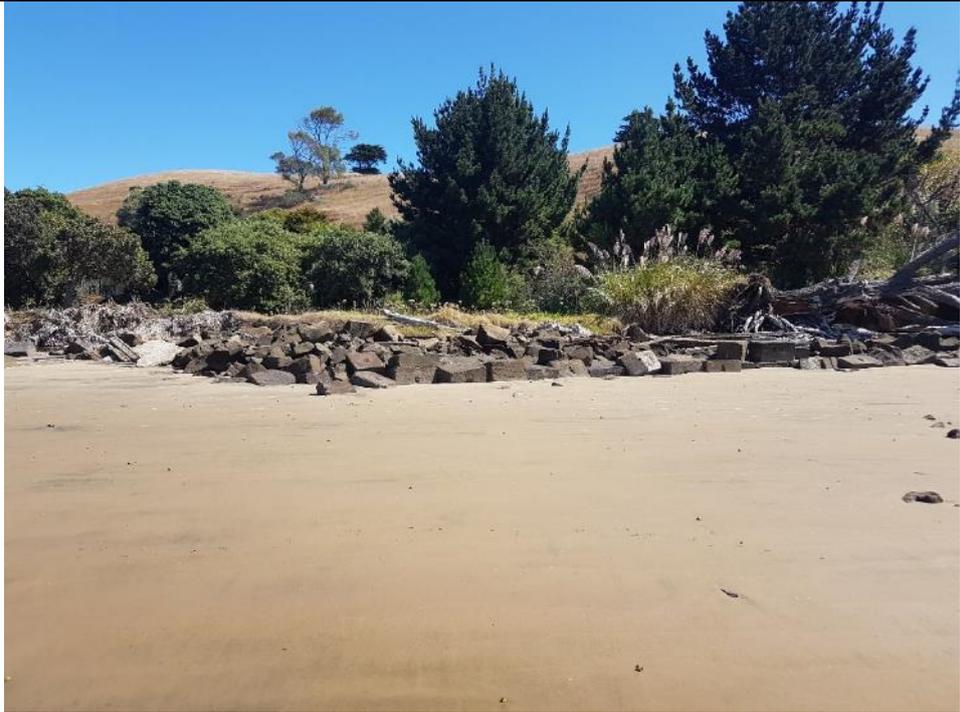
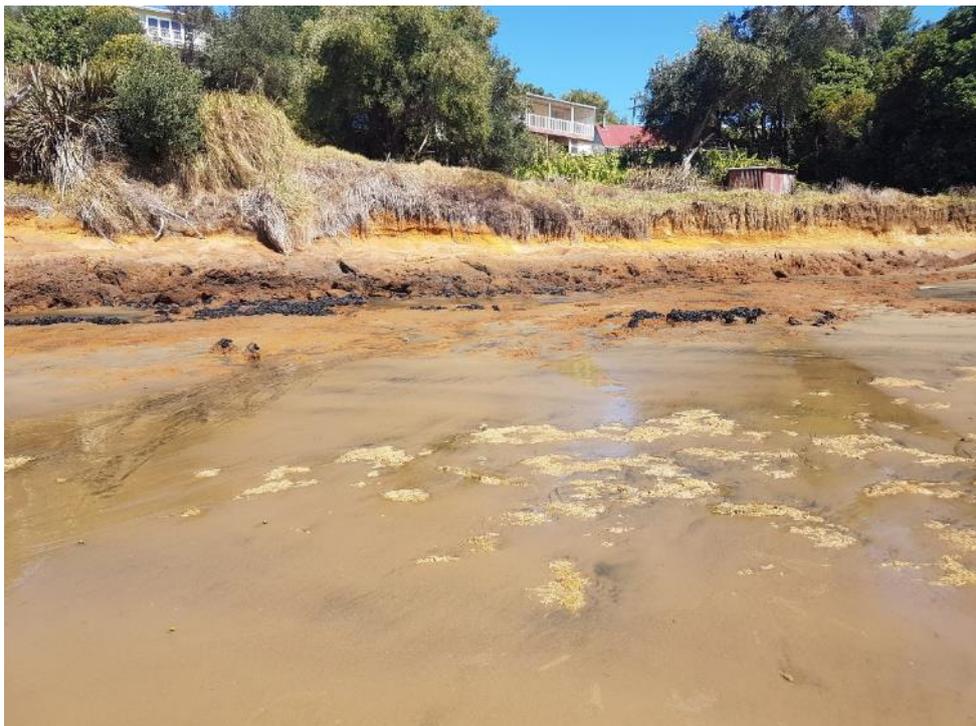
Thin veneer of
sand over
bedrock with
wave cut
platforms visible
at foot of cliffs

Site 2 & 3 at
"Northern Bay"
viewed from
high ground at
Pouto Point.
Note extent of
shallow water
seaward of
MLWS tide level

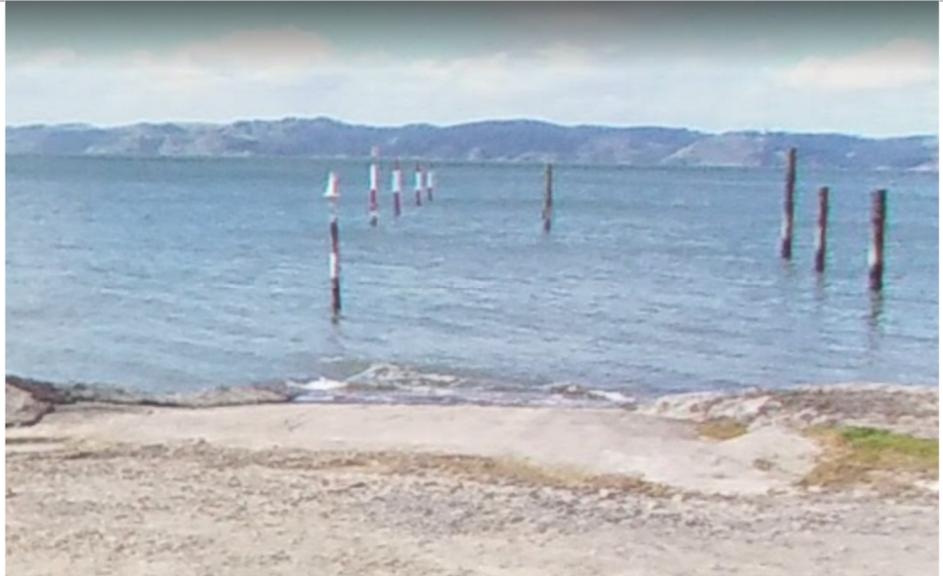
The 'all tide' boat ramp is in Moderate condition. It is one lane wide and adequate for small trailer launched recreational boats only. There are a series of painted timber marker piles identifying the seaward approaches to the ramp. There are also three larger legacy piles to the east that may have been intended for use as fender or mooring piles or could simply be the remains of an old lead-in jetty structure. The condition of the piles was not investigated but they are highly likely to require replacement if the site was to be converted to accommodate a car ferry operation.

Concrete boat ramp and timber marker piles viewed at high tide

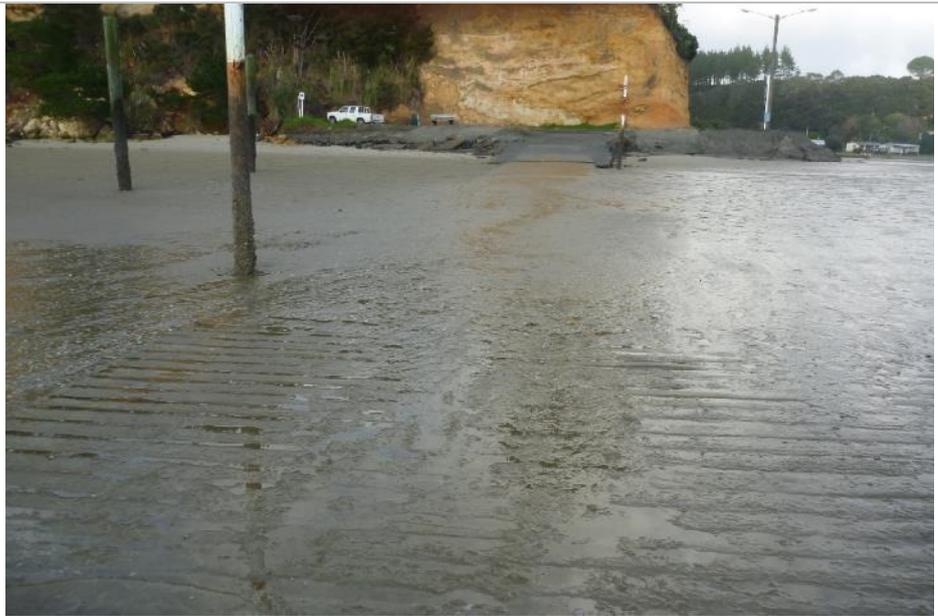
The 'all tide' status is somewhat misleading as the concrete boat ramp is of limited length. A section of intertidal sand foreshore must be traversed by vehicles at low tide for the launch and recovery of trailer mounted boats.

View landward on concrete boat from shallow intertidal area at low tide

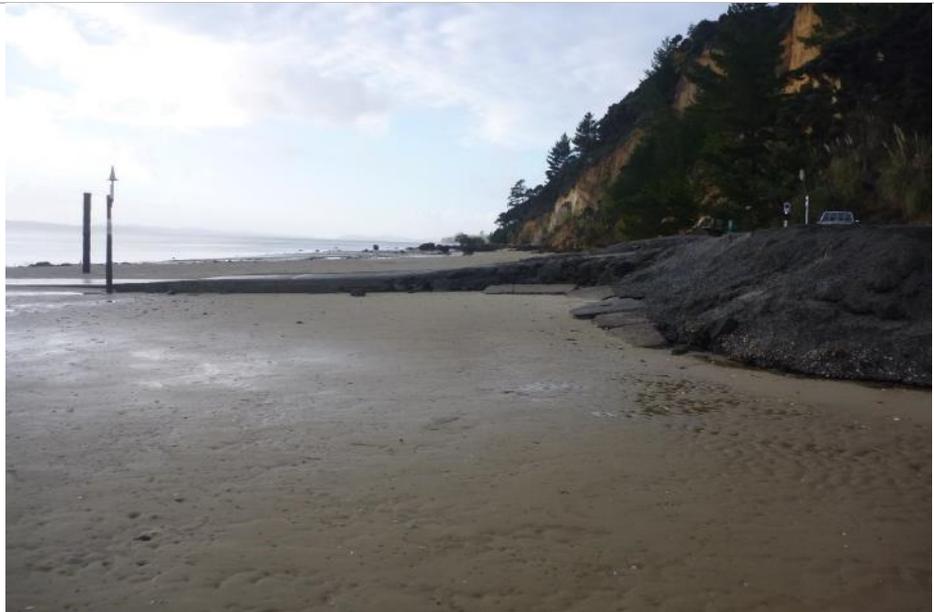
View south east on boat ramp - note insitu mass concrete pours for bank erosion protection either side of ramp
