Project Number: 1-14129.03

Kaipara Moana

KDC Marine Asset Assessment Pouto Point

21 April 2020

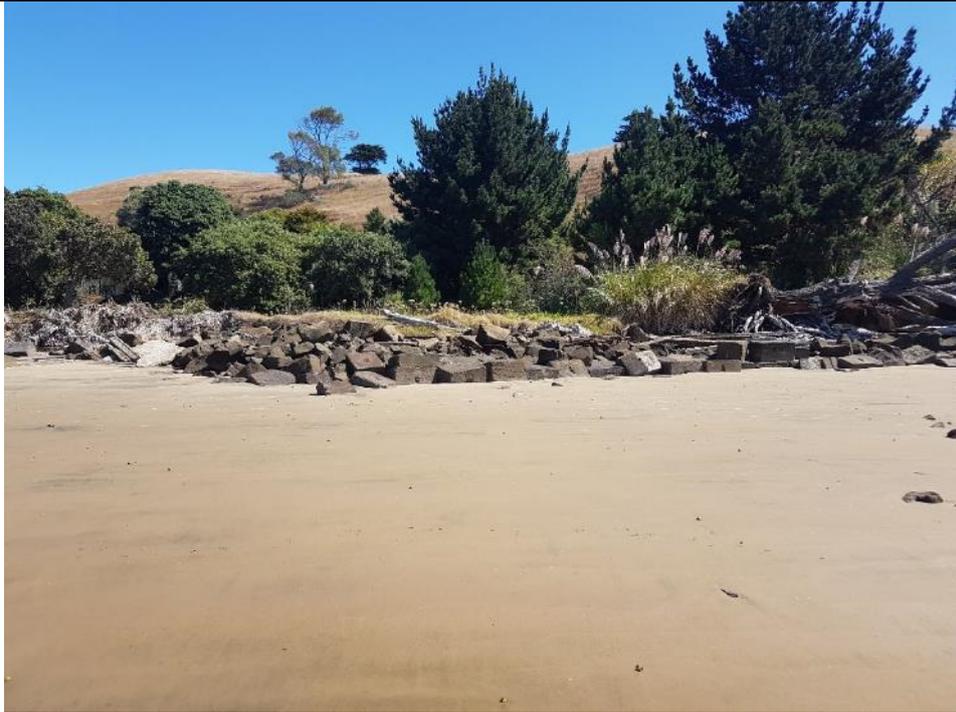
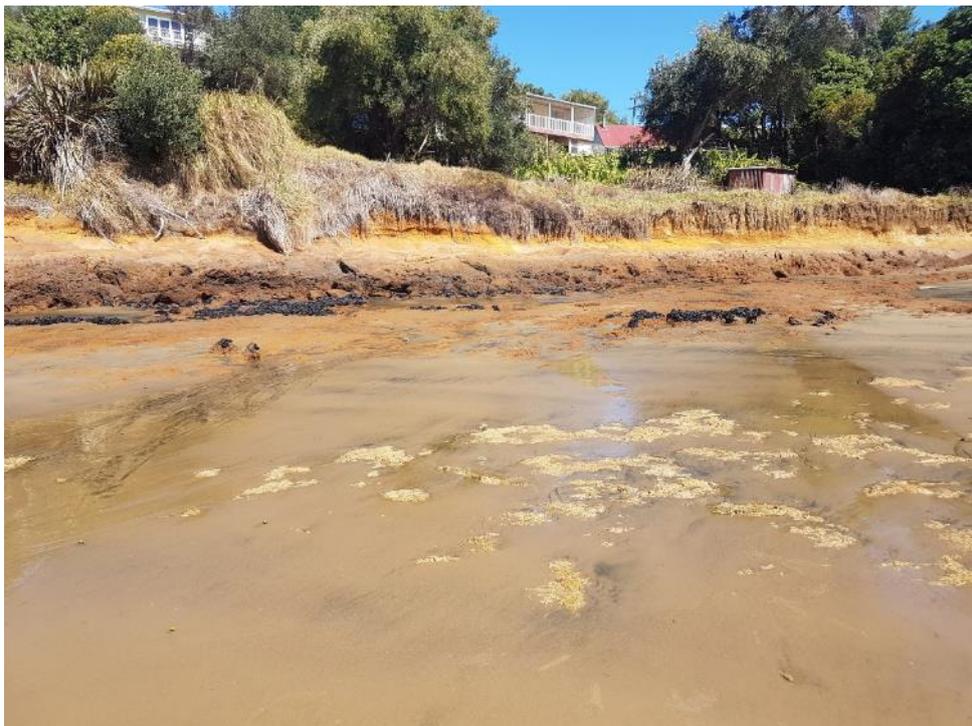
Thin veneer of
sand over
bedrock with
wave cut
platforms visible
at foot of cliffs

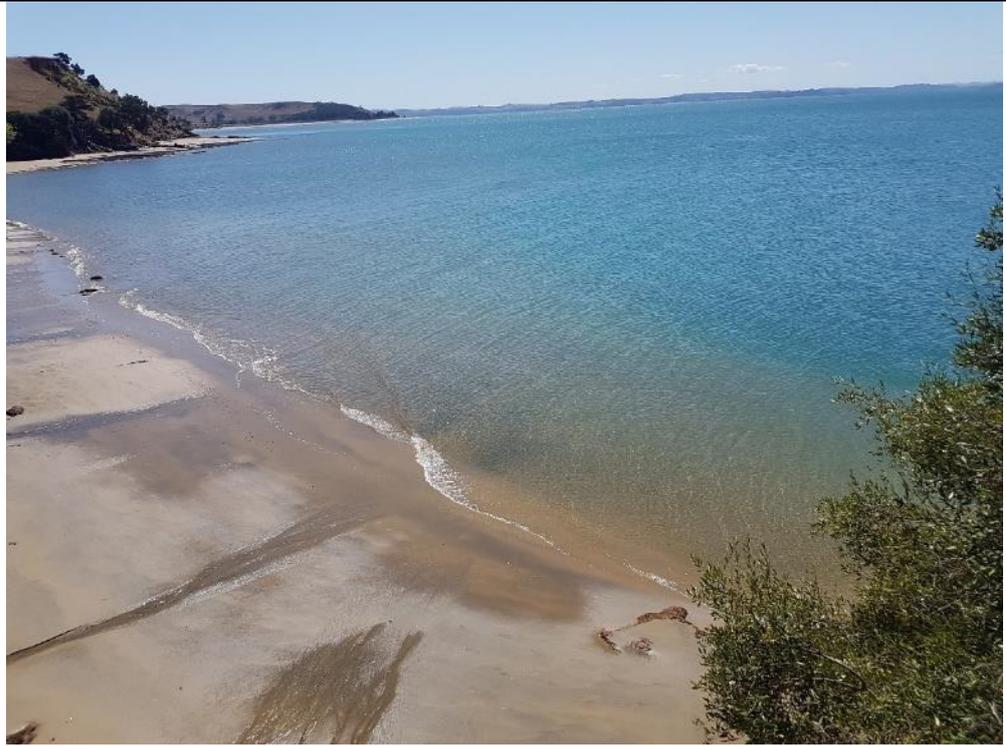
Site 2 & 3 at
“Northern Bay”
viewed from
high ground at
Pouto Point.
Note extent of
shallow water
seaward of
MLWS tide level
