Geotechnical Assessment

Kaiwaka

Kaipara District

28.03.2019
15601.000.001_02

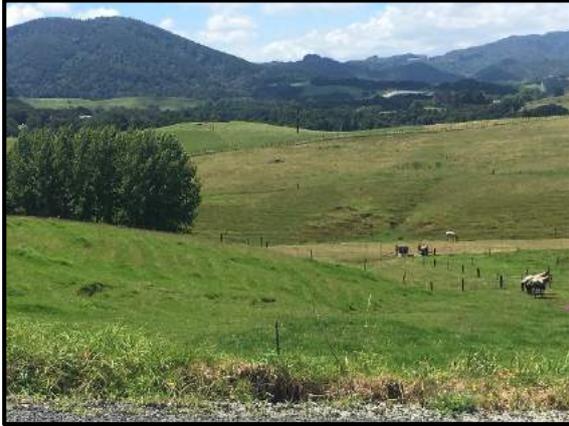
Photo 1: Typical landscape featuring hummocky, irregular ground, inferred landslide debris and soil creep.

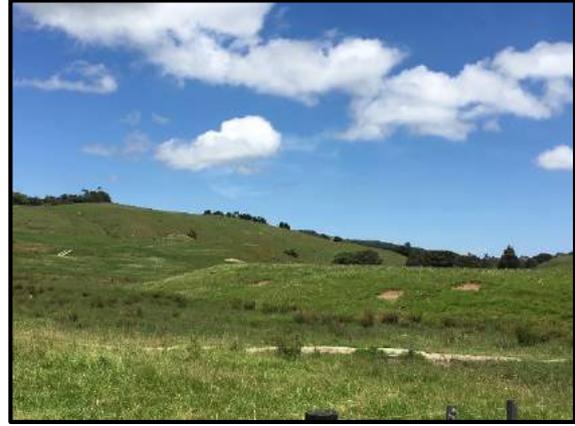
Photo 2: Active landslides, soil creep and failing slopes on relatively gentle slope angle.

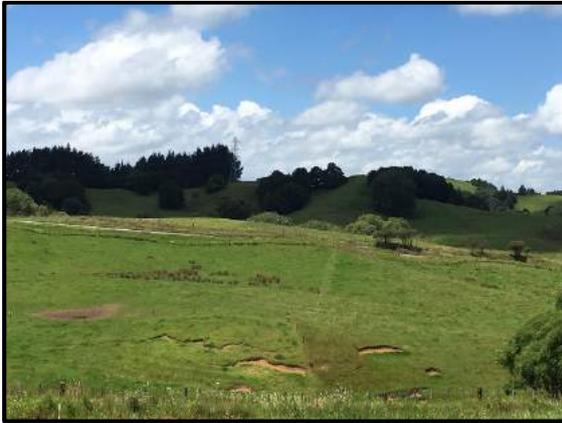
Photo 3: Moderately steep slope exhibiting shallow slope instability.

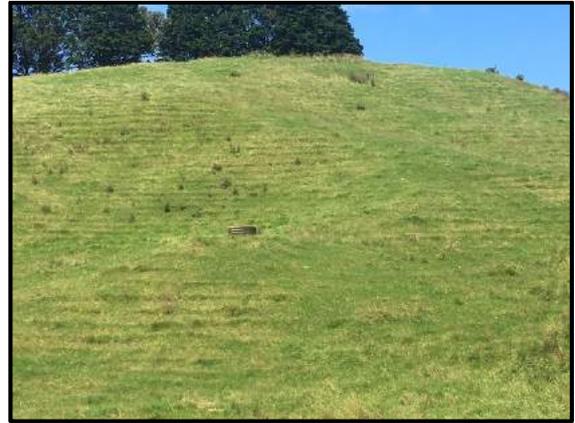
The drainages and gullies observed were commonly flanked by slope instability features, such as shallow rotational landslides and active soil creep within the gentle slopes above. The rolling hills within the study area are well vegetated and express widespread evidence of historical slope instability, as well as active slope instability (Photos 1, 2 and 3). This is primarily expressed in the form of shallow rotational failures and hybrid rotational / translational failures. Mid-slope benches and arcuate head scarps were observed on many of the moderate (16-30 degrees) to steep (>31 degrees) slopes. Active soil creep, particularly in the form of terracettes, was evident over much of the study area (Photo 4).

Photo 4: Shallow instability and soil creep in the form of horizontal soil ridges.

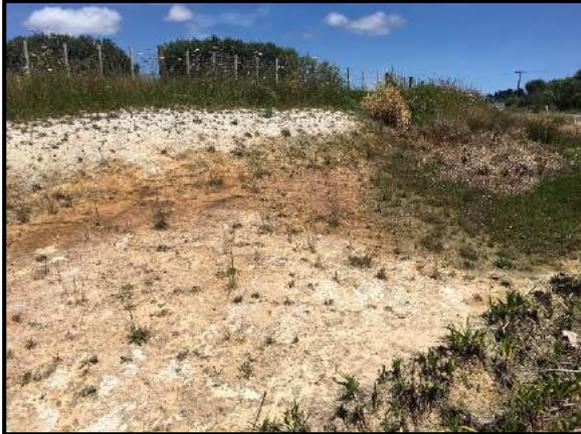
Groundwater appeared to be relatively shallow near the lower lying gullies and along the flood plains adjacent the main branches of the Kaiwaka River. Groundwater was also observed seeping out of road and rail cuts within Undifferentiated Mélange (Photos 5 and 6).

Only limited areas were observed to have rock outcrops. Where exposed, we observed extremely weak, very thinly bedded to laminated, sheared and crushed mudstone mapped as Undifferentiated Mélange (Photos 5 and 6).

Photo 5: Road cut on the south side of Oneriri Road. Note the water seeping from the shallow cut.

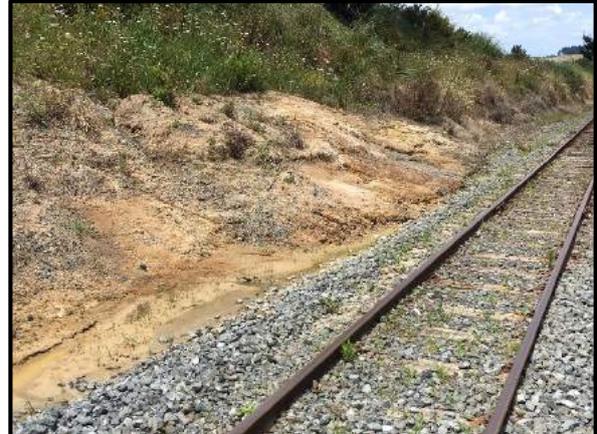
An exposed railroad cut at the southern end of the site was observed to be failure at an approximate 18-degree batter. The slope consisted of crushed claystone (Undifferentiated Mélange), had an active groundwater seep and was sliding toward the railroad tracks (Photo 5).

Photo 6: Railroad cut on the west side of the rail road, near the southern end of the study area. Note the water seeping from the cut and the slope failing at less than 1V:3H slope batter.

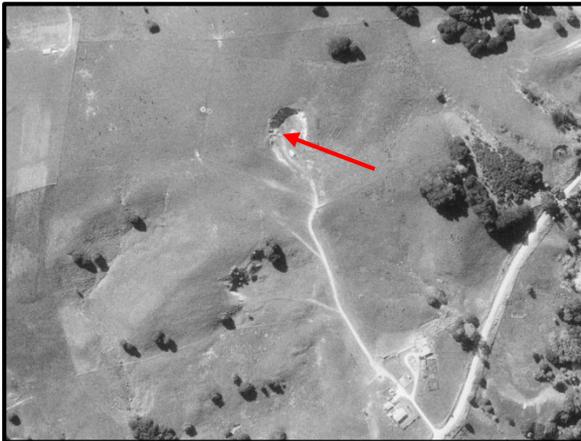
During our historical aerial photo review, we observed an apparent open pit borrow area or quarry exploration area north of Gibbson Road, in the northern part of the study area, that predates 1961 (Photo 7). Additionally, we understand that Parker Lime Co. currently operates a lime quarry on the west side of Gibbons Road, just north of the study area. It is likely that other localised areas used as quarry sources for farming improvements or roading works exist within the study area. If present, local areas of instability are expected where excavations have created over-steepened slopes. A discussion on geotechnical hazards associated with open pit quarries is in Section 15.1.

Photo 7: 1995 aerial photo of a possible open pit borrow area. This feature is present in photos dating back to 1961.

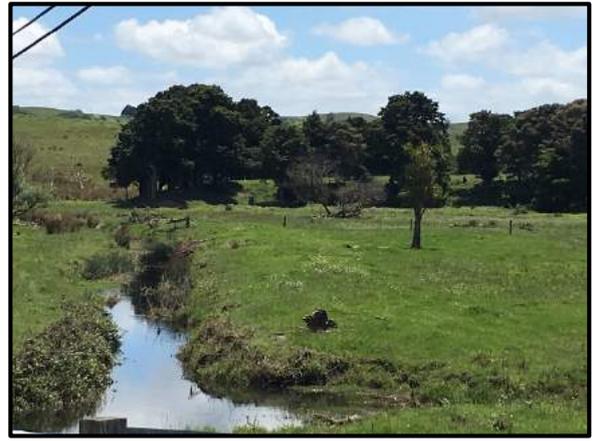
Holocene alluvial deposits are not mapped in this area by GNS, however these deposits were observed near the mouth of the Kaiwaka River in the north-western end of the study area (Photo 8) and along tributaries near the mouth of the Kaiwaka River. Pleistocene alluvial deposits have been mapped by GNS adjacent the Holocene alluvial deposits, Kaiwaka River, creeks and tributaries in the northern third of the study area. Pleistocene alluvial deposits observed near Oneriri Road and Gibbons Road, appear to be failing on slopes steeper than 1V:3H, or about 18.4 degrees. This observation is generally consistent with our mapping in Maungaturoto, as well as slope performance reported by others (GNS 2009, T+T 2006 and 2008, and Auckland Council 2017) and supports our assessment of slope instability in Section 14.4.

Photo 8: Young Holocene alluvial soils on the flood plain of this tributary to the Kaiwaka River near Oneriri Road.
