#### 14 August 2023

#### BECA HunterH2O Mangawhai WWTP Optimisation Summary Report

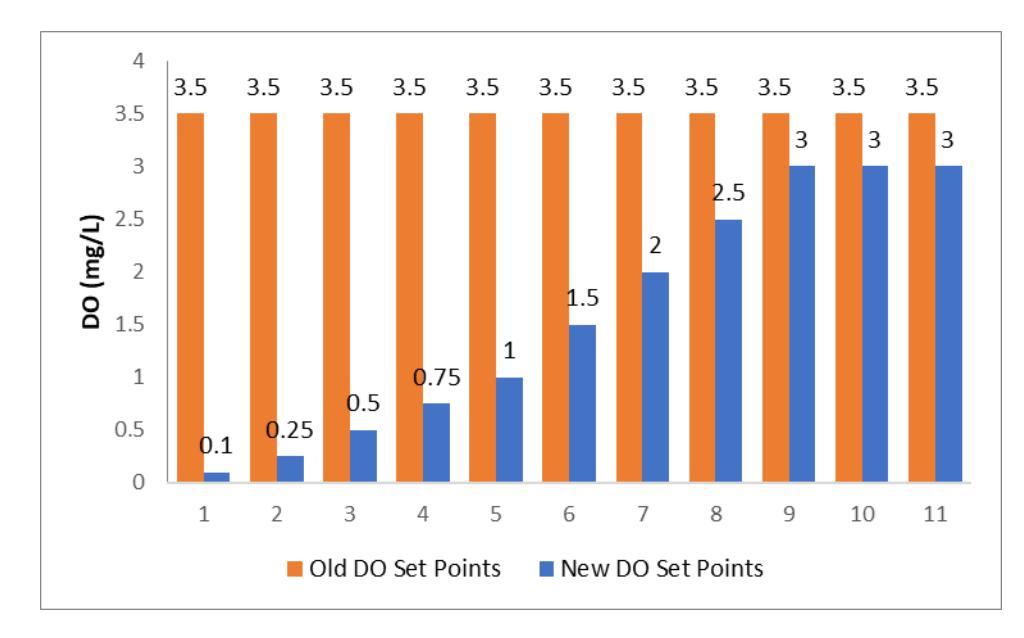
On the first day we lowered the DO significantly and targeted a ramp up DO profile. The ramp up profile aims to provide very little DO initially to maximise the removal of nitrate. The DO is later gradually increased to allow for ammonia and phosphorus removal. The figure below shows the initial DO vales and our changes. The numbers 1 to 11 are equal spaced times over the CASS 120 min react phase (i.e. 11 min intervals)

The above change to DO has lowered the blower use and has had no negative impact. As of the 14/8/2023 the DO for periods 7 to 8 has been lowered to 2 mg/L. However, as we not below due to blower turndown issues we can't reach this value.

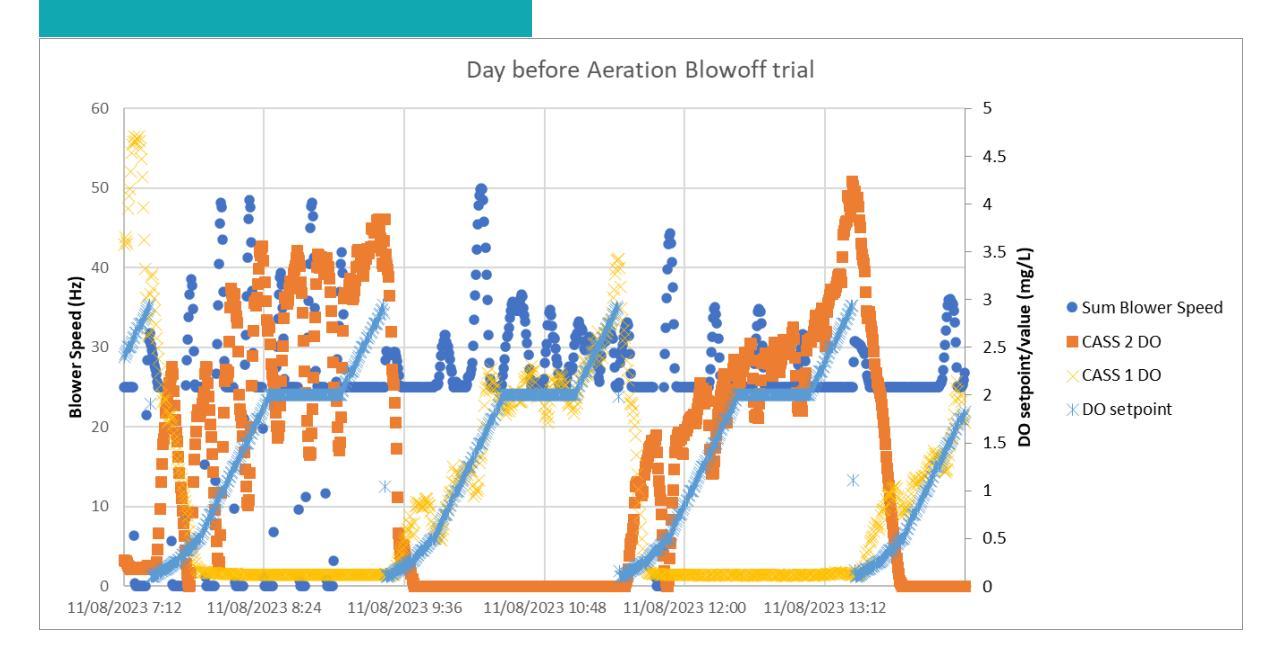
As part of the DO changes, we have identified and issue with blower turndown. In the graph below it shows the DO set point, actual DO and blower speed. You can see in the three cycles below despite one blower running at minimum speed the plant generally struggles to meet the target DO. Often it is rising in a non-controlled sense to 3.5 to 4 mg/L towards the end of the cycle. Some form of enhanced aeration turndown is likely required for operation during the non-tourist period. This could be shutting the blowers down in a controlled way, an aeration blow off or a smaller blower.

We have also identified an issue with how DO is controlled by the PLC system. It brings the assist blower in and does not adjust the duty blower down. This results in a larger (50%) increase in airflow which the PID controller struggles to address. We have a proposed fix for this issue we have discussed with McKay via Downer. We have a draft control change for this.
