**Proposed Plan Change 85 to the Operative Kaipara  
District Plan**

**STATEMENT OF EVIDENCE OF ANDREW JAMES TOWNSEND**

**(ECOLOGY)**

**ON BEHALF OF THE DIRECTOR-GENERAL OF CONSERVATION**

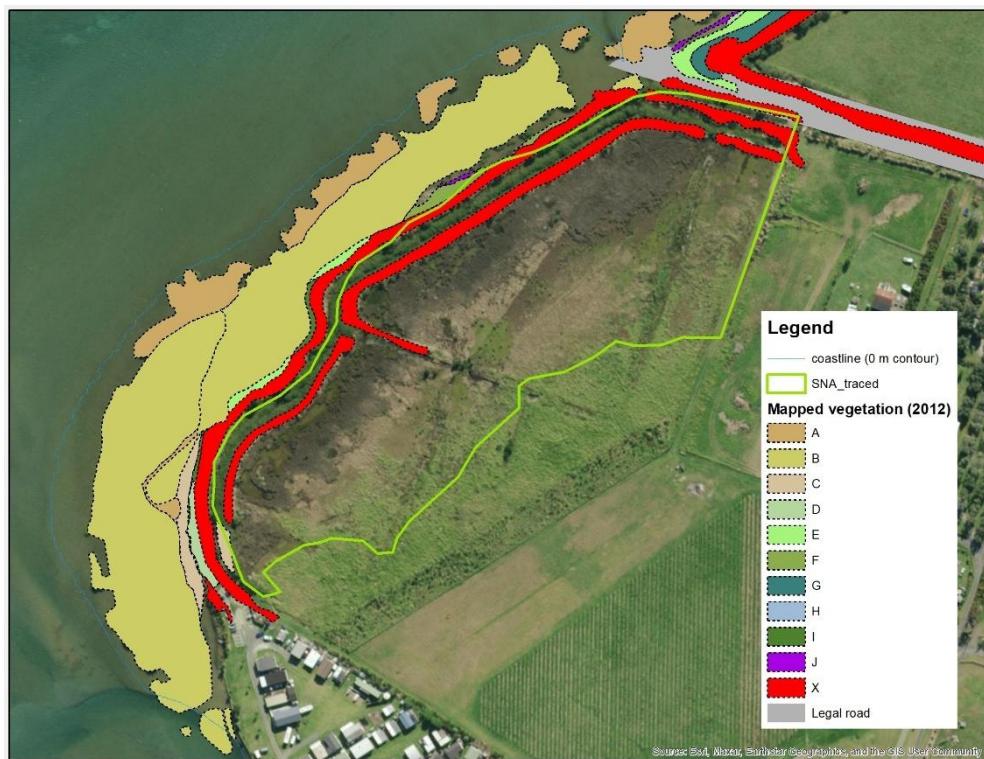
**Figure 1.** Vegetation predominantly on the seaward side of the saltmarsh SNA.<sup>4</sup>

<sup>4</sup> Key: A = scattered mangrove over open water; B = mangrove shrubland; C oioi (*Apodasmia similis*)—sea rush (*Juncus kraussii* subsp. *australiensis*)—scattered mangrove reedland; D = oioi reedland; E = oioi-sea rush reedland; F = oioi—*Machaerina juncea*—*Austrostipa stipoides* reedland; G = oioi—*M. juncea*—*Machaerina articulata* reedland; H = *M. juncea* reedland; I = *Schoenoplectus tabernaemontani* reedland; J = sea primrose (*Samolus repens*)—remuremu (*Goodenia radicans*) herbfield coastal turf; X = dense pampas grass tussockland on stop-bank (red).

24. Vegetation along the southern shoreline of Mangawhai Harbour has not changed significantly since my assessment in 2012 (Figure 1), so the assessment I undertook then is still useful context today. The full analysis is attached to this body of evidence as Appendix 1.

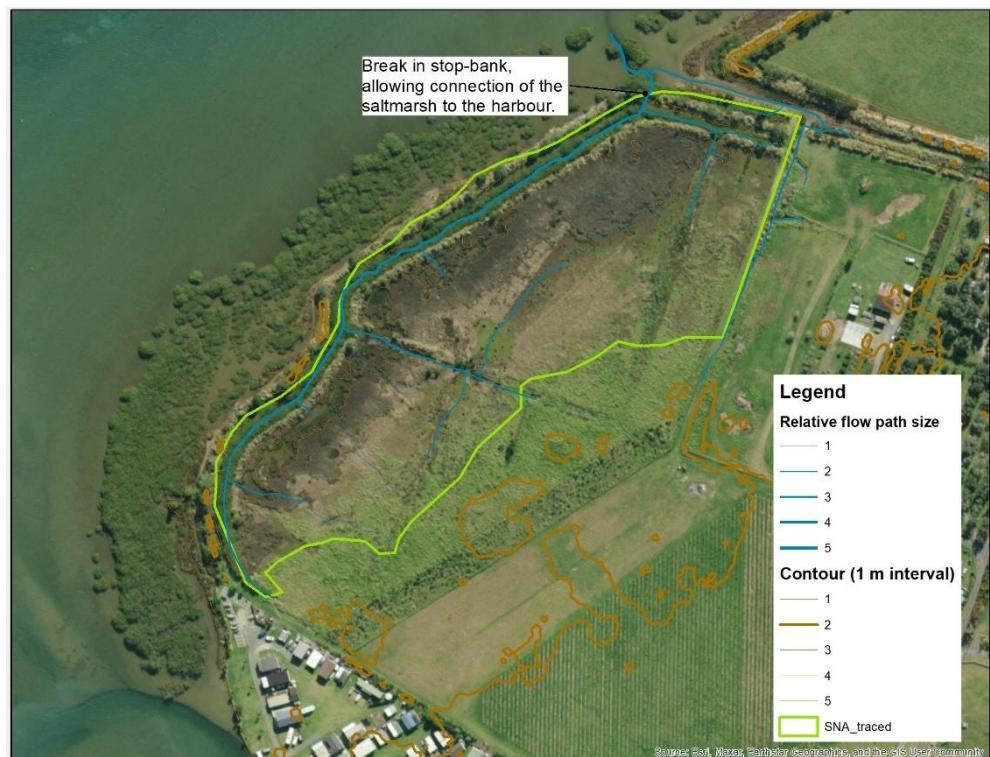
**Figure 2.** Hydrological connections and flow-paths between the saltmarsh and the harbour.

26. I developed a 10 cm contour interval for the Saltmarsh SNA and used this to plot flow paths (Figure 2) within the wetland. This, in conjunction with confirmation of those flow paths in the field undertaken during the 19 January visit, identified importance of the break in the stop-bank at the western end of Raymond Bull Road for maintaining the saltmarsh.

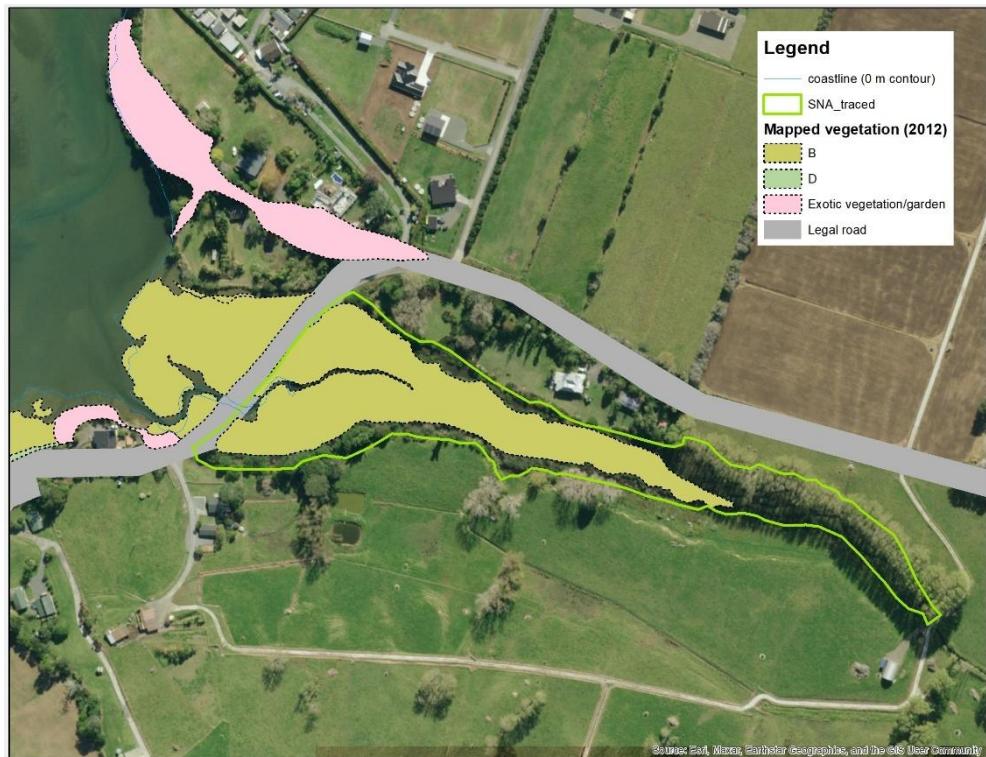
**Figure 3.** Extent of mangrove shrubland in Black Swamp SNA in 2012, showing mangroves on the seaward side of Black Swamp Road<sup>8</sup>.

<sup>8</sup> Key: B = mangrove shrubland; D = oioi reedland.

27. The 2012 assessment indicates that the area of mangrove treeland in the Black Swamp SNA has been reduced in size (Figure 3), with two areas of mangroves on the seaward side of Black Swamp Road having been removed (Figure 4).

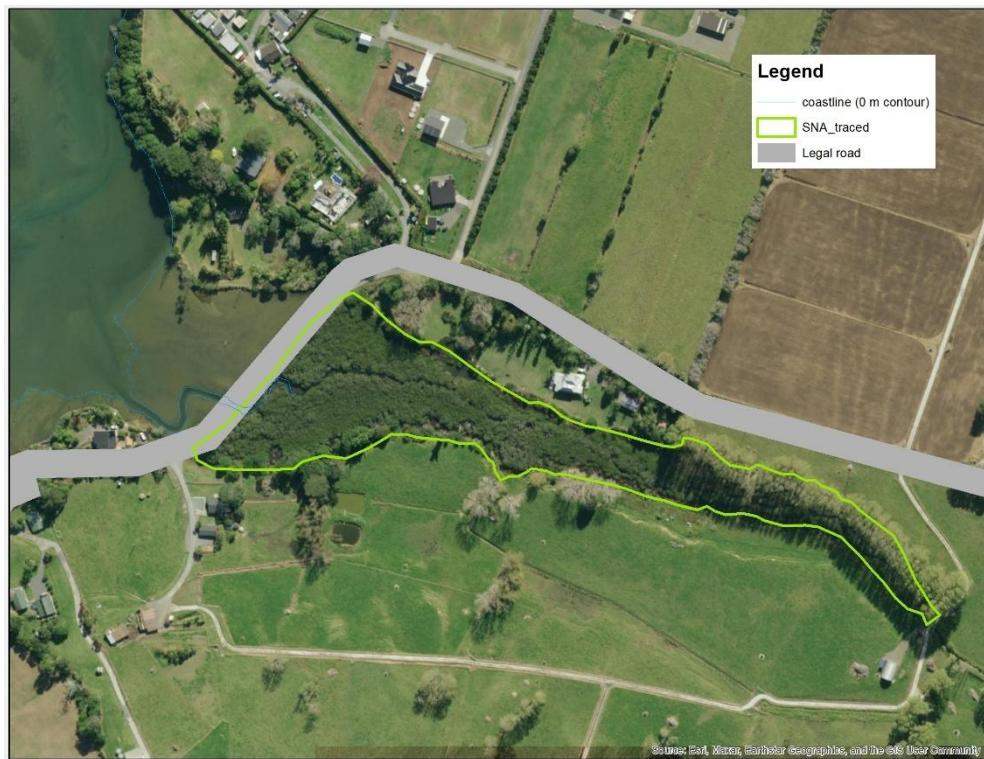
**Figure 4.** Current-day extent of mangrove shrubland in Black Swamp SNA.

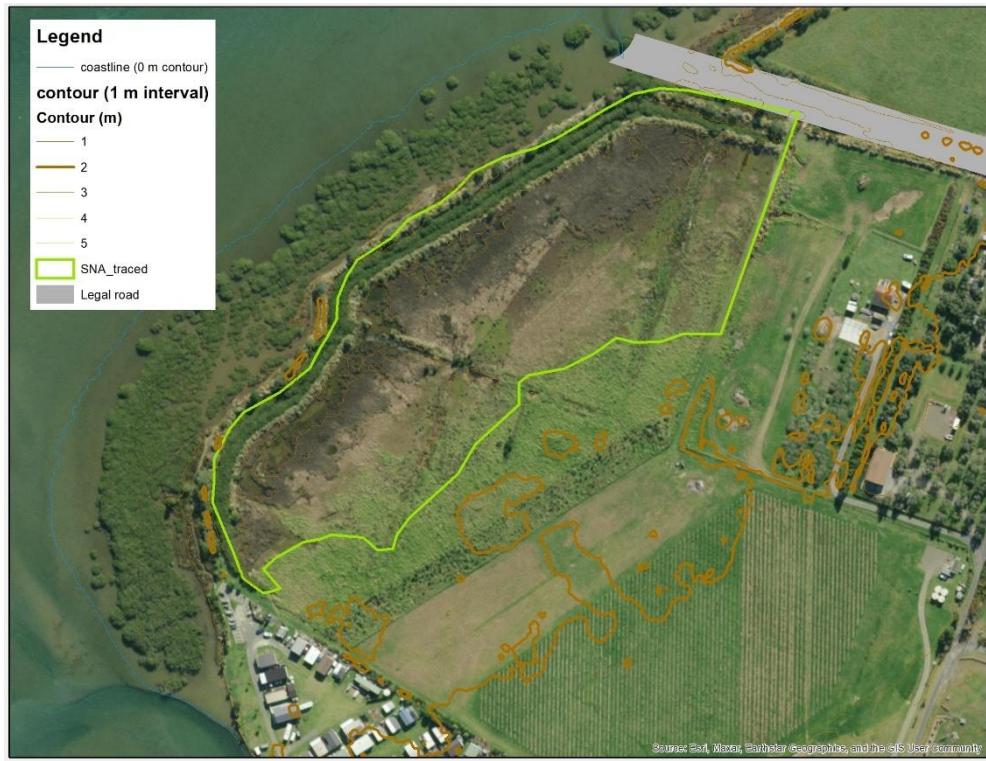
**Figure 5.** The saltmarsh SNA with 1-metre interval contours.

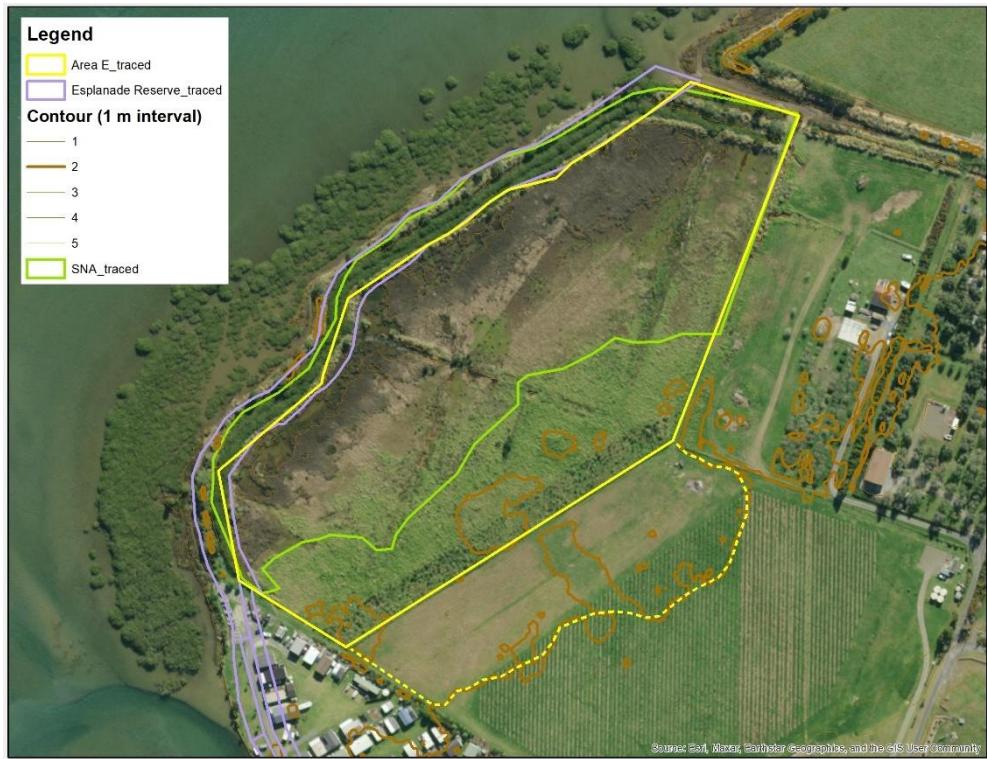
**Figure 6.** Alternative boundaries that would improve the ecological integrity of the SNA. (Dashed yellow line = approximate 2 metre contour, and solid yellow line = fenceline outside the existing restoration planting.) (Note that polygons have been drawn as they were shown in the underlying documents, i.e. overlaps and slices are deliberate).

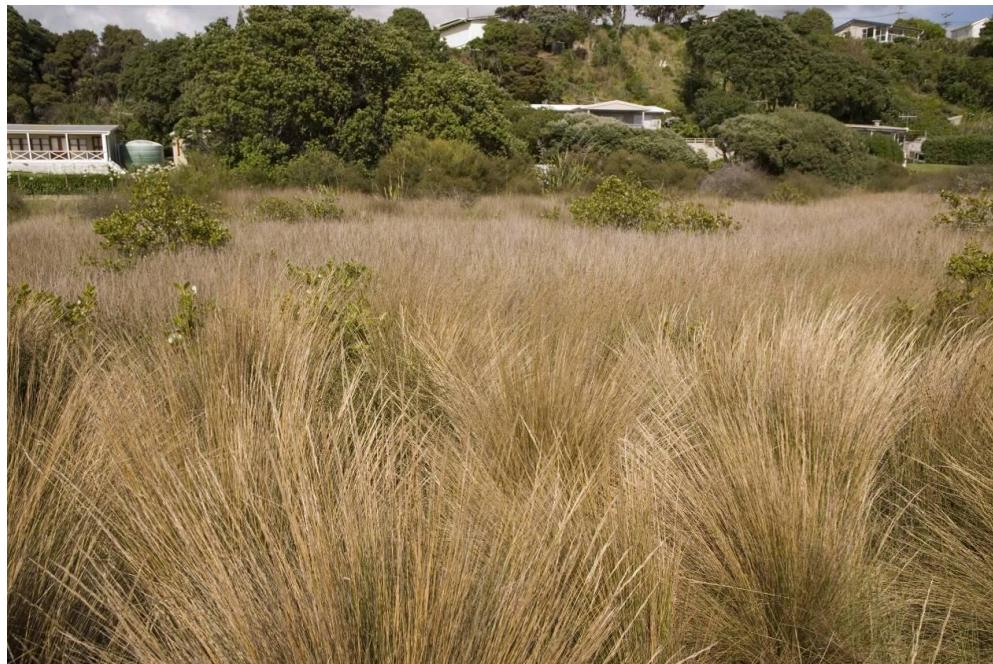
Photo 9348: Lincoln Street salt-marsh with *Austrostipa stipoides* (in the foreground), oioi and sea rush amongst scattered mangroves (middle) and a margin of *Olearia solandri*, pohuehue, harakeke and *?Coprosma propinqua* on the landward edge.

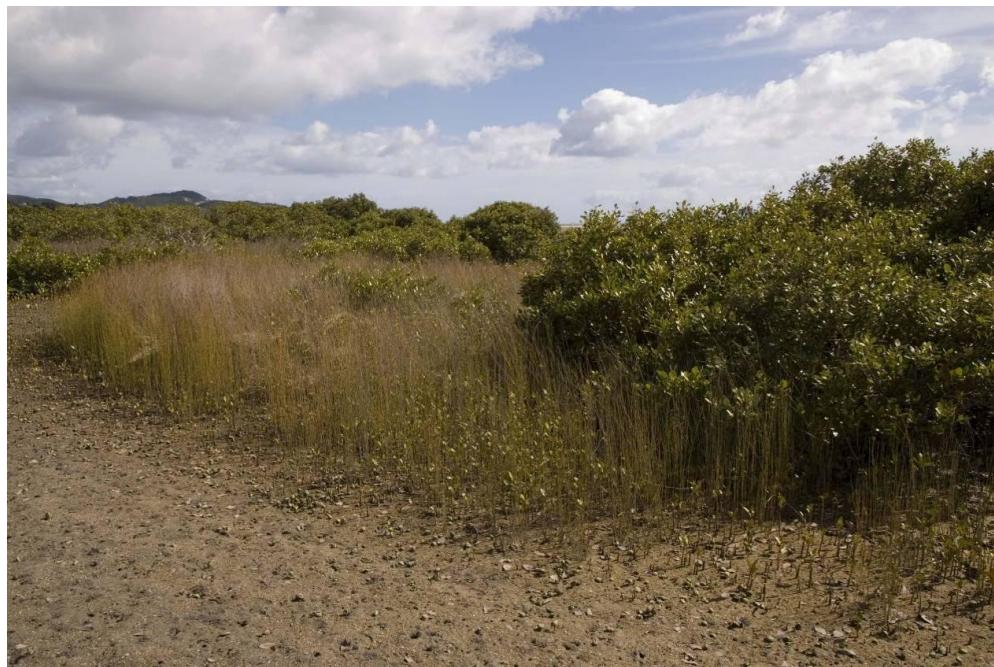
Photo 9349: Lincoln Street salt-marsh and fringing mangrove tree-shrubland. Oioi sedgeland is on the left, with small mangroves in the centre. The area in the middle has been artificially cleared of mangroves, and propagules are dispersing along this and the track from which the photo was taken and re-colonising these areas.

The advance of mangroves at Lincoln Street Reserve appears to be the result of human-induced disturbance. Where drains have been dug, or tracks put in, mangroves are able to colonise during high tides that allow the relatively large mangrove seed to float up these cleared areas and establish (photo 9345) in the salt-marsh. Furthermore, the removal of mangroves appears to be accelerating the demise of the salt-marsh as it allowing wave action to erode this habitat.

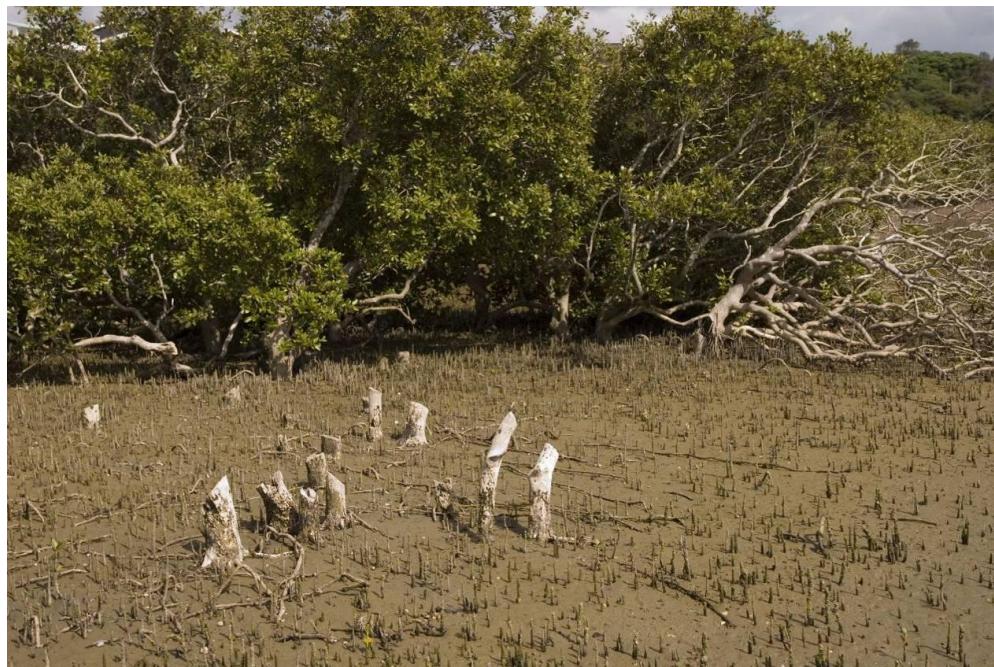
Photo 9354: Seaward edge of the mangrove tree-shrubland, where some trees have been removed.

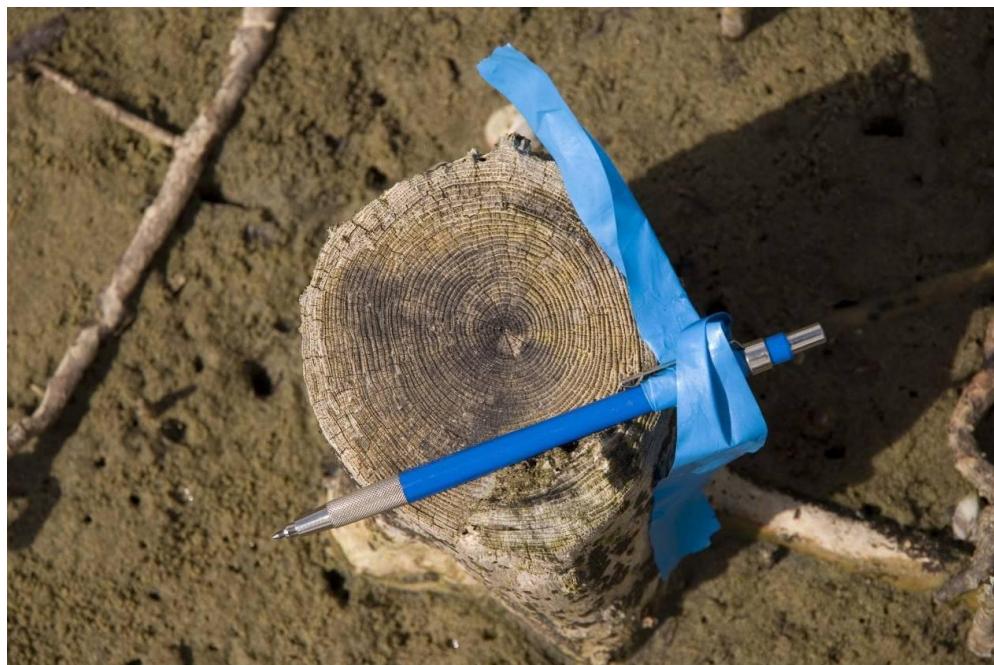
Photo 9355: Cut mangrove stump, showing c.46 growth rings.

0542); and drainage ditches dug at several localities (photo 0537). One mangrove on a cut track (GPS 746) with a diameter of approx. 11 cm had c.46 complete growth rings present and was estimated to be more than 30 years old. Where drains have been cut through the salt-marsh (GPS 744 & 751), small mangrove plants have established in the salt-marsh.

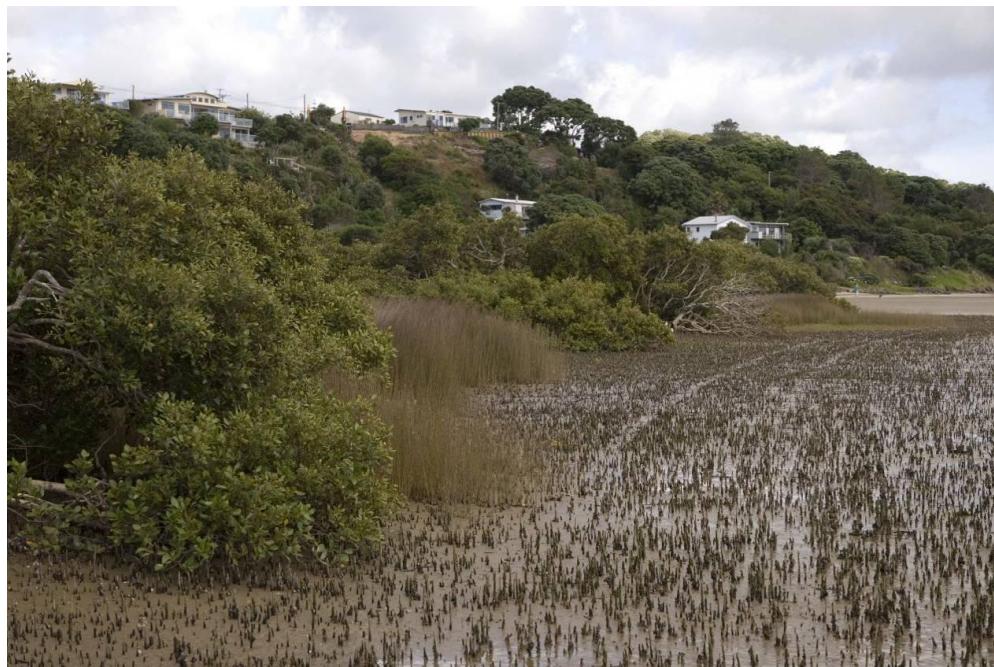
Photo 9337: Seaward side of the mangrove tree-shrubland with scattered patches of oioi sedgeland.

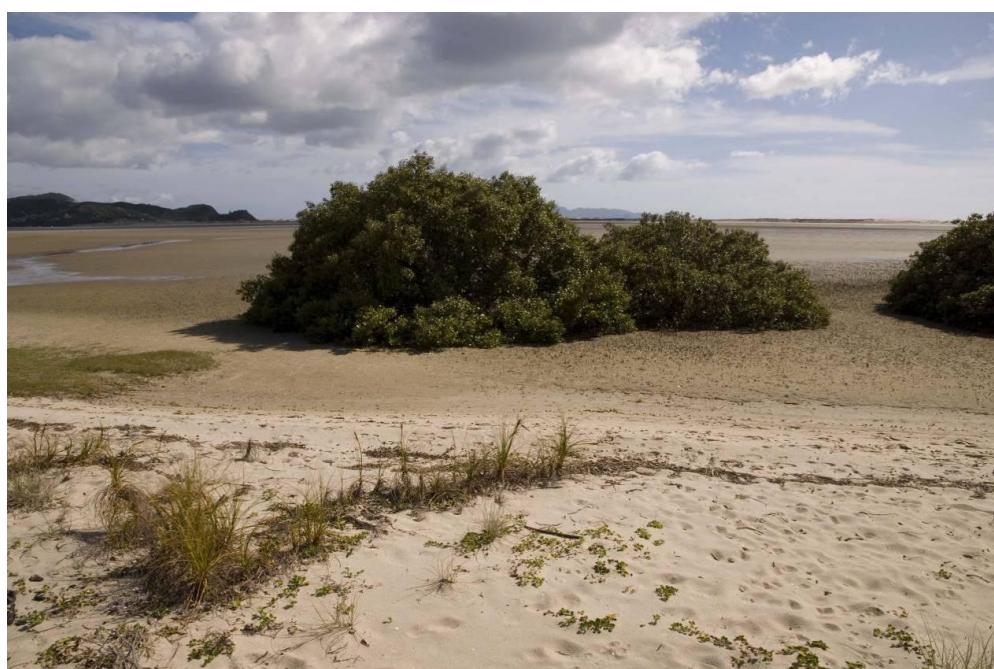
Photo 9339: Pingao, shore bindweed and spinifex sandfield (foreground); sea primrose herbfield (left) and mangrove tree land at the northern side of Lincoln Road Reserve site.

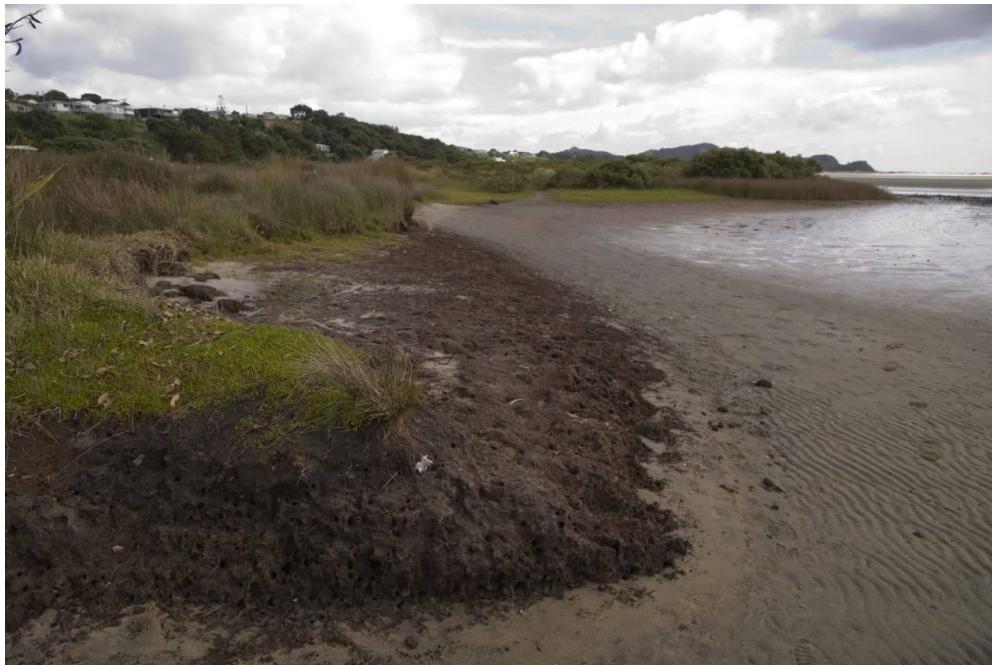
Photo 9631: Erosion of the peaty base on which the salt-marsh has formed (lower left and middle). The small turf (middle left) is dominated by *Selleria radicans*, with *Austrostipa stipoides* and buffalo grass.

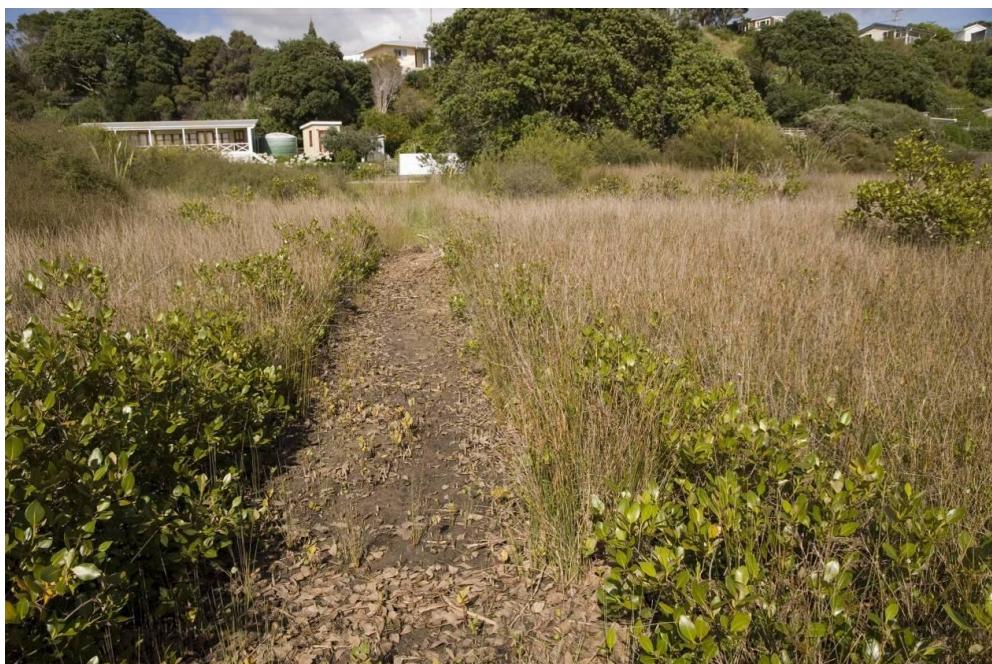
Photo 9345: Young mangroves colonising a recently cleared drain through the salt-marsh (centre), with older mangroves along the margins. Mangrove advance appears to be accelerated by disturbance which creates an access point into the salt-marsh. A few, older mangroves are also scattered throughout the salt-marsh.

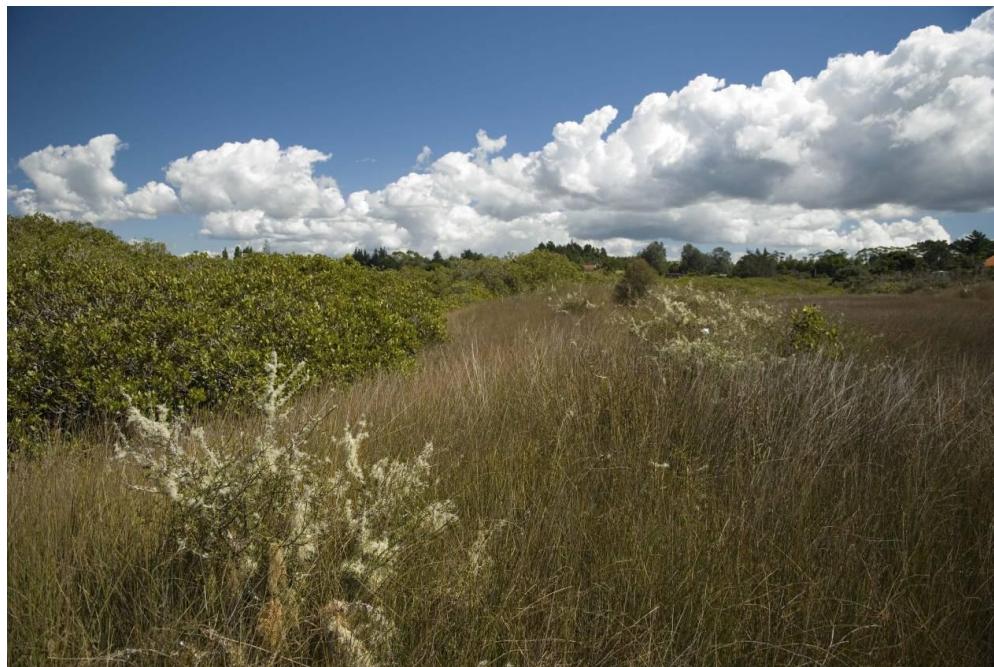
Photo 0545: Mangrove tree shrubland (left) on the outer edge of the salt-marsh ecotone, with *Plagianthus divaricatus* (foreground and centre) and epiphytic *Usnea rubicunda* and *Usnea* sp., and manuka on a small ridge and more salt-marsh on the inner edge (right). (This location is part of Kainui Street Arm in the Statement of evidence.)

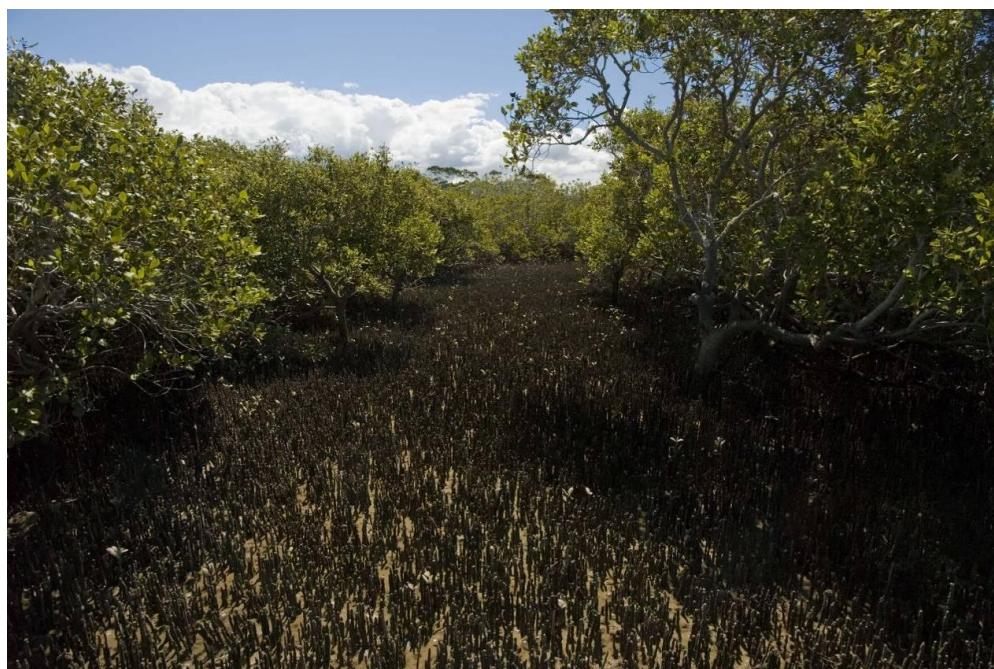
Photo 0540: An old track cleared through the mangrove tree-shrubland.

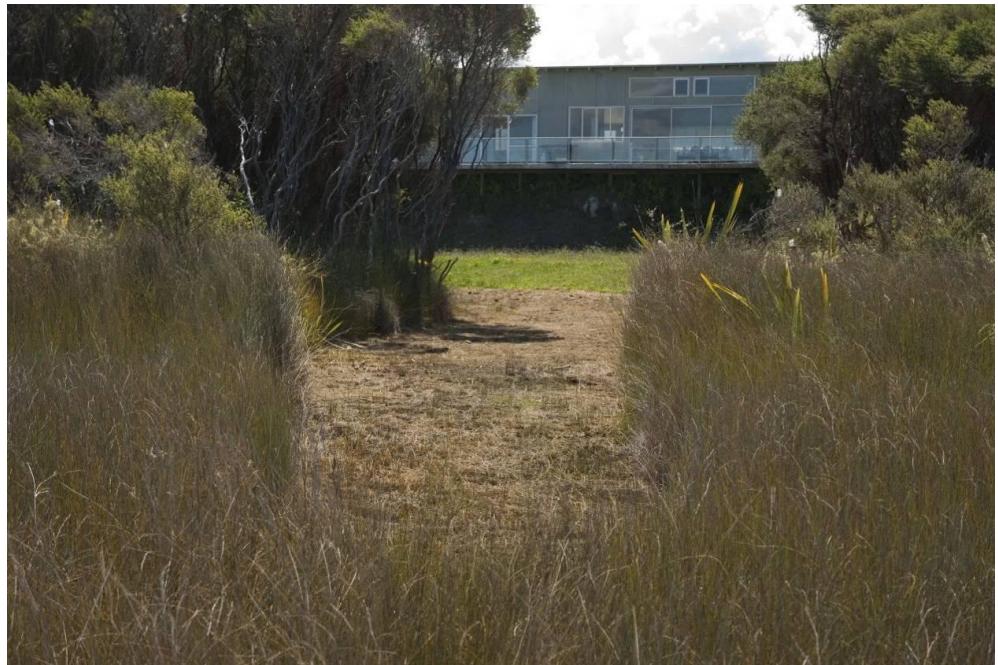
Photo 0546: A track recently cleared through the manuka shrubland and salt-marsh sedgeland. (This location is part of Kainui Street Arm in the Statement of evidence).

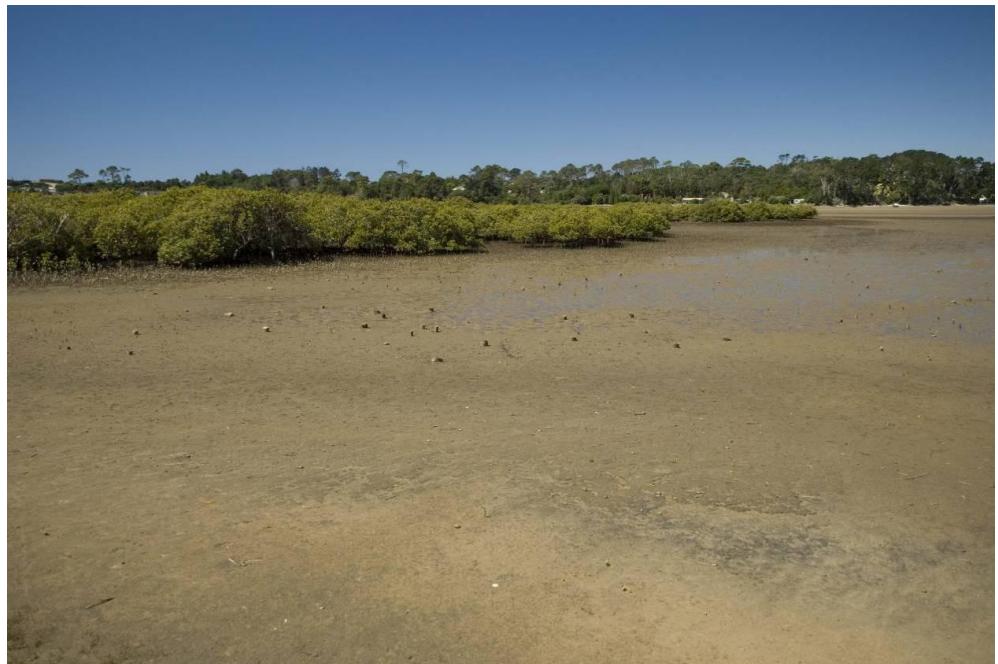
Photo 0542: Evidence of long-term human intervention at this site: mangrove stumps in an area where mangroves have been removed from near the jetty.

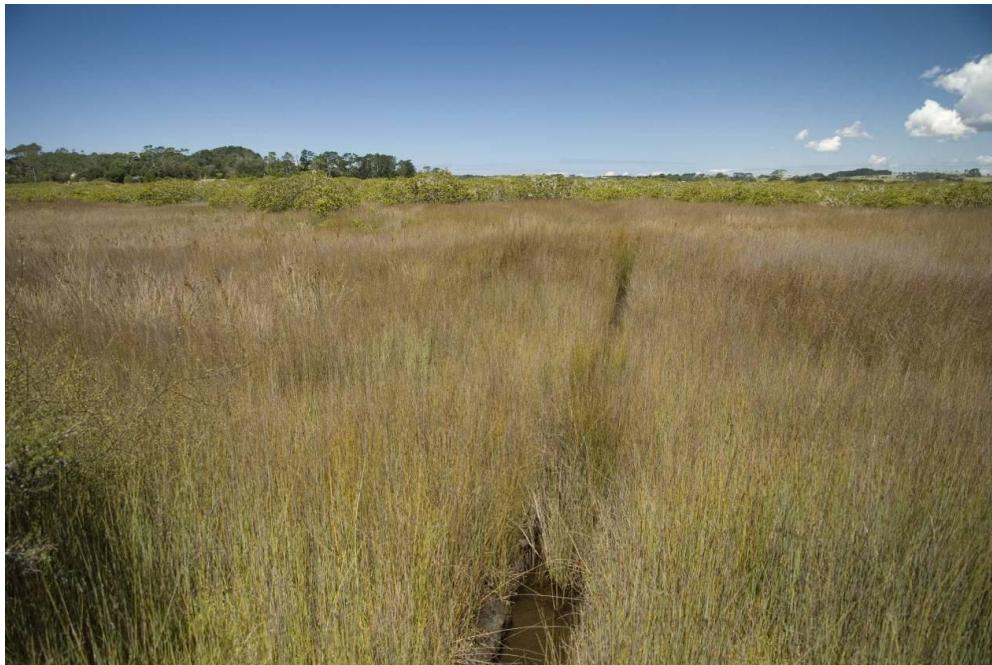
Photo 0537: Drainage ditch cut through the salt-marsh sedgeland.

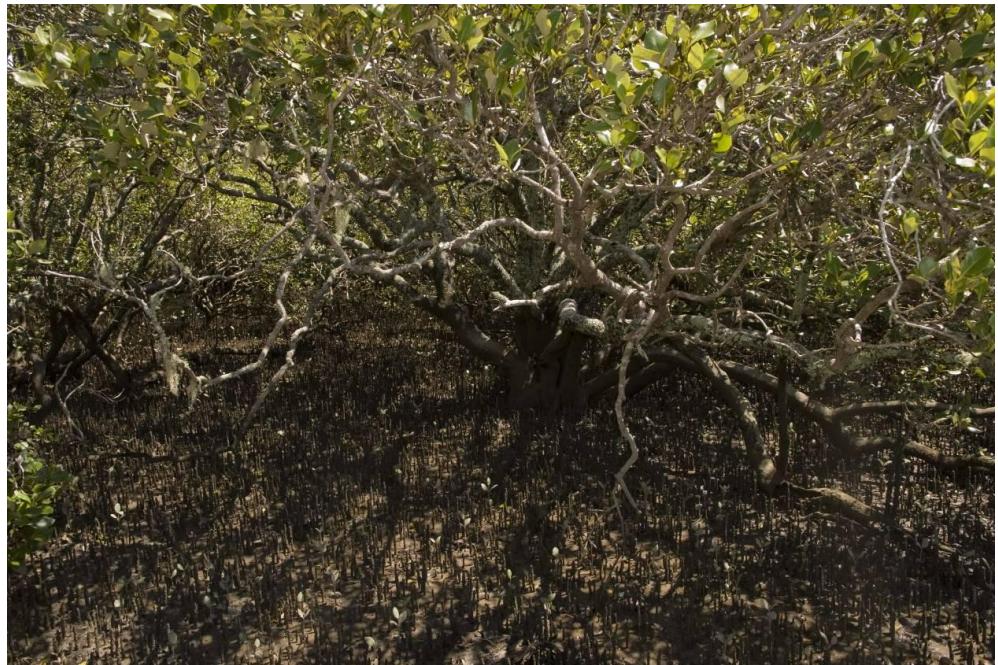
Photo 0672: Tall mangrove tree-shrubland in Kainui Street Arm where some lichens and bryophytes are present.

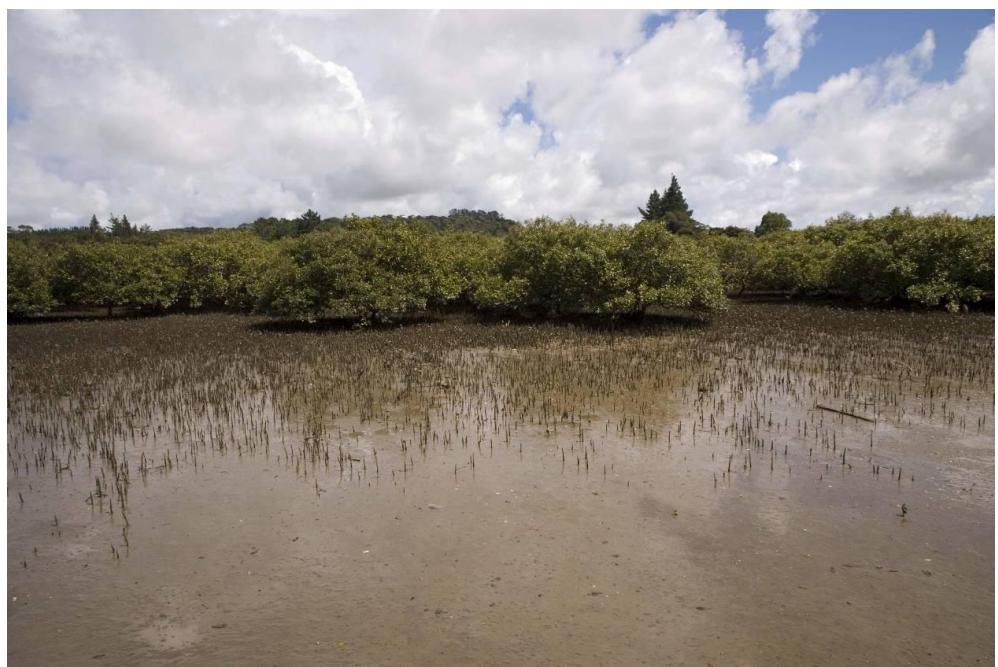
Photo 0669: Mangrove treeland interspersed with colonising mangrove saplings in Kainui Street Arm.

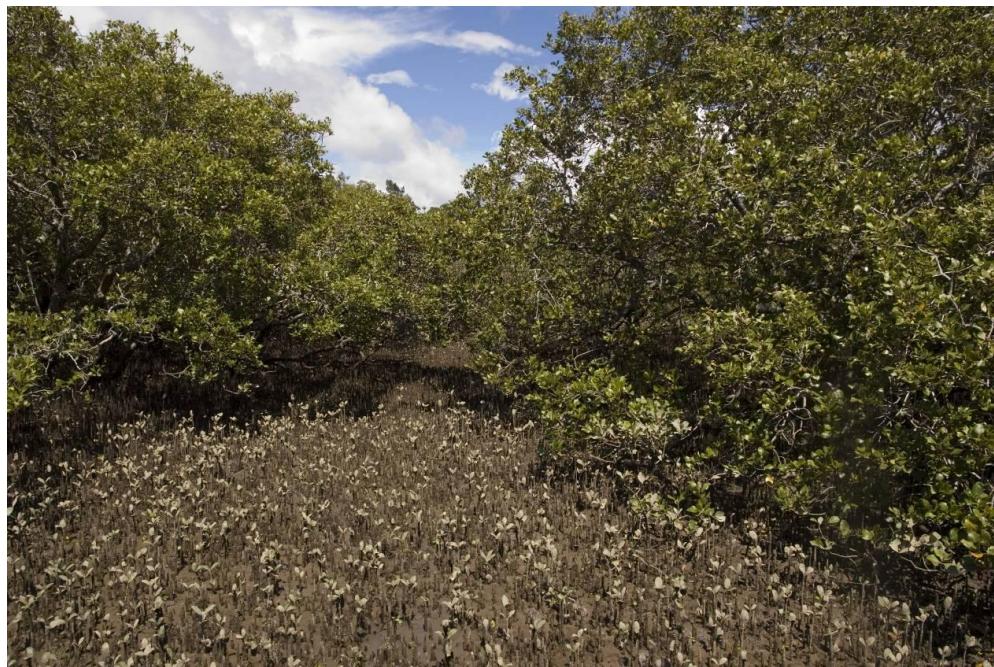
Photo 0674: Mangrove treeland interspersed with colonising mangrove saplings in Kainui Street Arm.

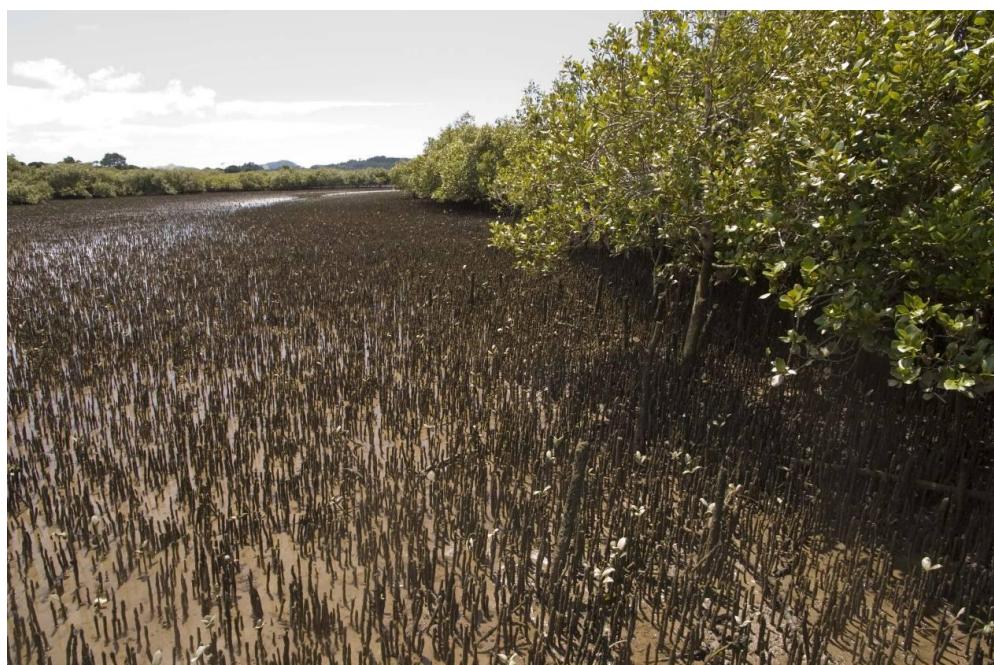
Photo 0675: Mangrove treeland and cut mangrove stumps in Kainui Street Arm.

A discussion was entered into with a local resident on 13 February, who said that he does not like mangroves and admitted to cutting larger trees and pulling out smaller seedlings and saplings. On 17 February., consistent with this, several areas of mangrove stumps were observed (GPS/photo 803, 807/0675, 808/0676, 809/0677). Along the frontage to this person's home (and several others), a boulder retaining wall had been built to minimise the effects of tidal erosion. Where this did not exist and mangroves were absent, erosion was evident.

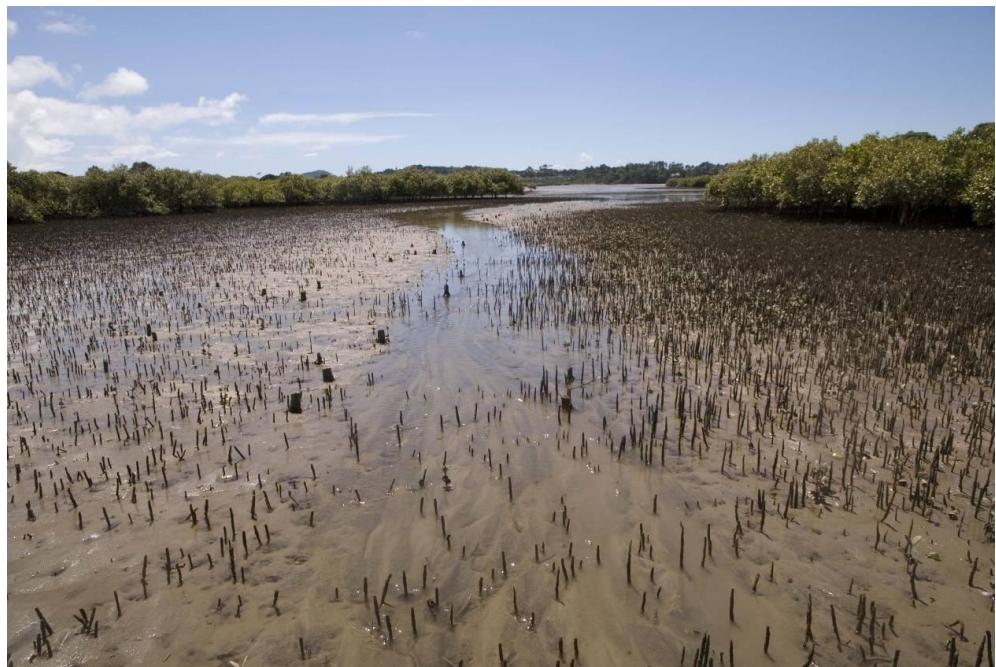
Photo 0676: Mangrove stumps in Kainui Street Arm.

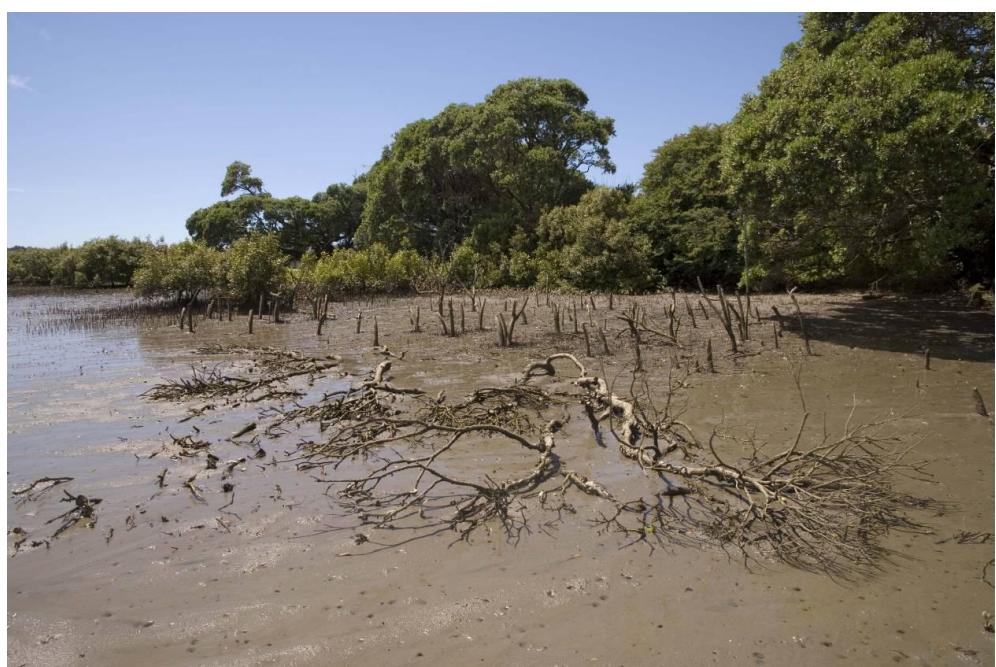
Photo 0677: Recently cut mangroves and stumps in Kainui Street Arm.

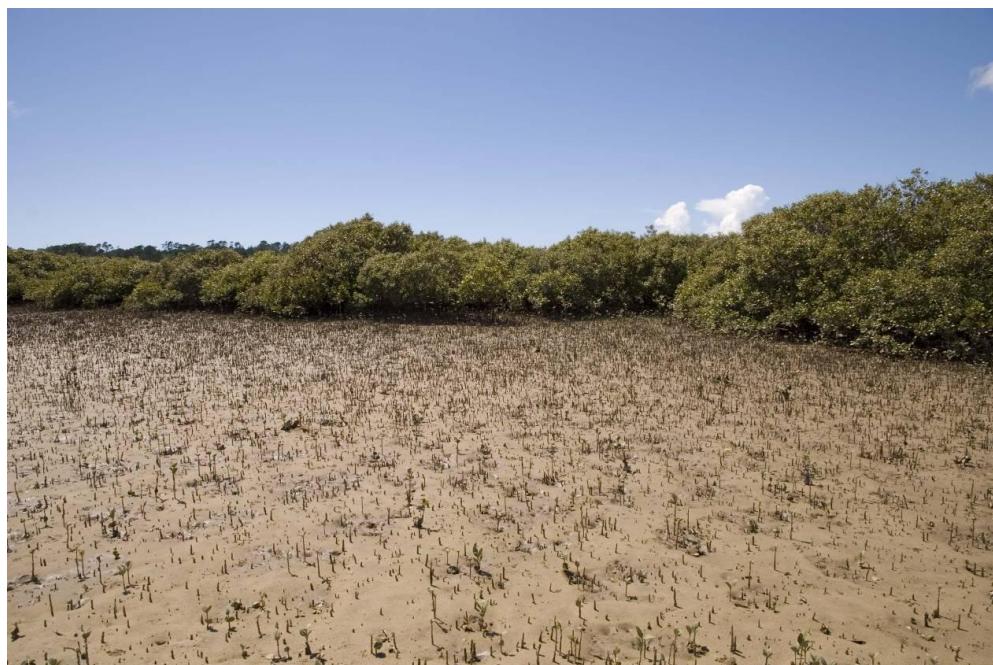
Photo 0648: Colonising sapling mangrove shrubland (foreground), and mangrove tree-shrubland and mangrove treeland (background) on Sand Island.

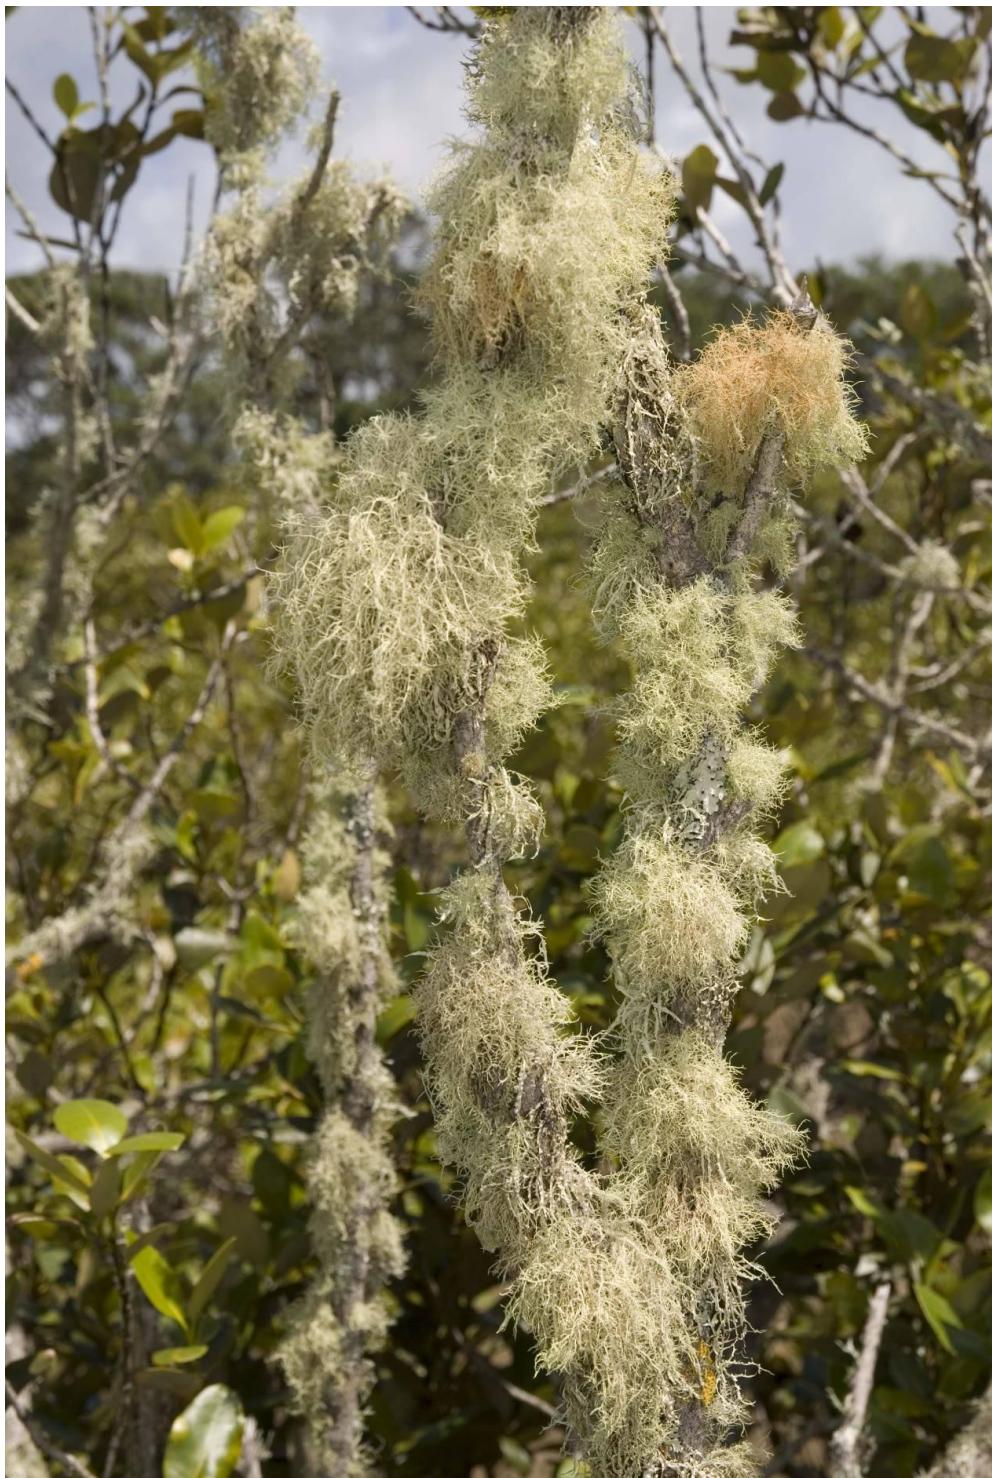
Photo 0636: An assemblage of several lichen species including *Usnea* spp. and *Ramalina* spp. epiphytic on mangrove on one of the 'islands' at Insley Street causeway.

A channel of Bob's Creek runs between the causeway and two of the mangrove tree-shrublands (GPS 792-796). These 'islands' are vegetated by a mangrove tree-shrubland, and have a reasonable lichen diversity (photos 0635 & 0636). At the northern end of these islands (GPS 794 & 795), mangrove shrubland and mangrove treeland occur, and intervening spaces are occupied by mud and Pacific oyster beds (photo 0634). Around the margin of these islands, dense mangrove tree-shrubland occurs – especially on the inner side – and some of these have been cut down. One had a diameter of 10 cm and was therefore estimated to be around 30 years old, but as its centre had rotted out, this could not be confirmed through ring counts.

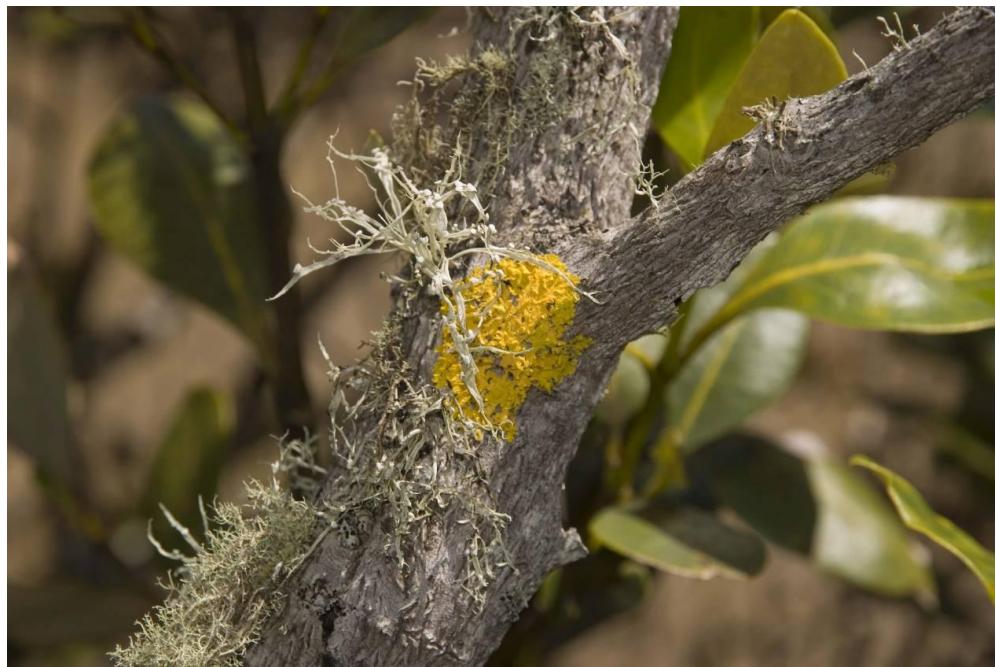
Photo 0635:Lichens seen on mangrove 'island' at Isnley Street causeway: *Ramalina celastri* (upright in centre of photo), *Xanthoria parietina* (yellow) and *Usnea* spp.

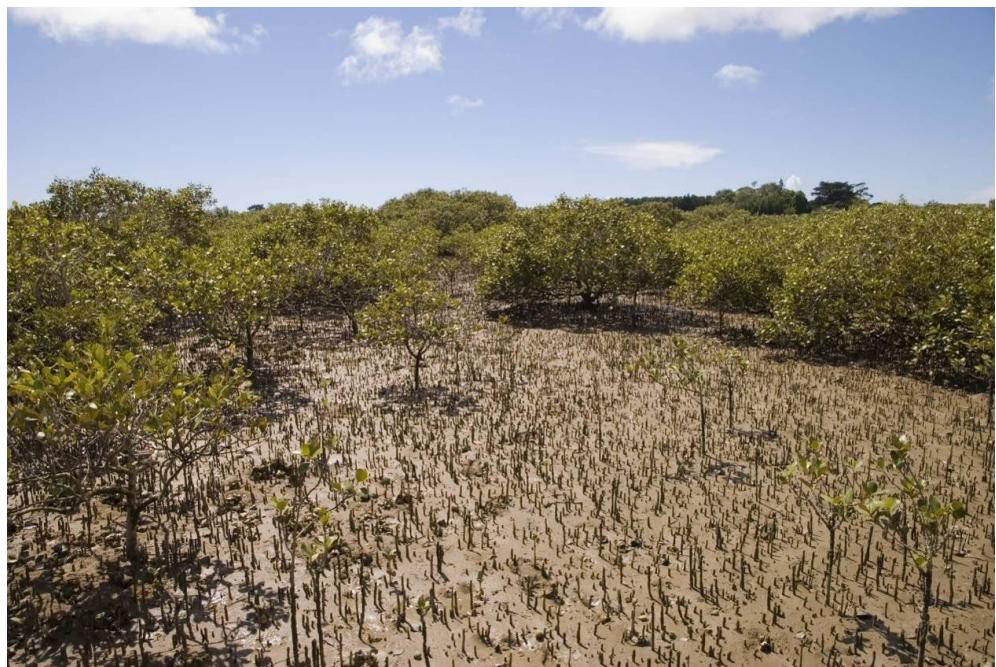
Photo 0634: Mangrove shrubland and Pacific oyster beds on one of the mangrove 'islands' at Insley Street causeway.
