**Proposed Plan Change 85 to the Operative Kaipara  
District Plan**

**STATEMENT OF EVIDENCE OF ANDREW JAMES TOWNSEND**

**(ECOLOGY)**

**ON BEHALF OF THE DIRECTOR-GENERAL OF CONSERVATION**

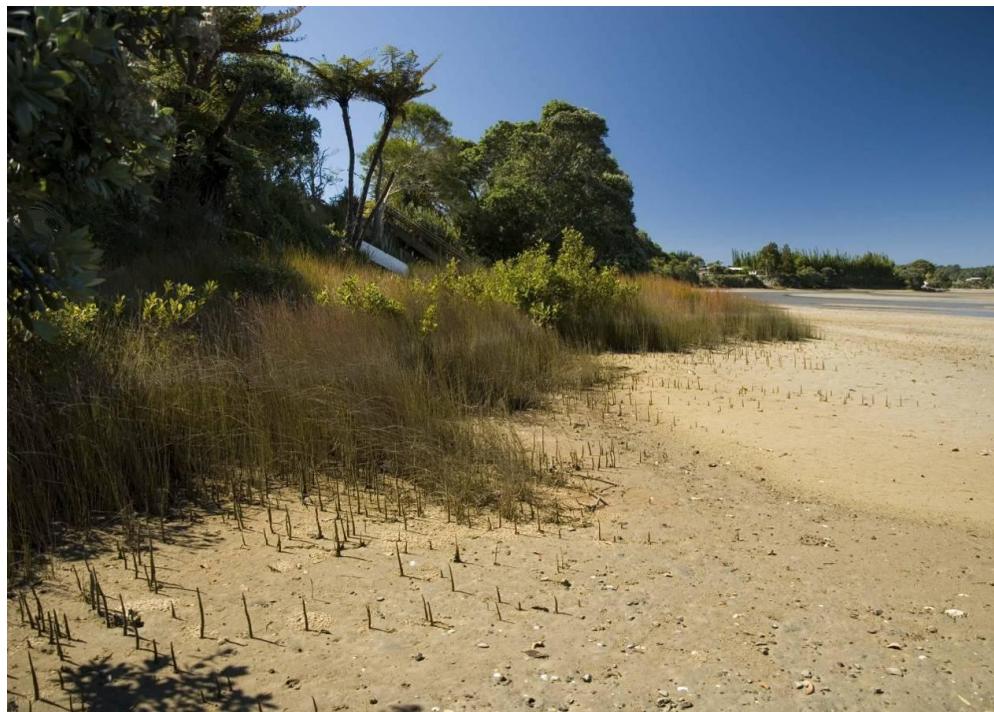
Photo 0548: Healthy salt-marsh with protective mangroves present. Note sand build-up amongst pneumatophores (right).

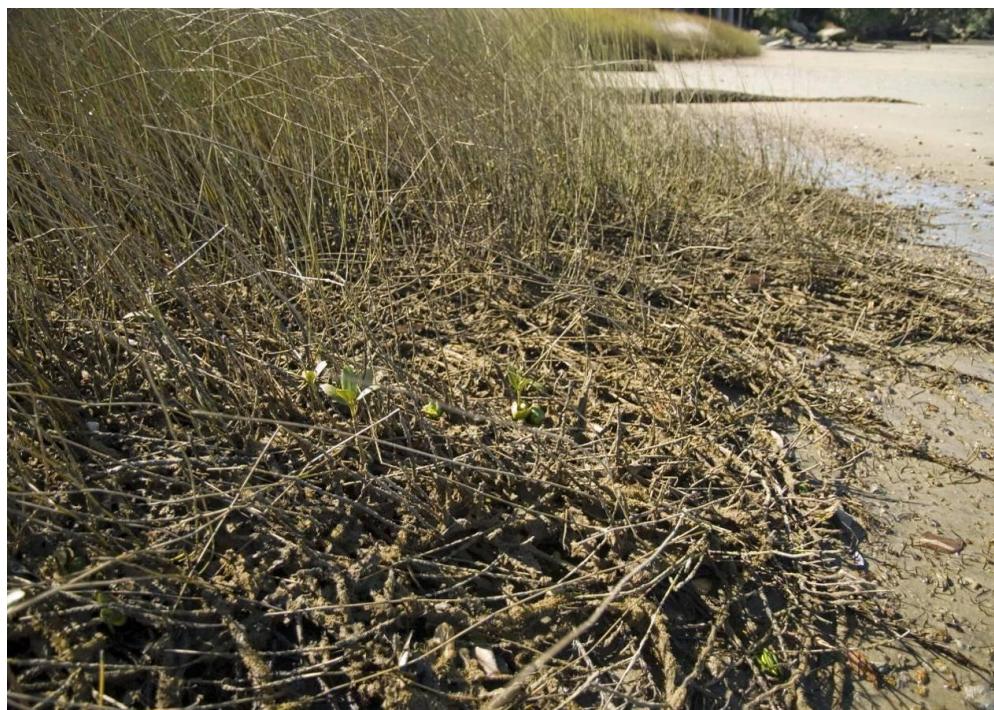
Photo 05558: Young mangroves establishing amongst eroded oioi salt-marsh sedgeland.

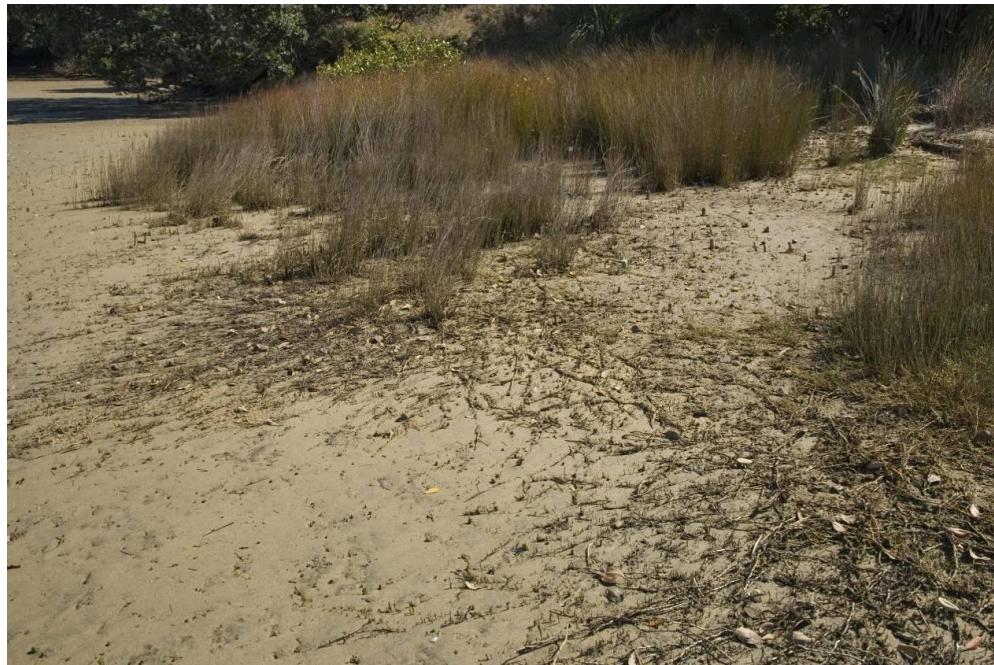
Photo 0551: Mangrove stumps (upper right) where mangroves have been removed and degraded, dead oioi salt-marsh sedgeland.

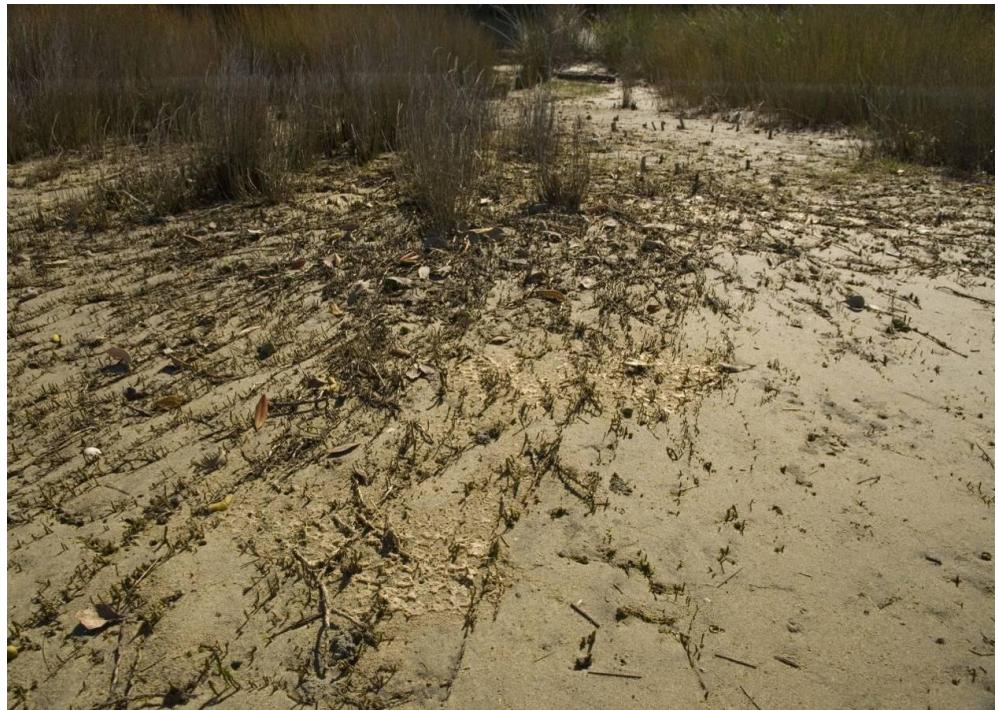
Photo 0552: Dead oioi in-front of an area where mangroves have been removed.

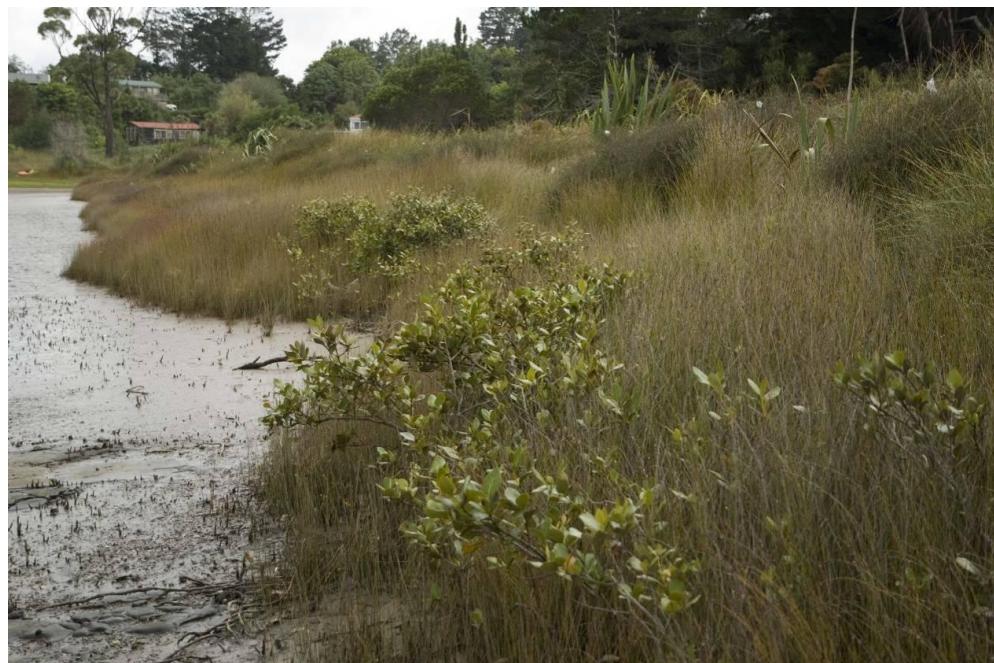
Photo 0559: Mangrove shrubs amongst healthy sedgeland at the eastern end of Moir Point site. Also visible in the photograph is oioi, wiwi, slat-marsh ribbonwood, and harakeke.

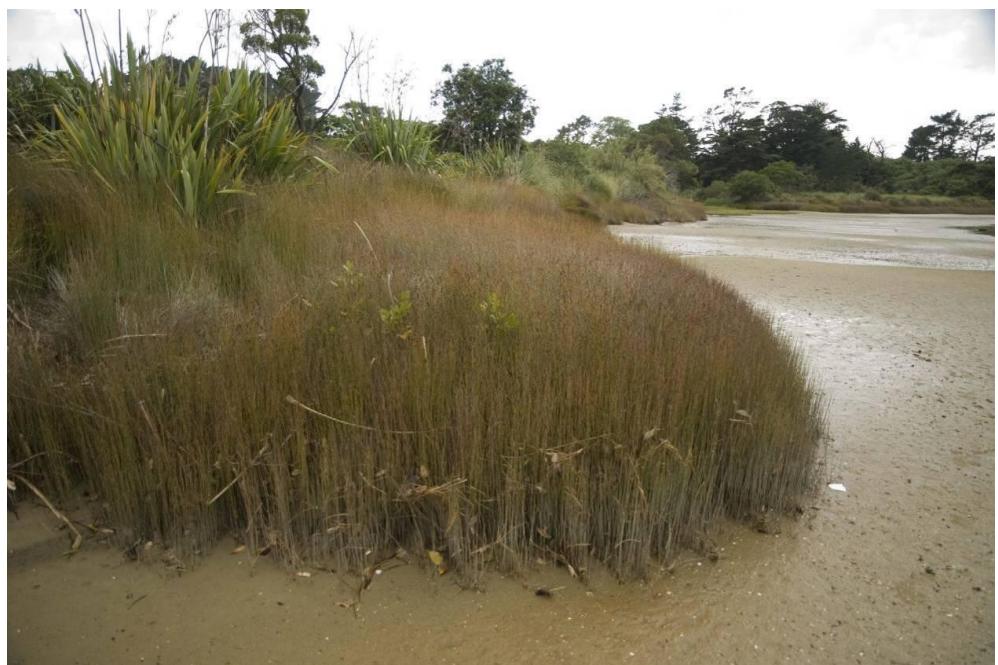
Photo 0563: Healthy salt-marsh with mangroves present.

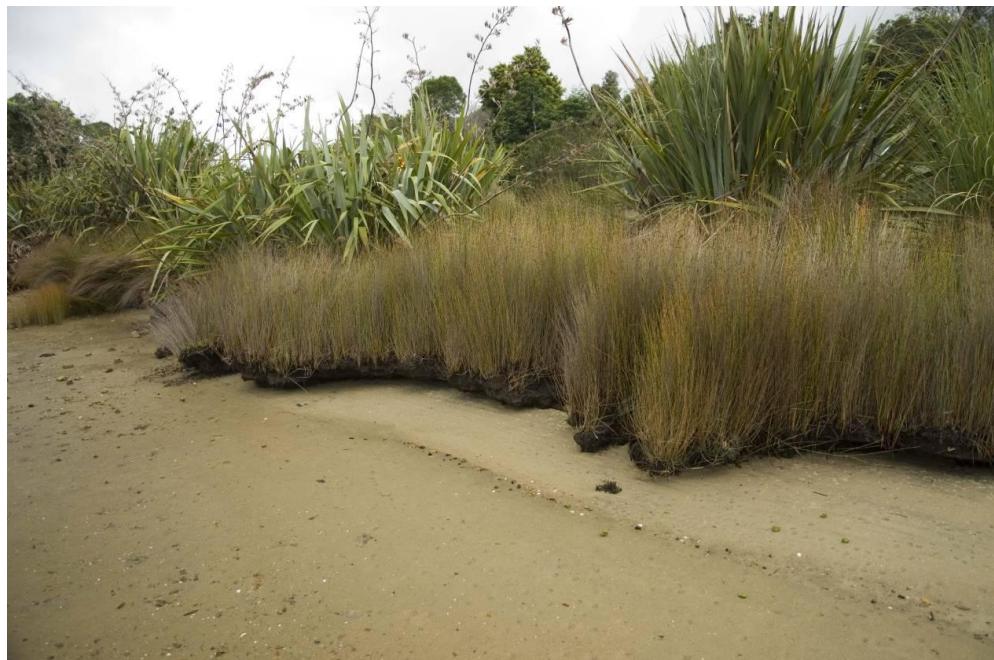
Photo 0562: Eroding salt-marsh at the same location as 0563, without any mangroves present.

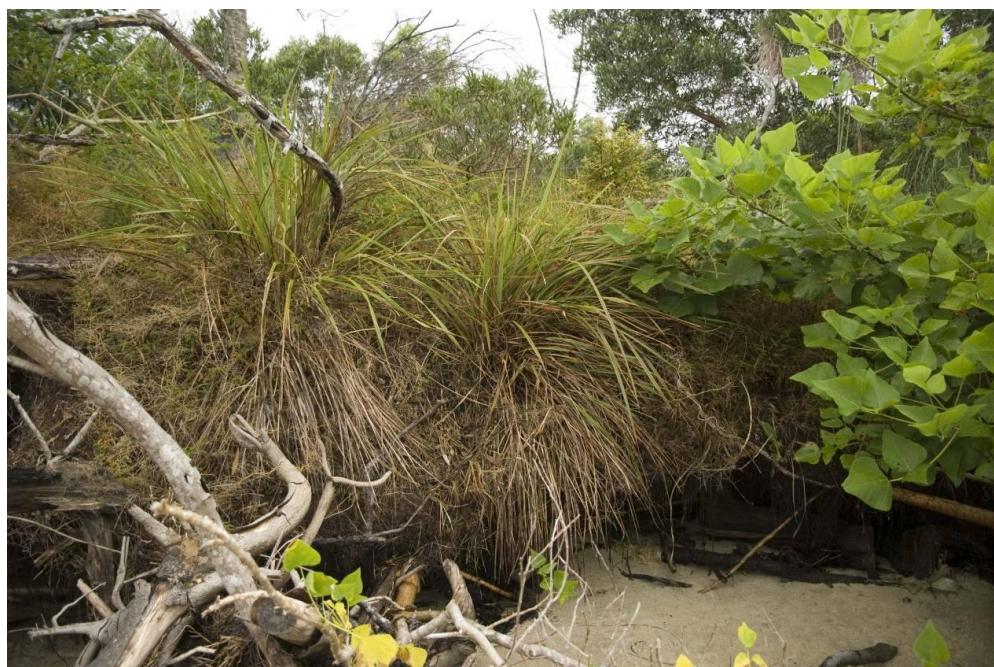
Photo 0568: Swamp blueberry (*Dianella haematica*) on a bank that has eroded back to a line of established trees. Also present is scrambling asparagus (*Asparagus scandens*), coral tree (*Erythrina ×sykesii*), Sydney golden wattle, pampas grass and red mapou (*Myrsine australis*).

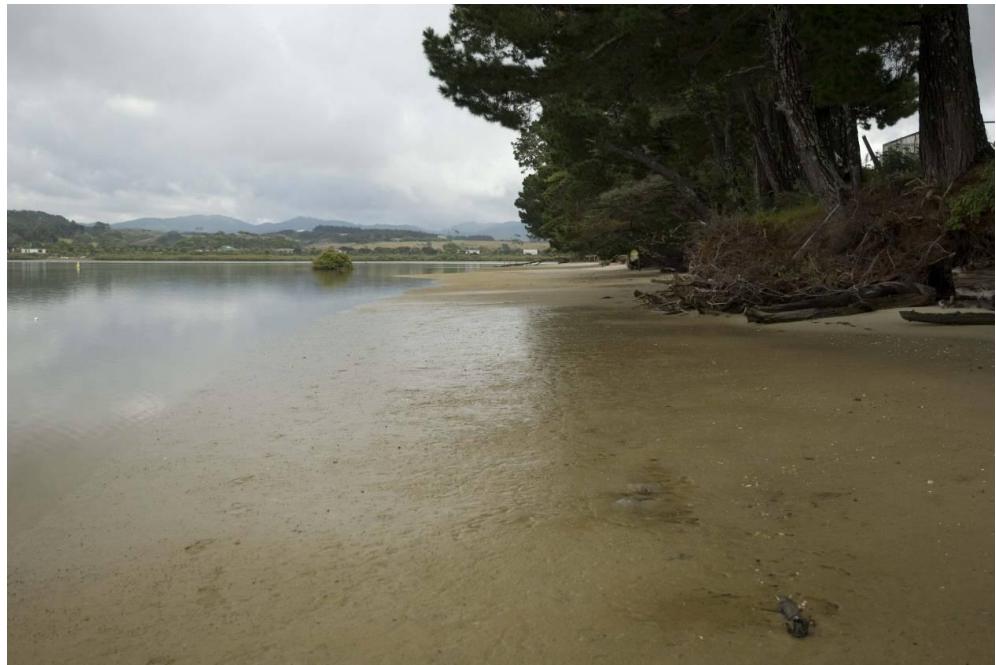
Photo 0569: Single mangrove tree near the Holiday Park. The tidal margin comprises a steep, eroded bank at the base of the pine trees.

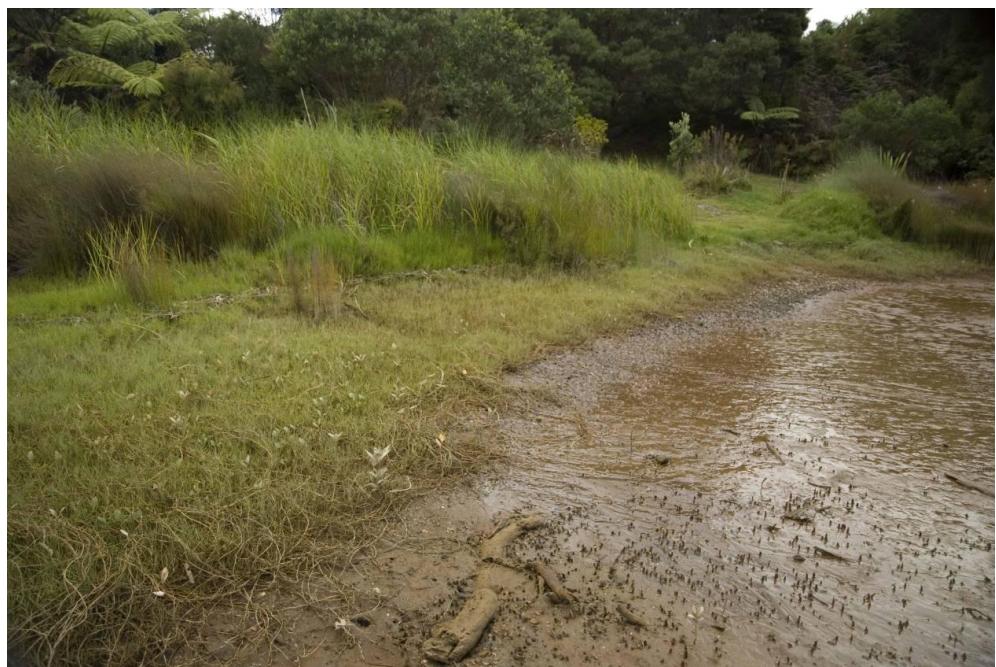
Photo 0573: Mangrove stump, eroding saltwater paspalum grassland with oioi and *Bolboschoenus fluviatilis* sedgelands behind.

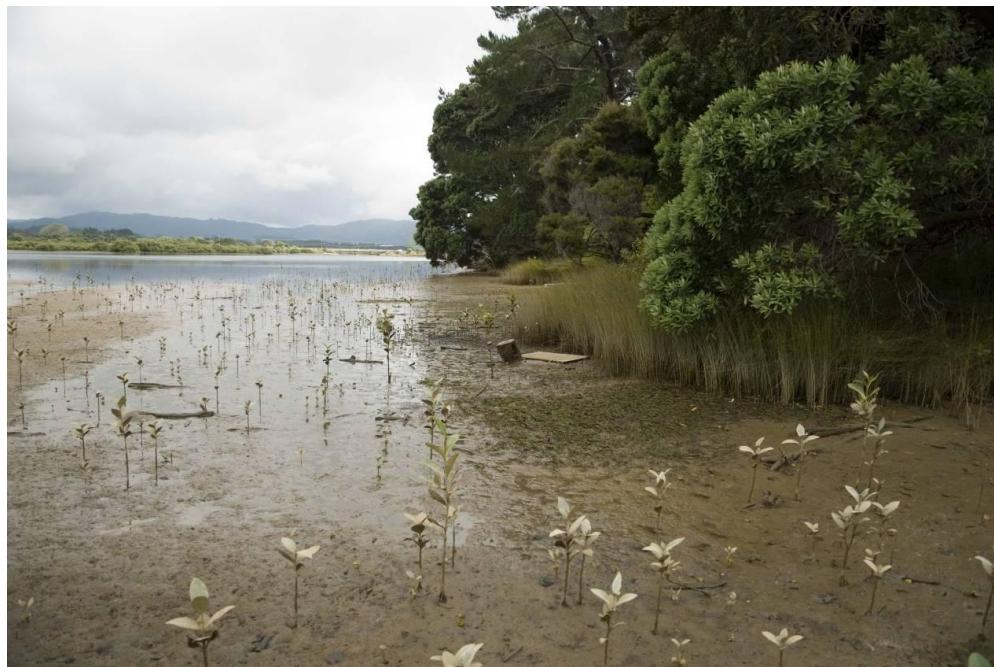
Photo 0571: Colonising sapling mangroves with a small *Zostera* herbfield on mud-flat, oioi sedgeland on the margin and a shrubland with pohutukawa, manuka and narrow-leaved kanuka and radiata pine behind. Both these photos are in close proximity to each other.

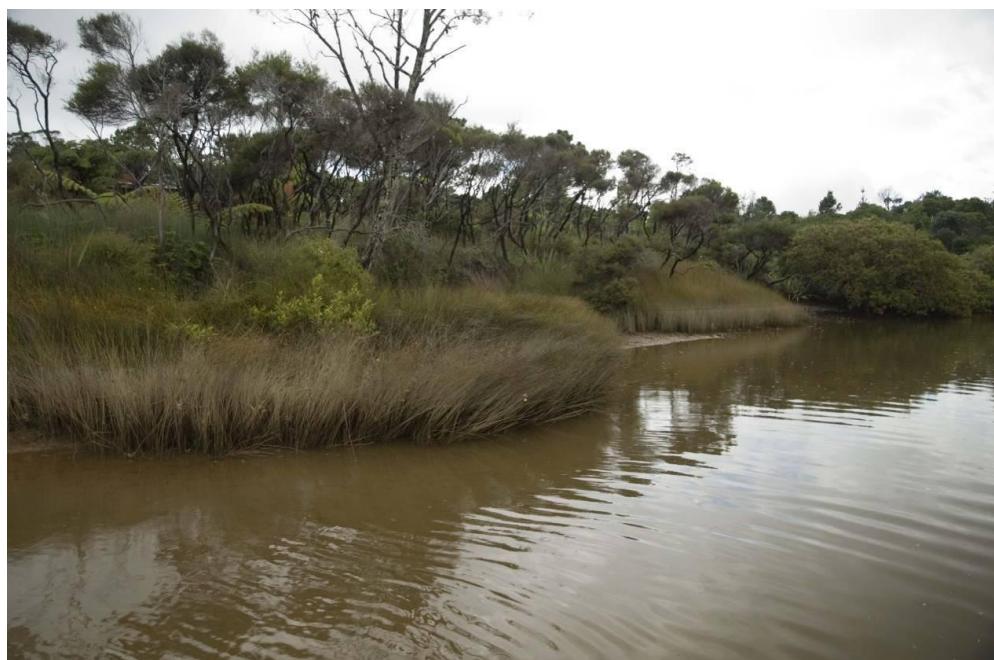
Photo 0581: Natural vegetation Between Moir Point and Molesworth Drive causeway. Scattered mangrove copses with salt-marsh vegetation comprising sea rush tussockland and oioi sedgeland on the tidal margin and *Machaerina juncea* behind. Beyond this is a manuka shrubland with an understory predominantly of *M. juncea* in a largely fresh-water environment.

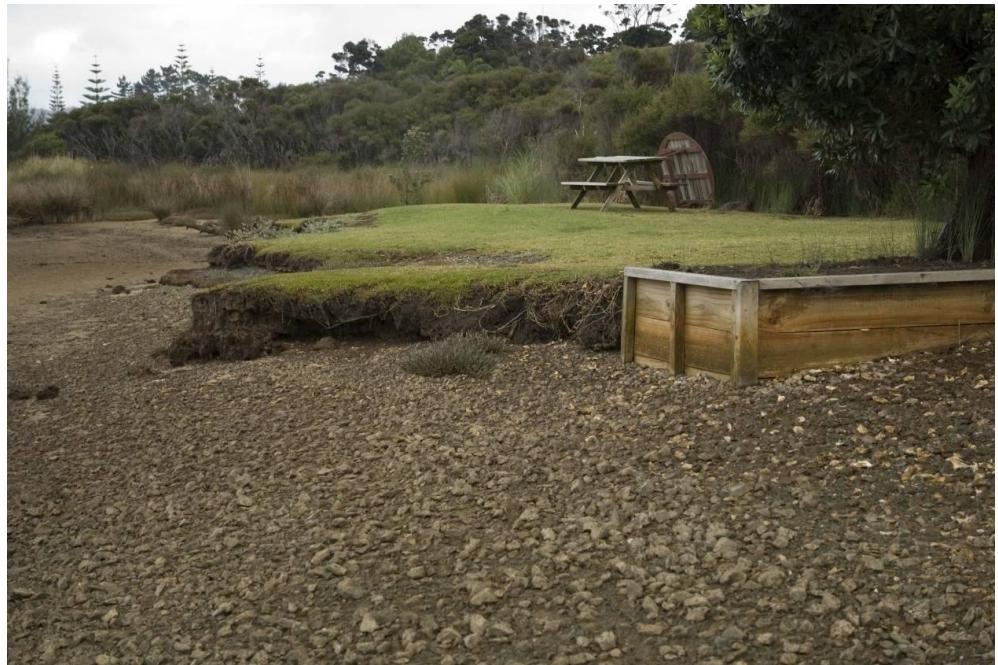
Photo 0582: Retaining walls erected to minimise effects of tidal erosion, which is evident on the edges of the small bank in beyond the wall. Note salt-marsh and largely indigenous shrubland in the background.

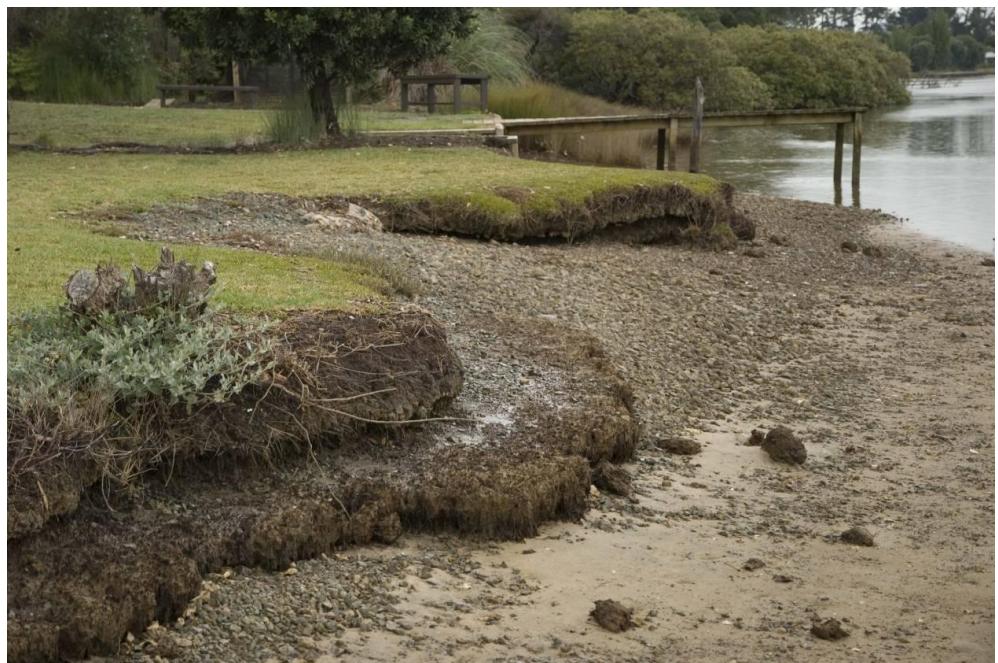
Photo 0585: Layers of eroding peat, that indicate that this shoreline has been stable for a relatively long period.

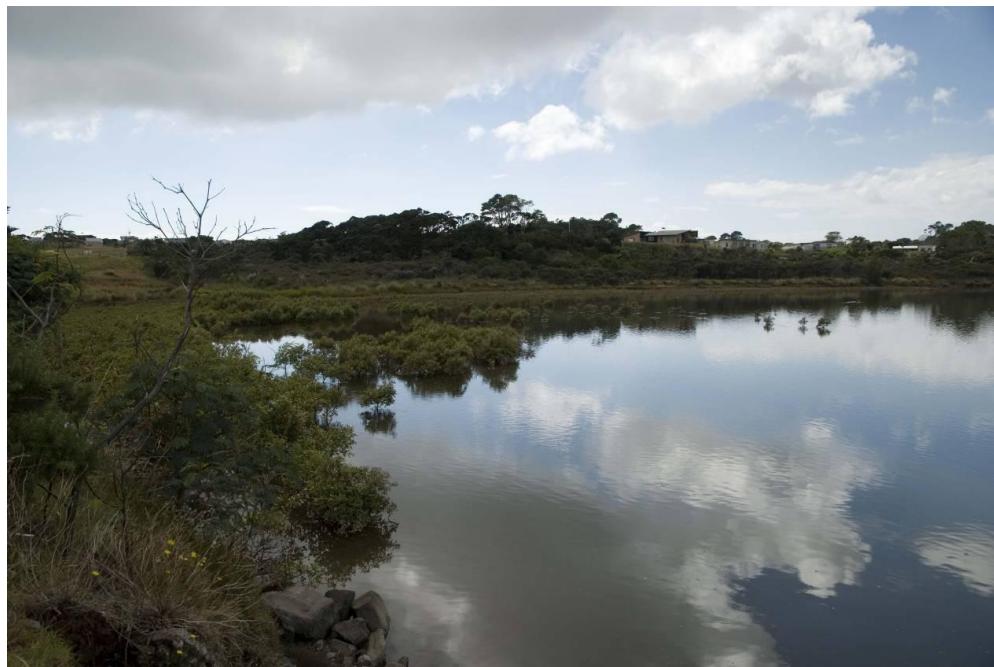
Photo 0595: Relatively natural vegetation near Molesworth Drive causeway, where sequences from mangrove (removed but re-colonising) to salt-marsh, to indigenous shrubland occur.

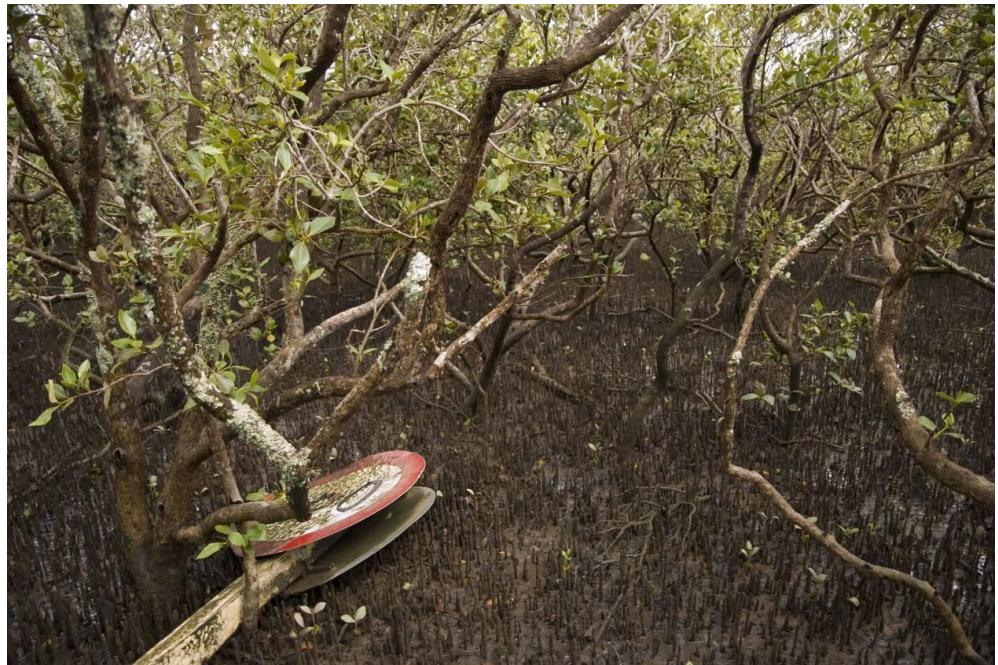
Photo 0613: Black Swamp mangrove tree-shrubland.

Black Swamp site is a dense mangrove tree-shrubland on sand- and mud-flats in the mouth of Black Swamp Creek. The site extends up as far as the causeway but mangrove tree-shrubland extends further up the catchment than this. The mangrove tree-shrubland in the site is relatively open (GPS/photo 783/0613) and supports a wide range of epiphytic lichen species (e.g. photos 0609, 0615 & 0623). These include *Usnea rubicunda*, *Usnea* sp., *Teleoschistes chrysophthalmus*, *Pseudocyphellaria aurata*, *Dirinaria* sp., several species of Parmeliaceae and *Ramalina peruviana*, *Ramalina celastri*, *Ramalina pacifica*, (as determined by Dr. P.J. de Lange, pers. comm., 2012). *R. pacifica* has a listing of “Threatened/Nationally Endangered” and *T. chrysophthalmus* is “Not Threatened” in New Zealand but is threatened overseas (de Lange *et al.*, in sub., 2012). Peter commented that *R. pacifica* has declined rapidly from the northern part of New Zealand and was commonly found on mangroves but has declined markedly from much of the Auckland Region since 1993 (Dr. P.J. de Lange, pers. comm. 2012). It was relatively common in Black Swamp mangrove tree-shrubland. Along the northern margin, is a very narrow, intermittent band of salt-marsh. Vegetation is dominated by buffalo grass, but occasional salt-marsh ribbonwood, wiwi, sea rush and oioi (GPS 783) also occur. Glasswort, sea primrose and oioi form an understory under the mangrove tree-shrubland at GPS 784 (photo 0617). This was also the only area seen where an understory of species other than mangrove has developed under a mangrove tree-shrubland on Mangawhai Harbour.

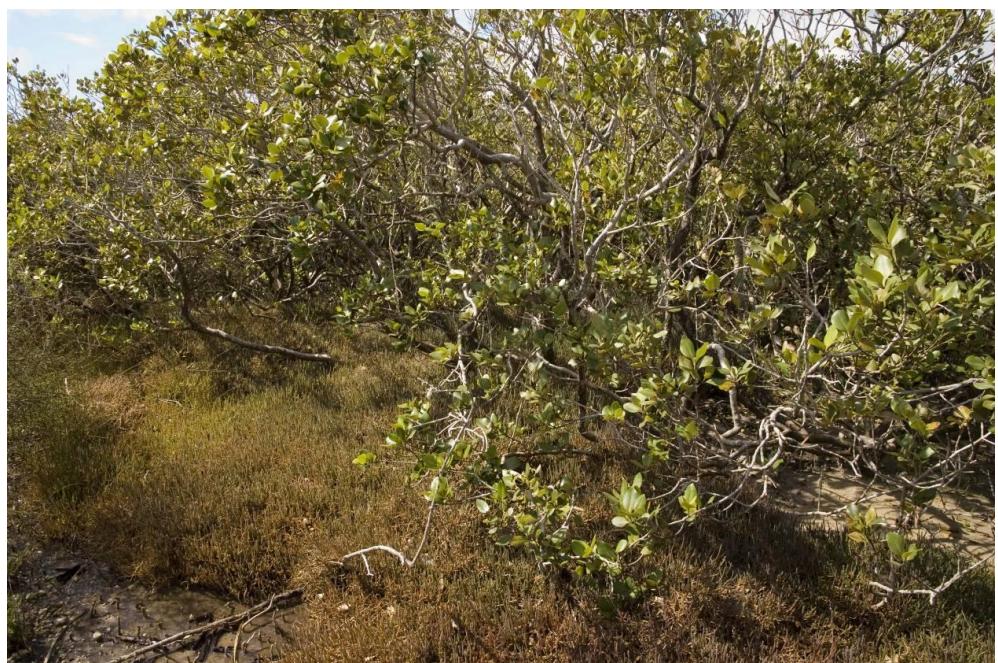
Photo 0617: Black Swamp mangrove tree-shrubland, where an understory of glasswort and oioi has developed.

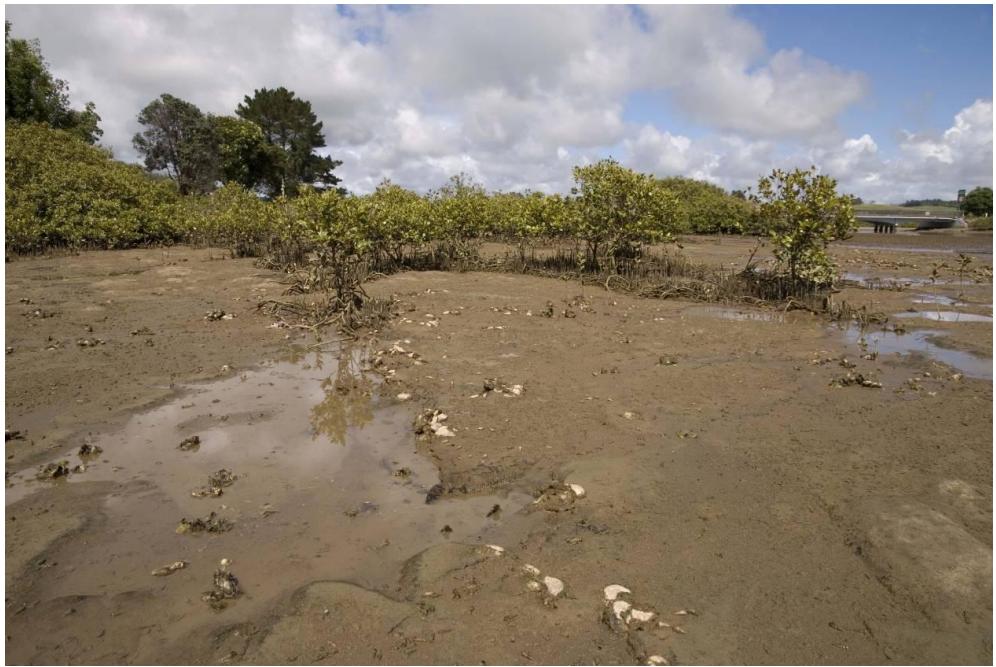
Photo 0624: Mangrove shrubland over sandstone pavement between Black Swamp and Insley Street Causeway.

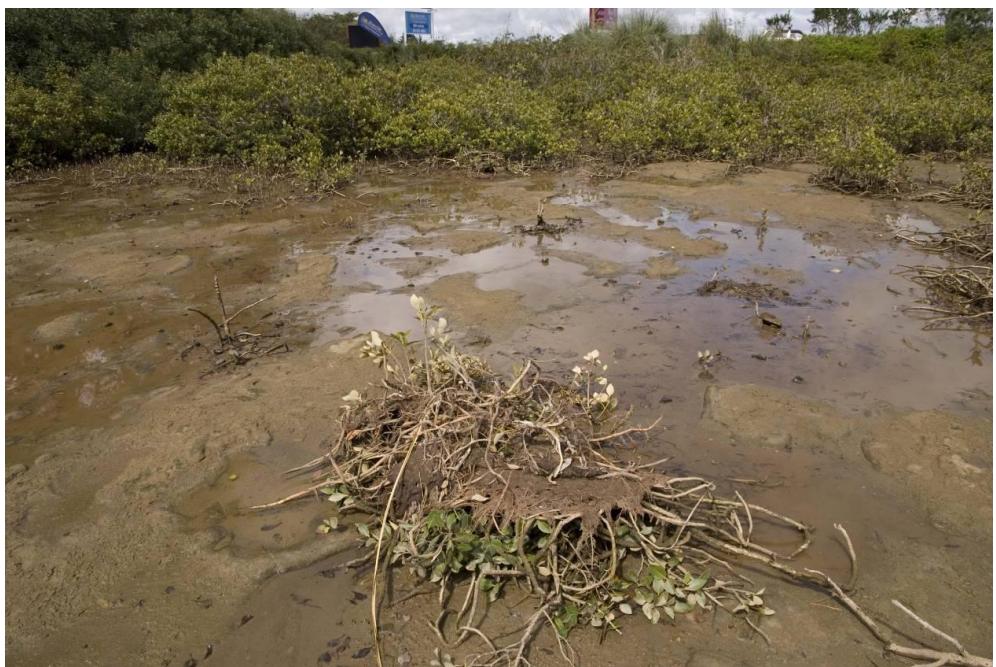
Photo 0628: Pulled up mangrove between Black Swamp and Insley Street Causeway.

On the seaward side of the tree shrubland, young mangroves have colonised an area of mud-flat (GPS 781), and south of this, where Black Swamp Creek disgorges onto the mud-flat, is an area of deep, sludgy mud, where mangroves have been removed but are re-colonising. Saplings to about 70 cm tall were seen here. To the east of this (at GPS 787) is an area of wave-cut sandstone pavement overlain and in-filled in cracks by squashy mud where mangroves are colonising (photo 0624). This extends to Insley Street causeway, where there are also patches of mangrove tree-shrubland (GPS 789) and evidence of mangroves having been pulled up (GPS 789; photo 0628) and cut (GPS 790; photo 0629).

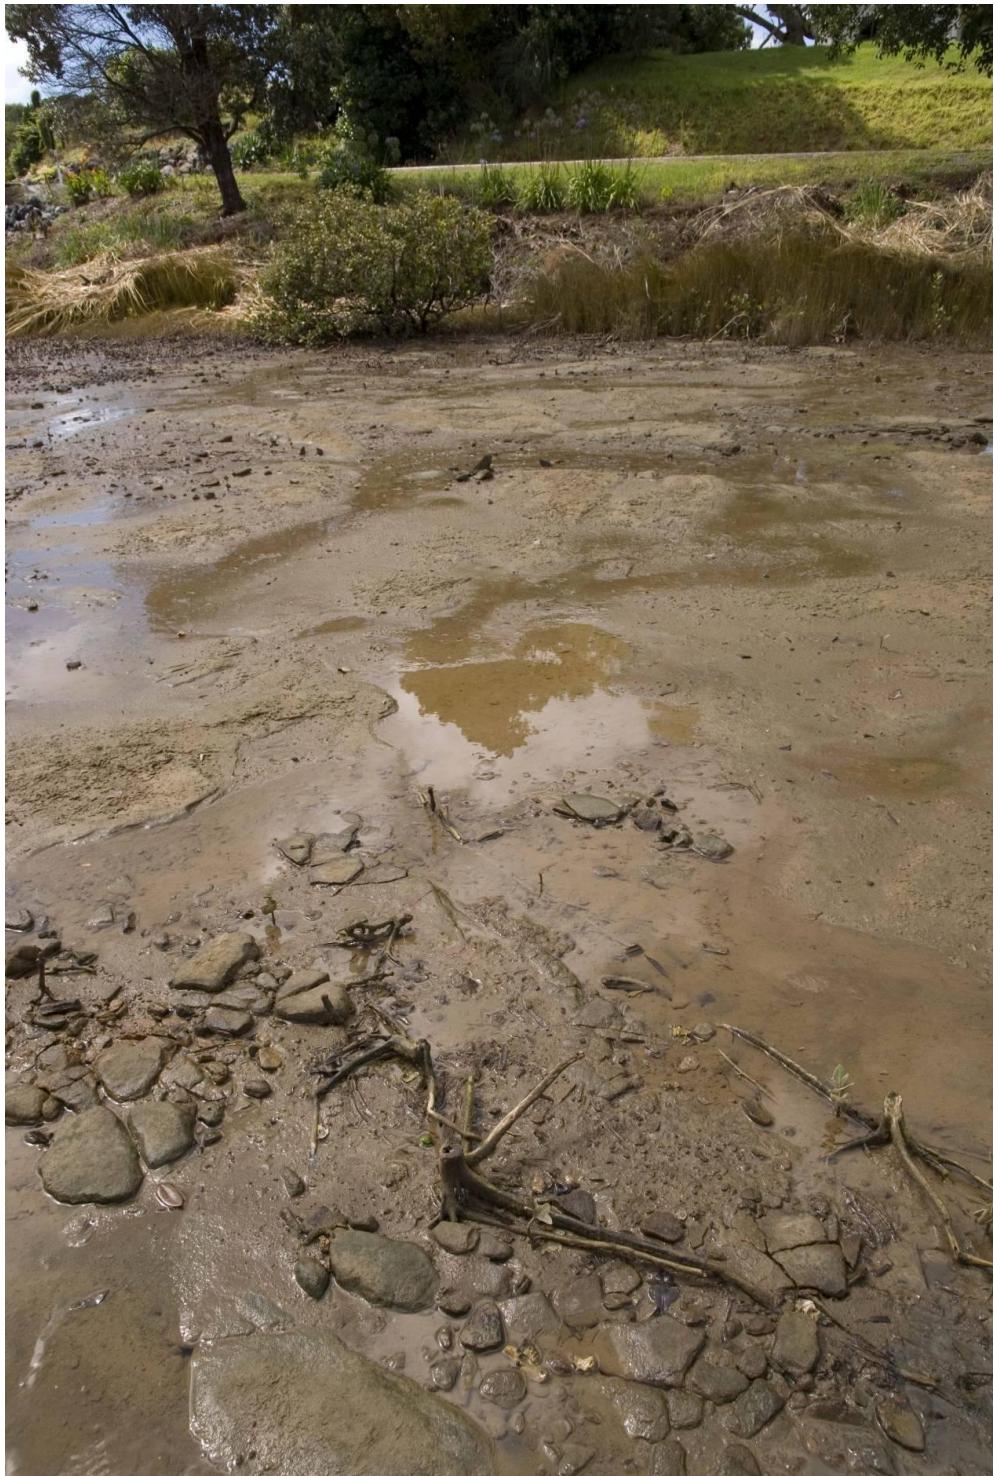
Photo 0629: Cut mangroves between Black Swamp and Insley Street Causeway.

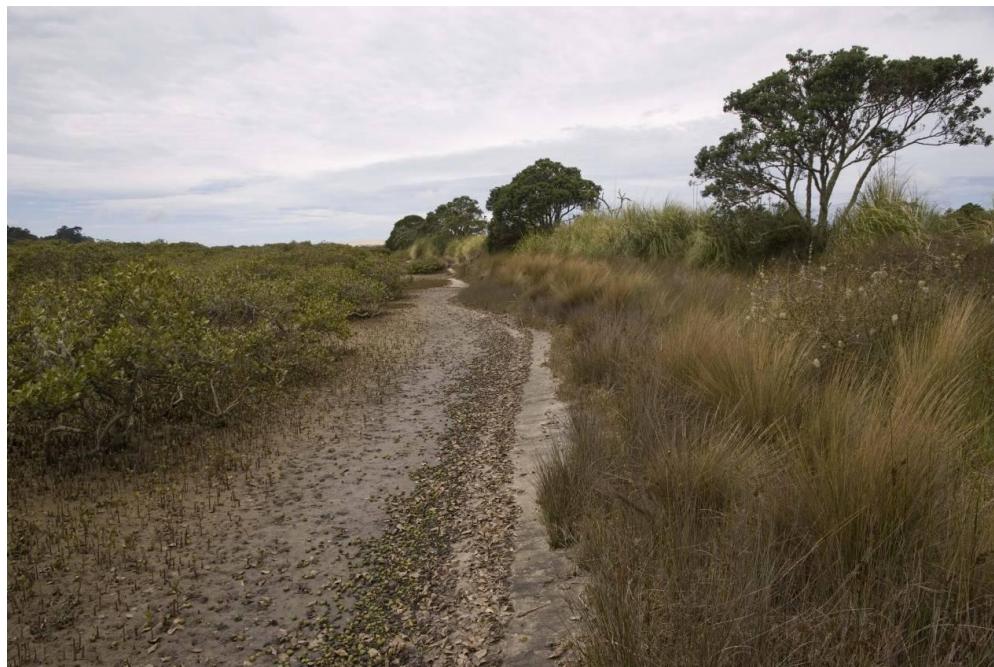
Photo 9792: Track running between mangrove tree-shrubland and salt-marsh vegetation, in this case, sea rush, *Austrostipa stipoides* and salt-marsh ribbonwood. The stop-bank with planted pohutukawa and pampas grass is visible in the background.

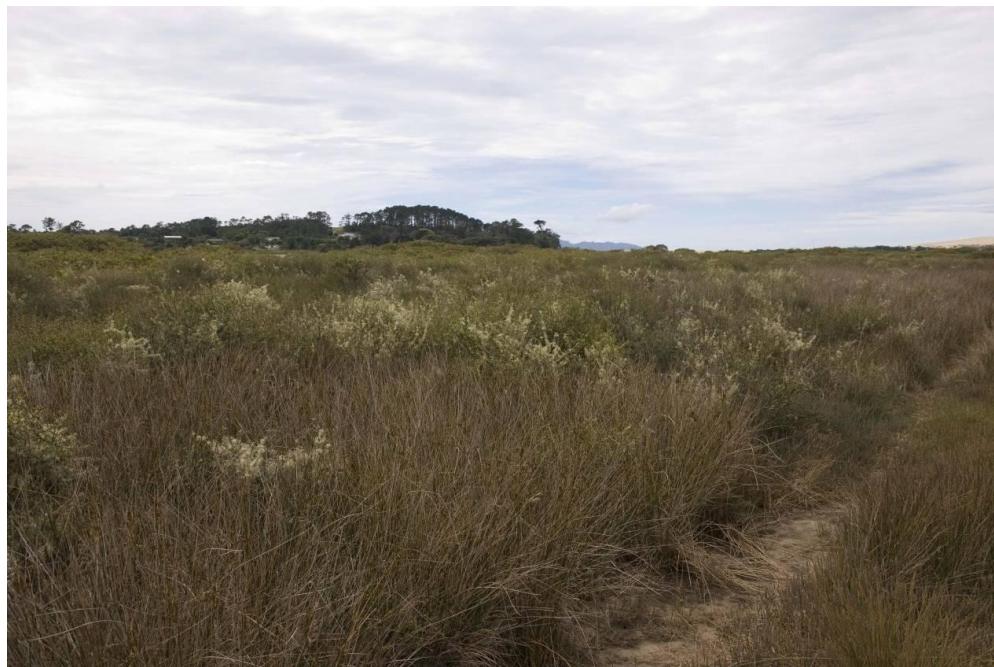
Photo 9797: Sea rush and salt-marsh ribbonwood shrub-tussockland. The vehicle track is on the right and mangrove tree-shrubland is in the background.

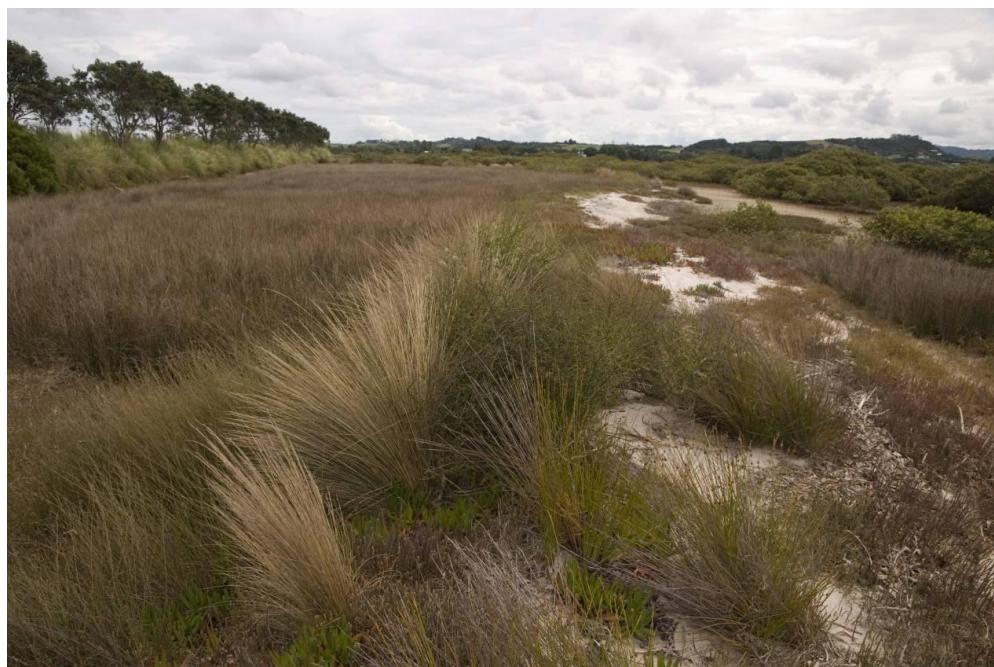
Photo 9798: Sand-bank separating Mangrove tree-sharbland (right) and salt-marsh of sea rush tussockland and oioi sedgeland. *Austrostipa stipoides*, wiwi, glasswort and South African iceplant with salt-marsh ribbonwood, are main plants on the sand-bank.

From around GPS 823, a sand-bank has formed between the mangrove treeland and shrubland on mud-flat and the salt-marsh vegetation (GPS/photo: 824/9798). Vegetation on the sand-bank is dominated in places by glasswort herbfield (GPS/photo 828/9799); South African iceplant herbfield (GPS/photo: 826/9804; 831/9816) with rare pingao; *A. stipoides* tussockland (GPS/photo: 837/9824); sea rush tussockland; oioi sedgeland and mangrove shrubland. Pingao is listed by de Lange et al. (2009) as “At Risk/Relict.” The salt-marsh vegetation behind contains similar vegetation types, but more usually sea rush tussockland, oioi sedgeland and mangrove shrubland. The mangrove tree-shrubland on mud-flat, sand-bank and salt-marsh all peter out near where Raymond Bull Road ends. At this point vegetation becomes a wiwi sedgeland, saltwater paspalum grassland on the shoreline and saltwater paspalum grassland with colonising mangrove seedlings (GPS/photo: 838/9829). Beyond this point, scattered seedling mangroves exist on the sand-flat (GPS 840) but these are not likely to establish (GPS/photo 841/9830); salt-marsh vegetation is absent.

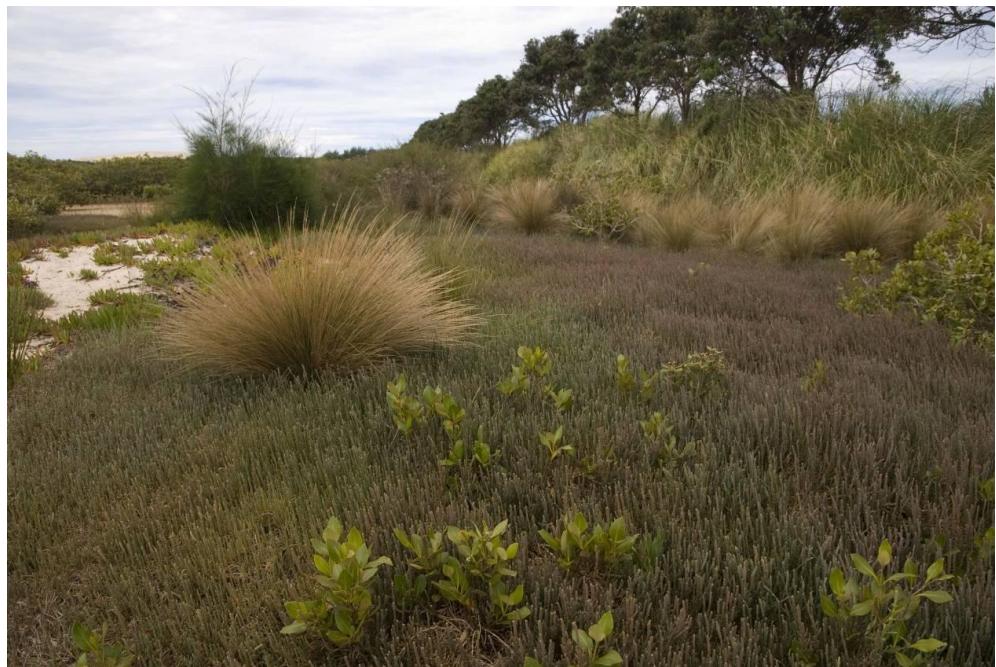
Photo 9799: Glasswort herbfield on the sand bank, with occasional mangroves. The tussock is *A. stipoides* and the tree is sheoak (*Casuarina cunninghamiana*).

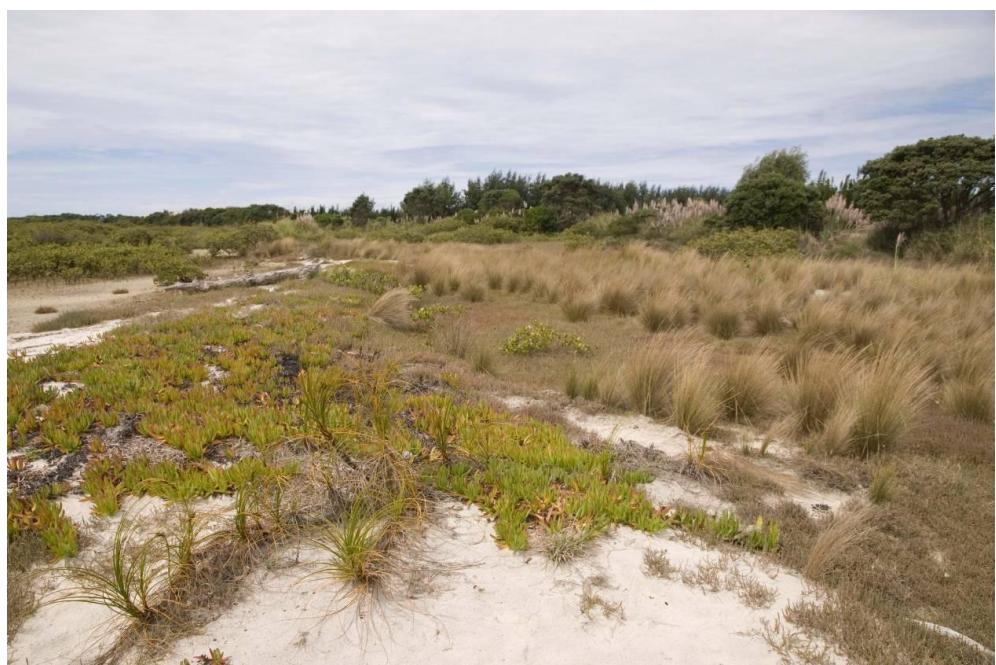
Photo 9816: South African iceplant herbfield on the sand bank, with pingao (*Ficinia spiralis*) and glasswort. Salt marsh at this point comprises an *Austrostipa stipoides* tussockland interspersed by a glasswort herbfield.

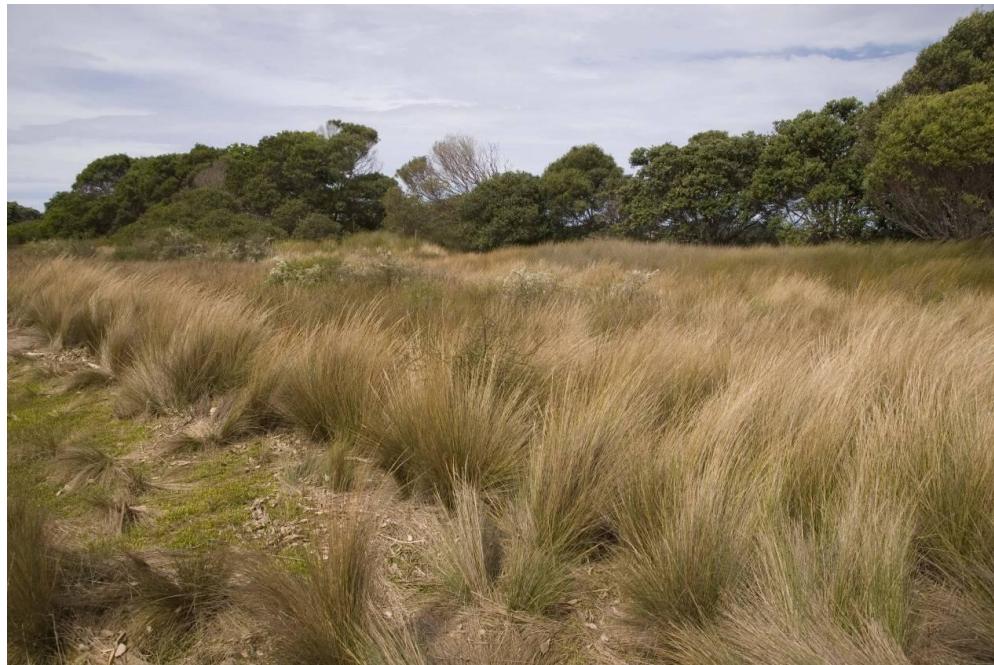
Photo 9824: *Austrostipa stipoides* tussockland with *Selleria radicans* herbfield on sand-bank. The salt-marsh at this point is a mixture of salt-marsh ribbonwood, oioi and *A. stipoides*. Sydney golden wattle is beginning to become common on the stop-bank, behind.

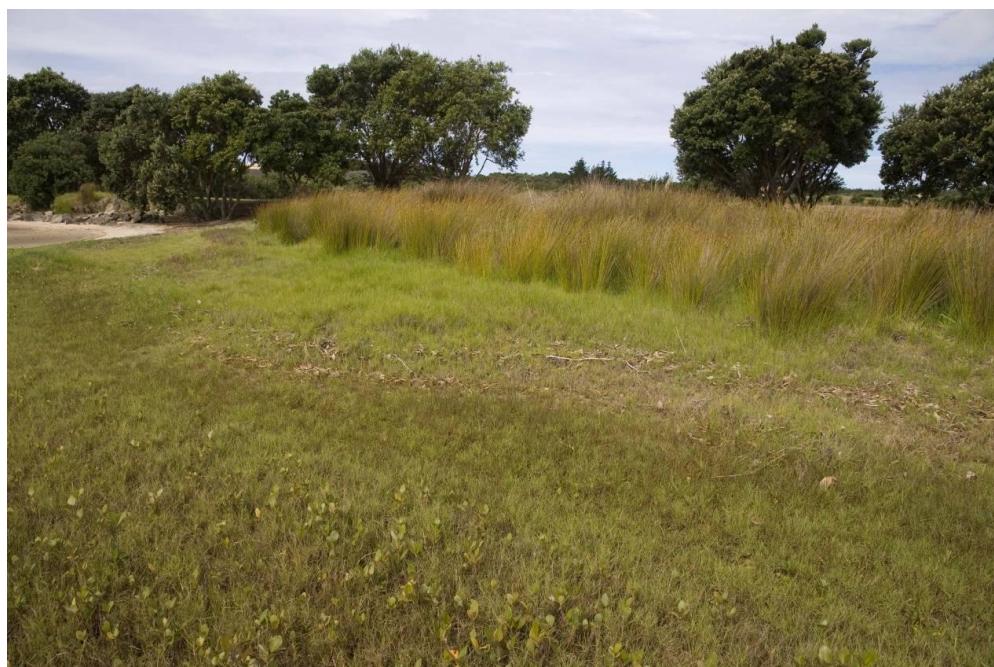
Photo 9829: At the point where the mangrove tree-shrubland ends, the salt-marsh also ends (note rock wall on right). At this point it is dominated by wiwi sedgeland and saltwater paspalum grassland. In the foreground saltwater paspalum grassland also contains seedling mangroves, which may be able to establish.

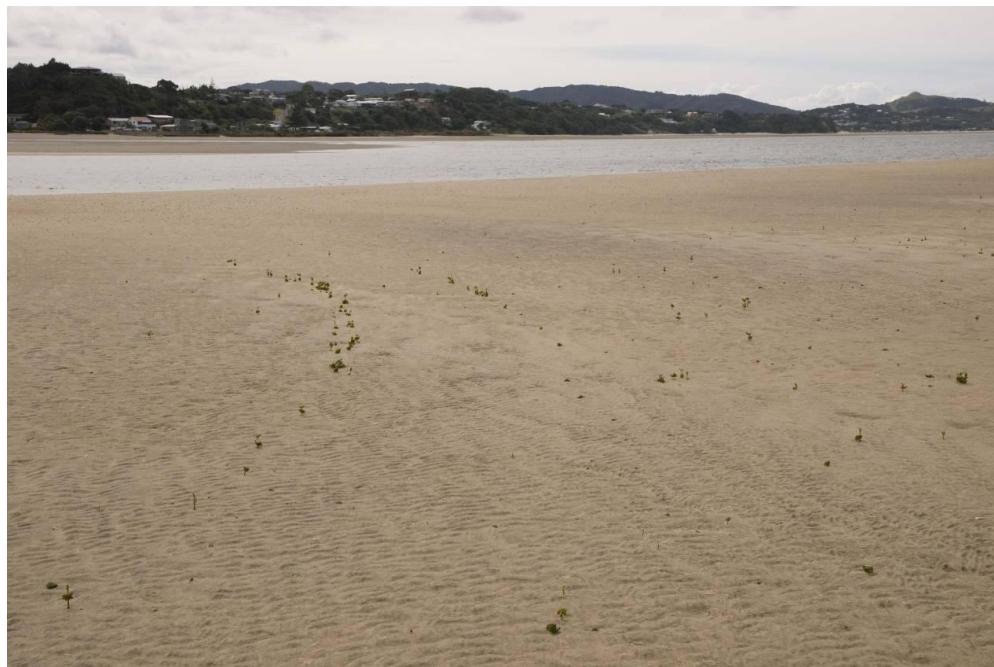
Photo 9830: Young mangroves attempting to germinate in consolidated sand caused by a vehicle.

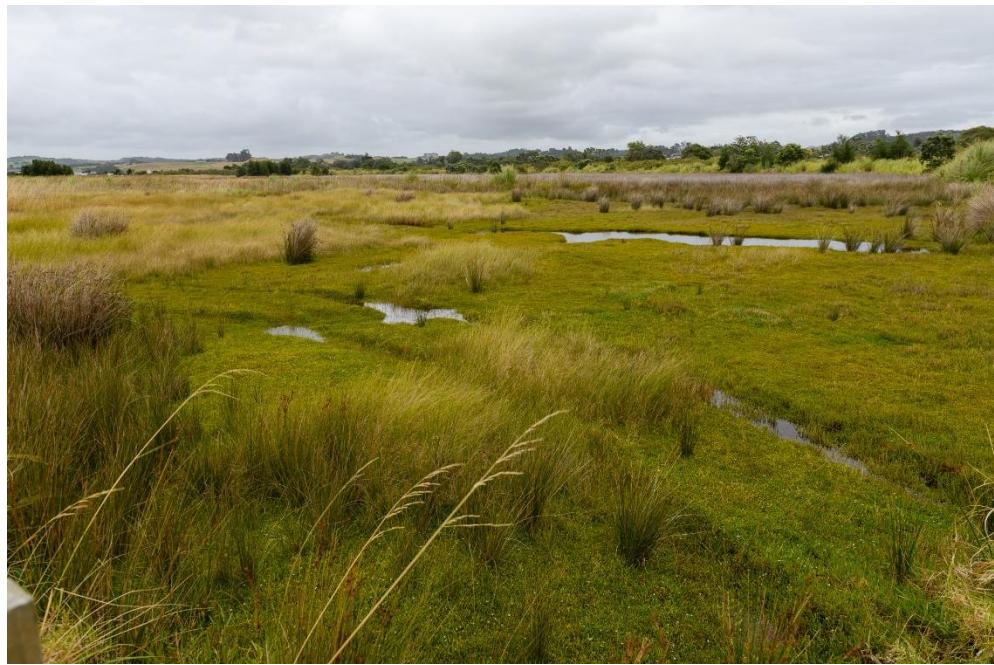
1. Raymond Bull Road end of the Saltmarsh SNA, showing herbfield of remuremu and sea primrose, and various reed- and sedgelands of largely indigenous vegetation.

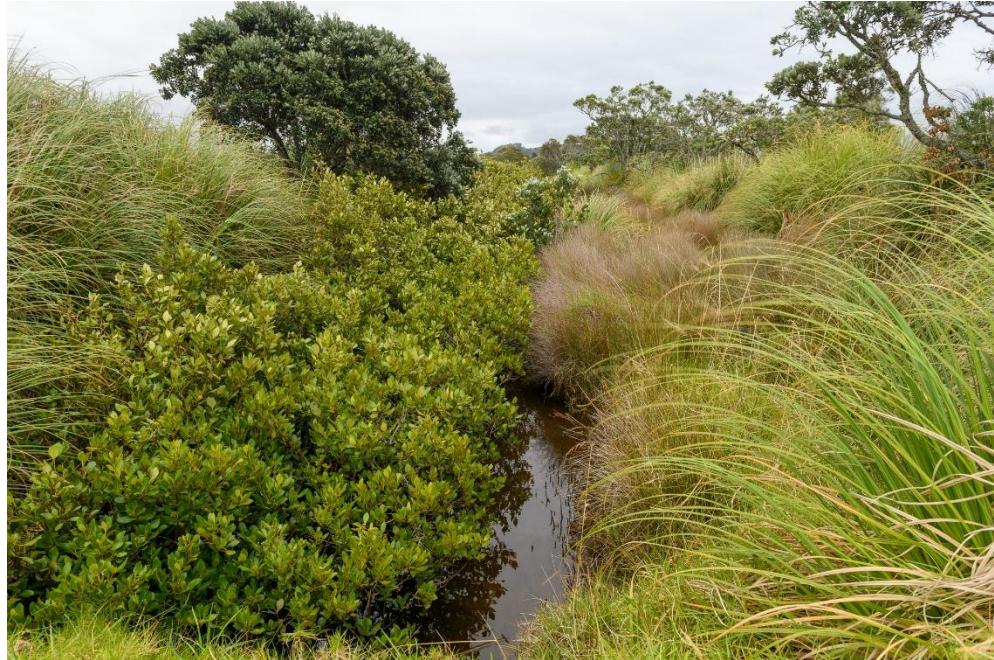
2. Drain between the Saltmarsh SNA and the end of Raymond Bull Road, showing mangrove shrubland, sea rush reedland and emergent pōhutukawa trees over pampas grass on the stop-banks.
