**Proposed Plan Change 85 to the Operative Kaipara  
District Plan**

**STATEMENT OF EVIDENCE OF ANDREW JAMES TOWNSEND**

**(ECOLOGY)**

**ON BEHALF OF THE DIRECTOR-GENERAL OF CONSERVATION**

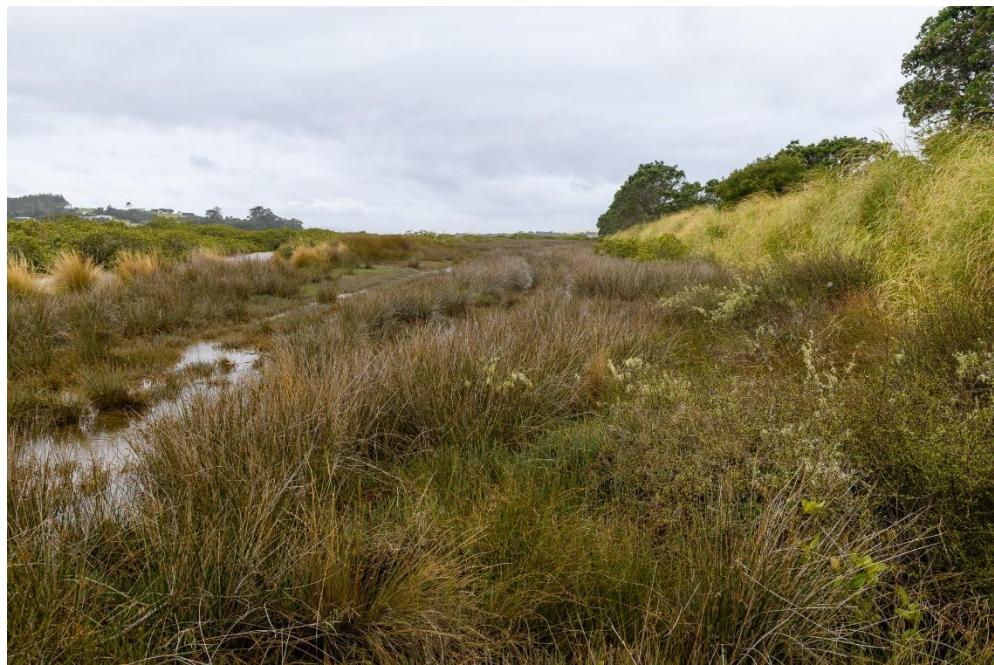
3. Vegetation on the southern shoreline of Mangawhai Harbour, looking very similar to how it looked in 2012.

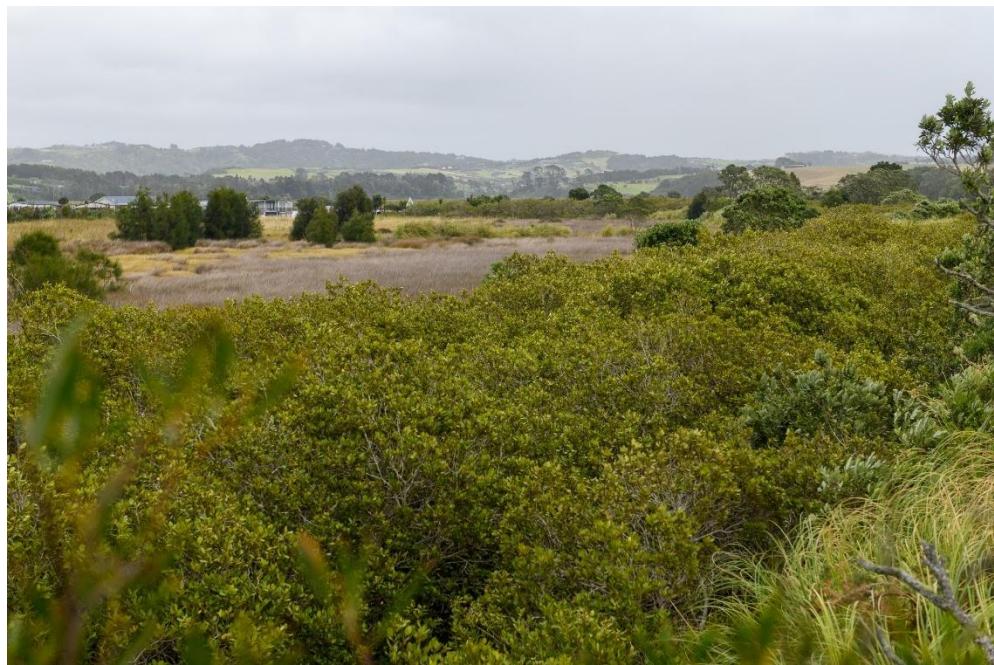
5. View of the eastern end of the saltmarsh SNA, showing mangroves in the drain, sea rush and other rush and sedge reedlands and sedgelands, with a few emergent casuarina (*Casuarina cunninghamiana*) trees and pampas grass clumps towards the motor camp. Raupo (*Typha orientalis*) and *Machaerina articulata* reedland are visible on the far left of the photo, indicating freshwater wetland.

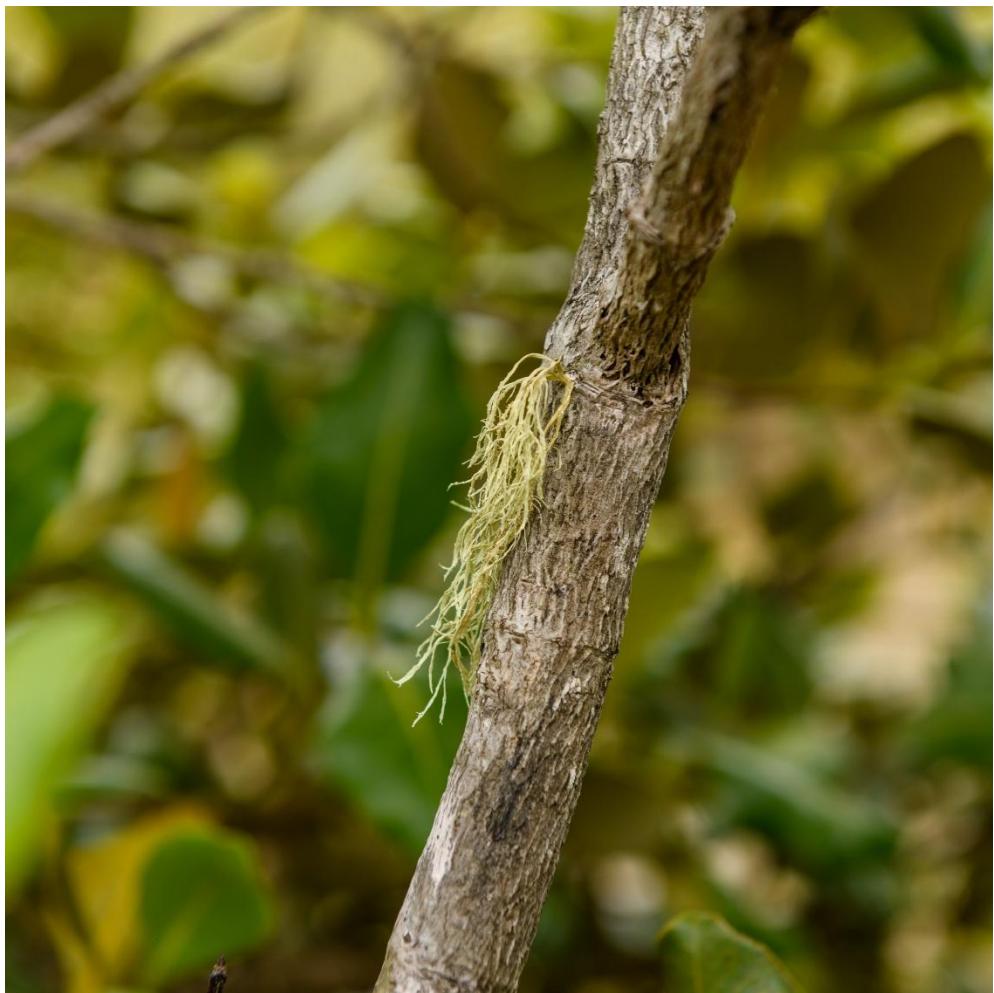
6. The Threatened–Nationally Vulnerable lichen *Ramalina pacifica*, seen growing on a mangrove stem on the southern shoreline of Mangawhai Harbour in 2026.
