Geotechnical Assessment

Mangawhai
Kaipara District

16.04.2019
15601.000.003_02

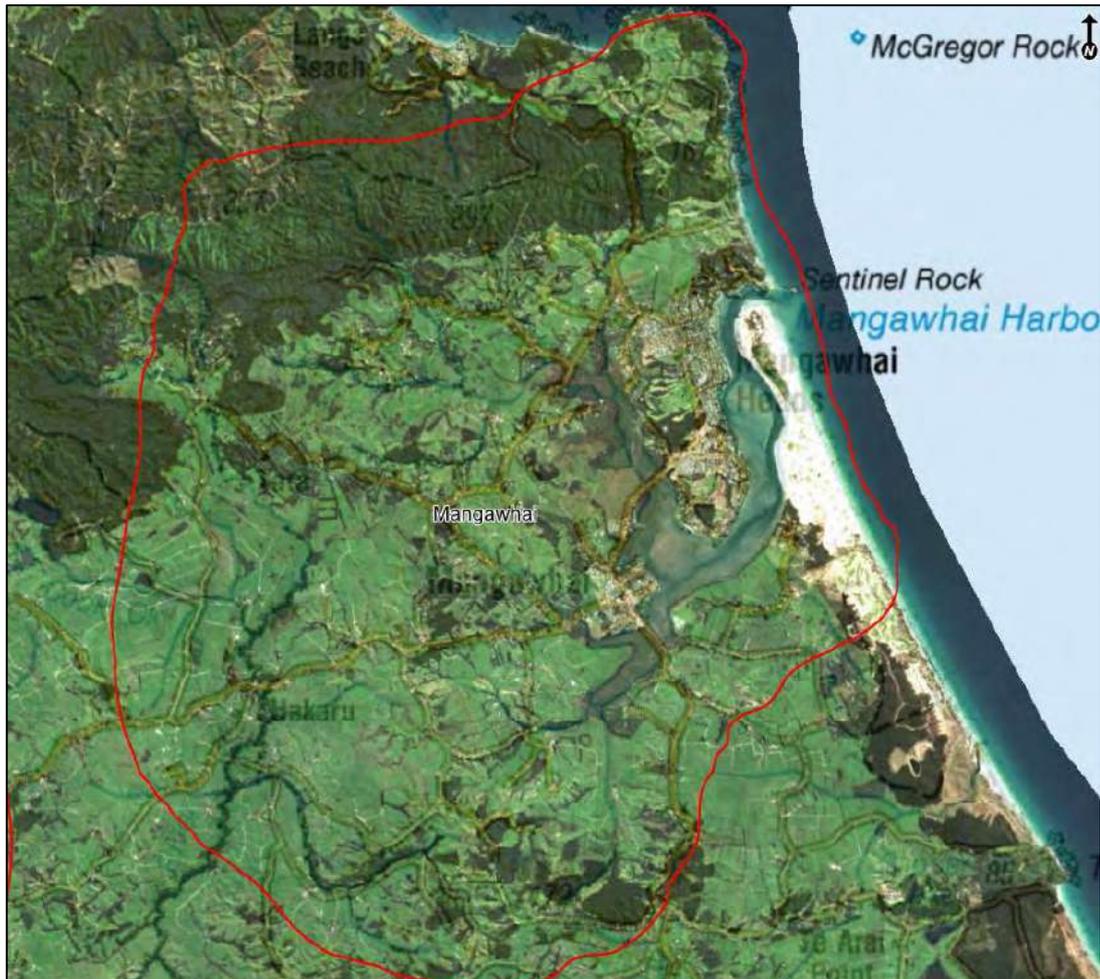
Figure 2: Indicative Growth Area

Image sourced from Eagle Technology, CC-BY-3.0. The Indicative Growth Area boundary was provided by Kaipara District Council. Not to Scale

The vicinity of the study area is shown in Figure 1, and the Mangawhai Indicative Growth Area is shown in Figure 2.

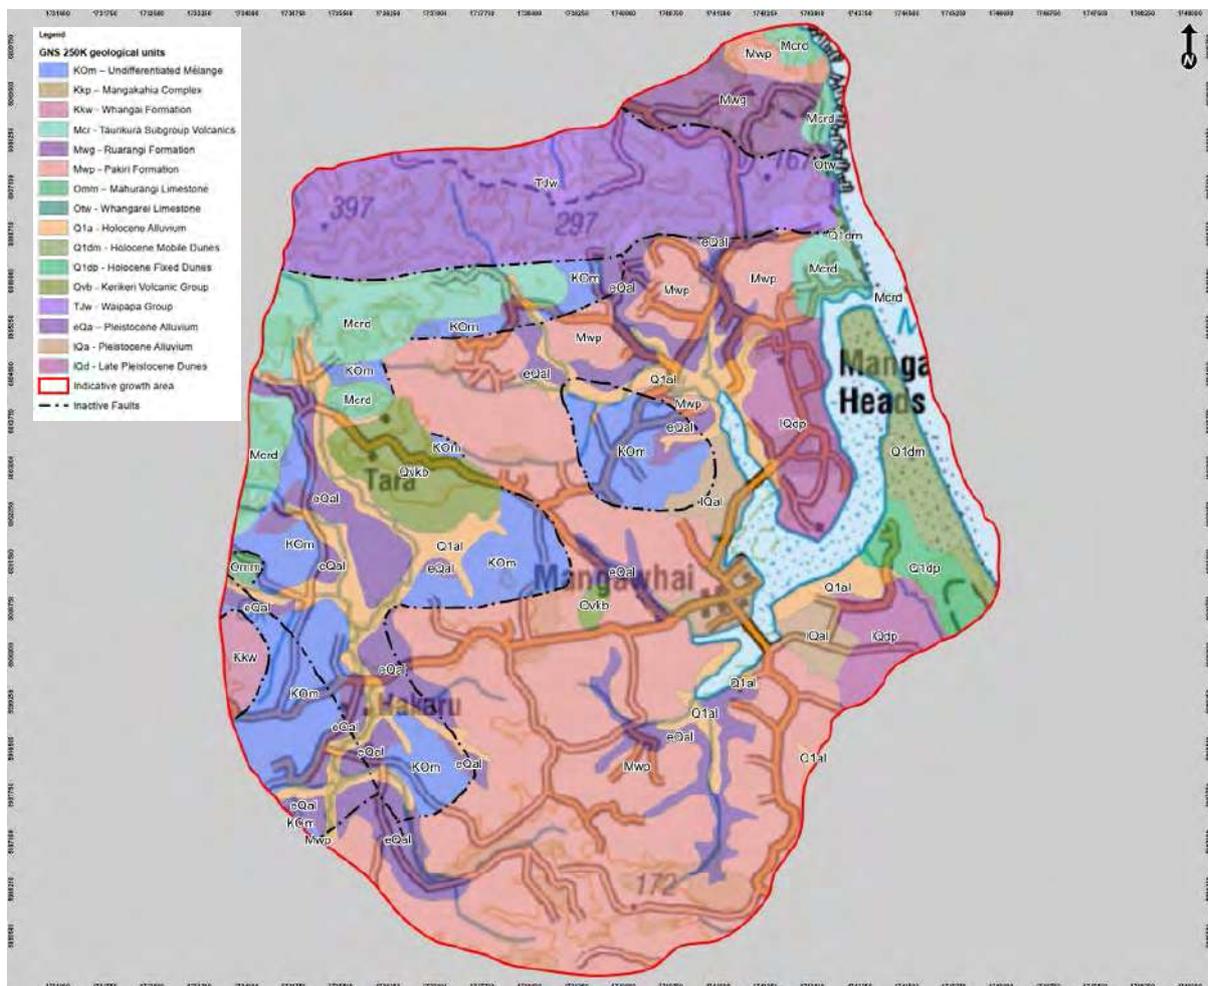
Figure 3: Geology Map

The map has been adapted to create Figure 3, depicting the surface expression of the geological units mapped across the study area.

Image adapted from GNS QMAP. Not to Scale

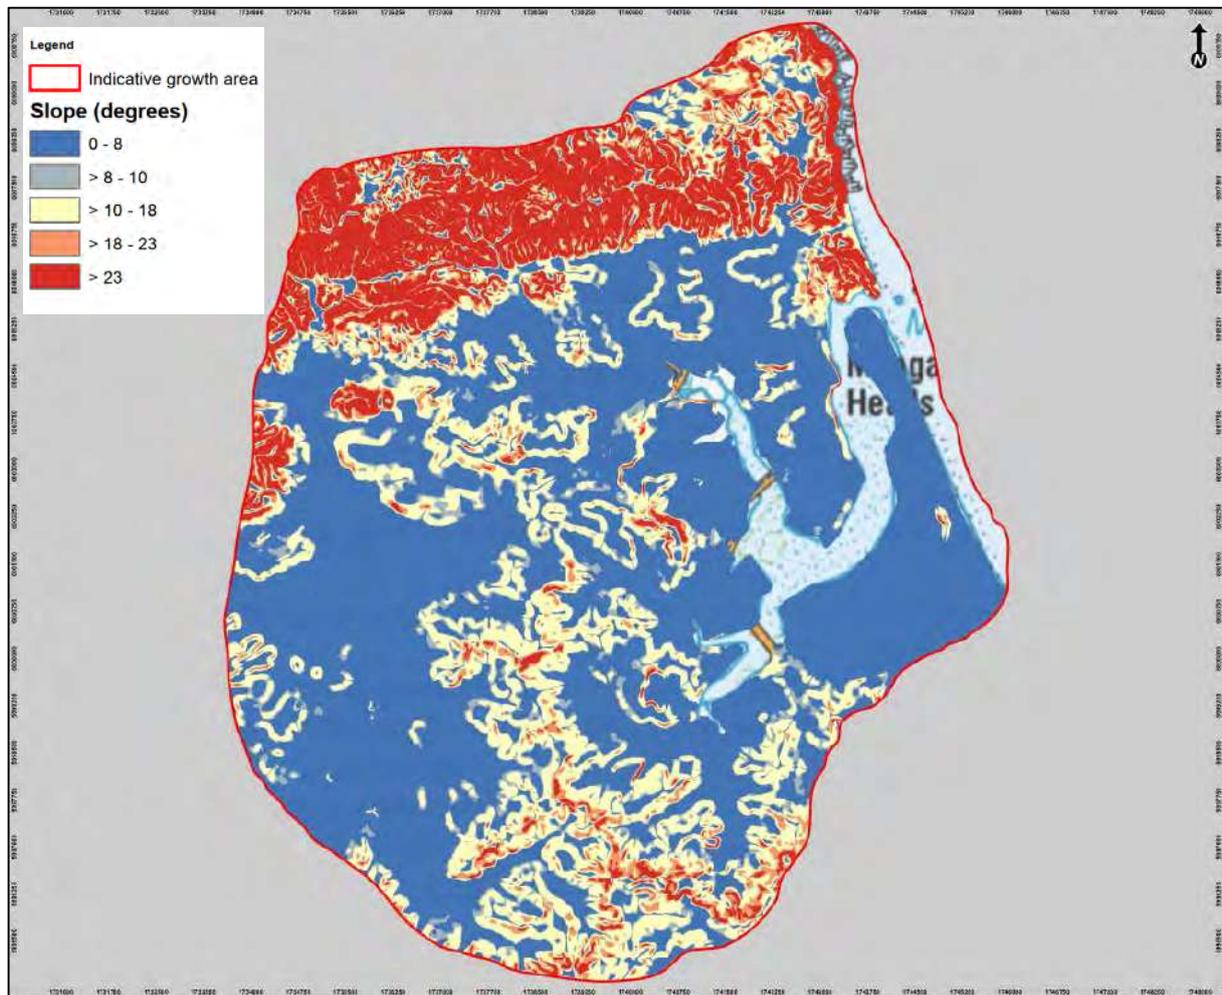
Figure 4: Topographic Slope Angles

A profile of existing slope angles was created using LINZ Topo50 20 m contours (vertical accuracy $\leq 10\text{m}$). From this, a digital elevation model (DEM) was generated, and then a Slope Profile (Figure 4) was produced to show relative steepness within the study area.

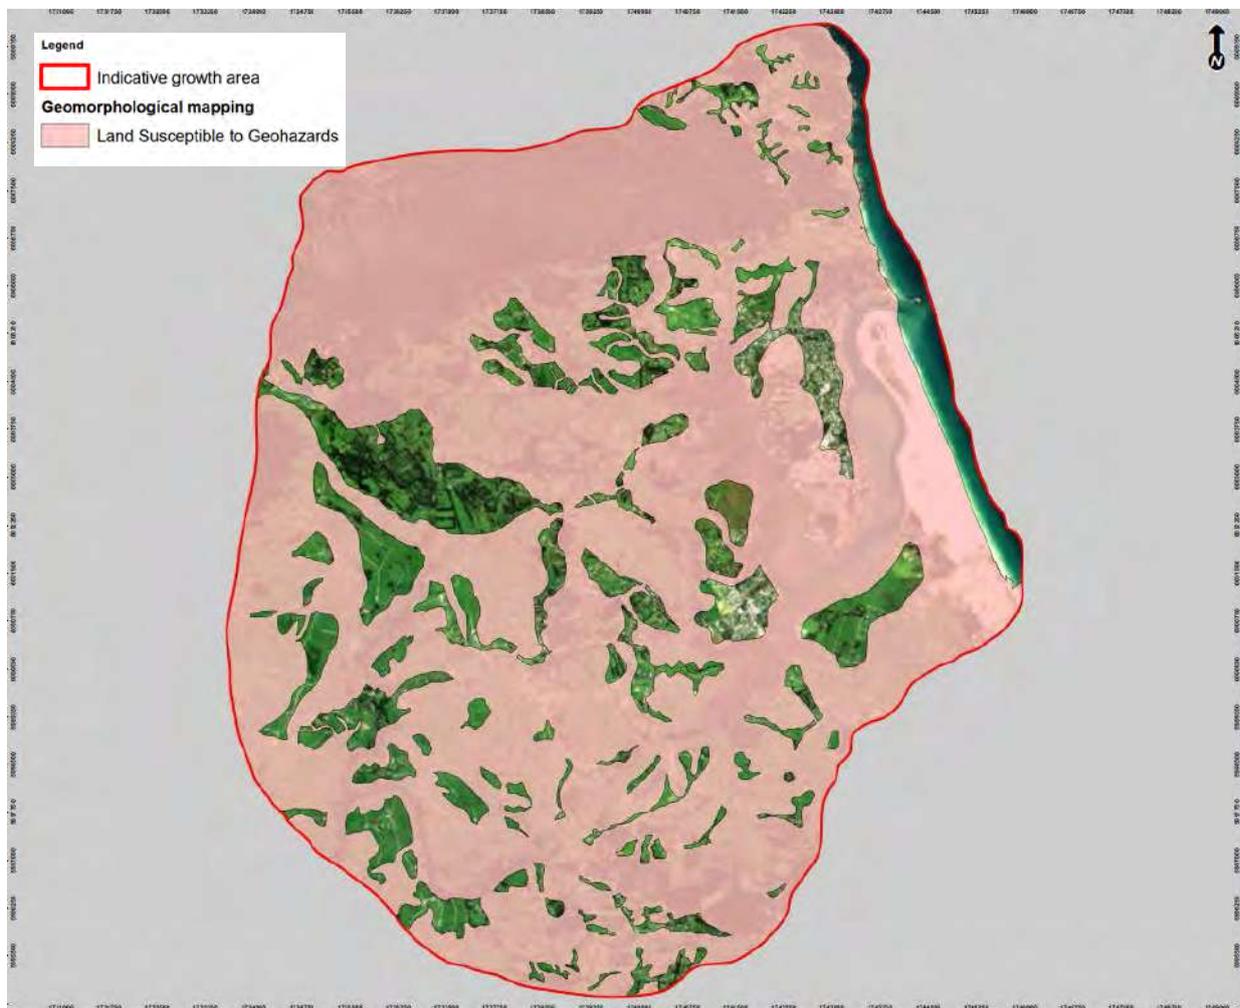
Figure 5: Geomorphological Mapping

The geomorphic mapping performed for this study should be considered a reconnaissance level effort, and is intended to provide a generalised delineation of geotechnical hazards for planning-level site evaluations. The accuracy was limited by the scale of the aerial images and other factors such as vegetative cover, farming, and urban development. The mapping depicted on Figure 5 should be supplemented by detailed site-specific geomorphic mapping for design level studies.

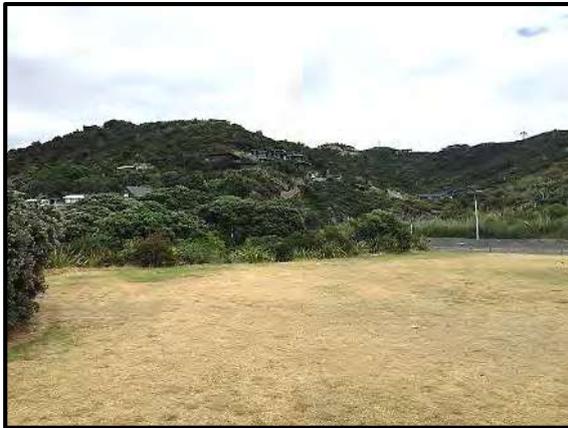
Photo 1: View north from Mangawhai Beach access towards Taurikura Subgroup dacite outcrop, with typical steep slopes and dense vegetation.

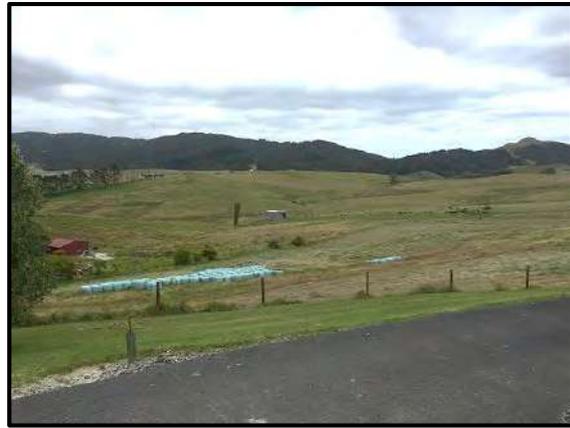
Photo 2: View north across Pakiri Formation low-angle rolling hills, with steep Waipapa Group terrain at rear.

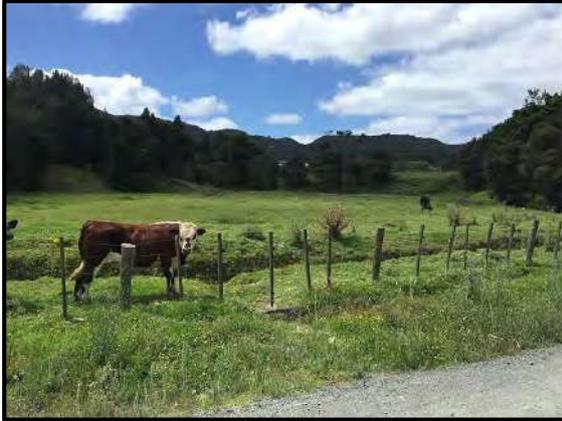
Photo 3: View north across Pleistocene alluvial terraces, with steep Waipapa Group terrain at rear.

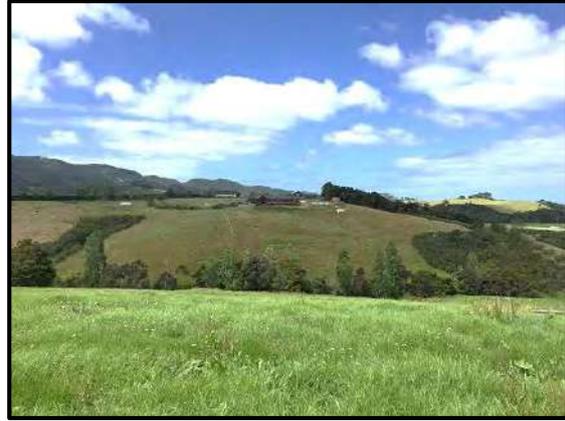
Photo 4: View south across Pakiri Formation hills in northern study area, showing mid-slope instability feature on the moderately steep ridge flanks.

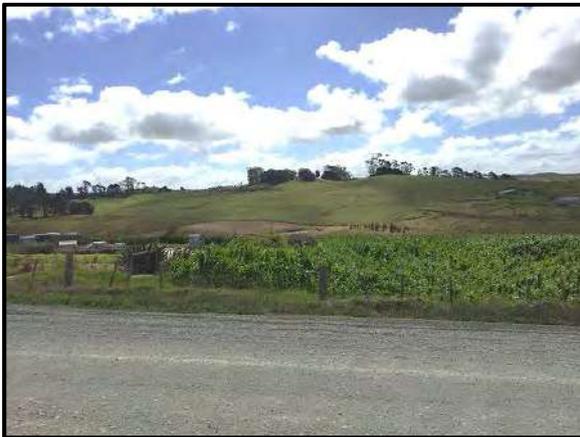
Photo 5: View east across low-lying alluvium in western study area, with Undifferentiated Mélange low-angle slopes at rear.

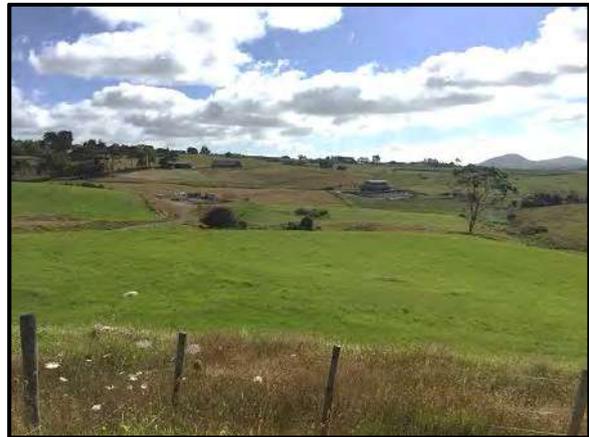
Photo 6: Undifferentiated Mélange in central study area, forming low-angle slopes bisected by wide gully features infilled with alluvium.

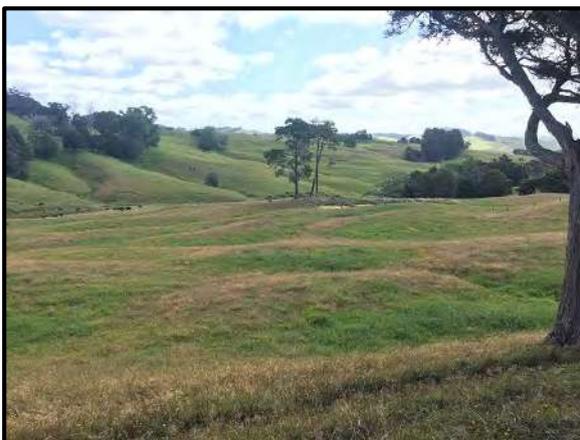
Photo 7: Pakiri Formation slopes in southern study area, note hummocky ground and extensive gully regression across slopes.

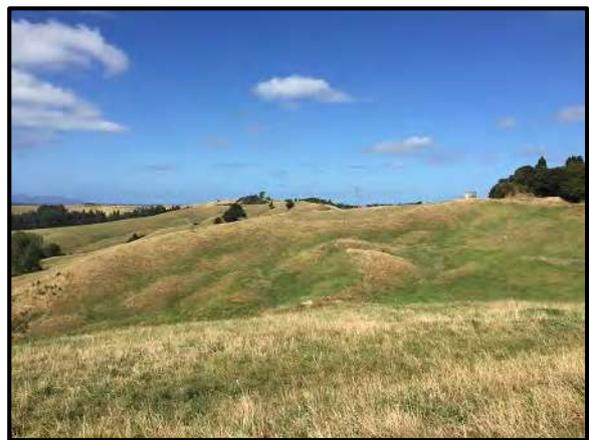
Photo 8: Pakiri Formation narrow ridgelines with steep flanks showing evidence of historical instability.

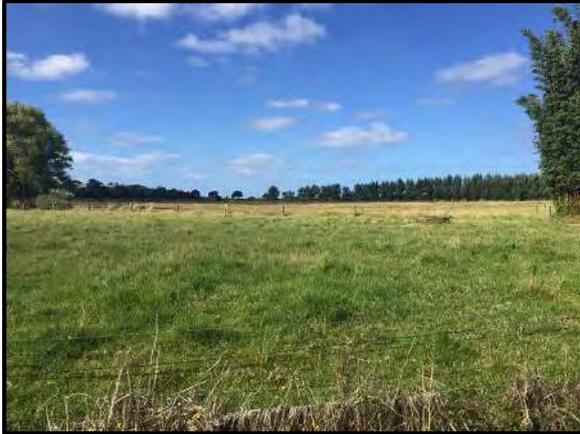
Photo 9: Holocene alluvium in south-eastern study area forming broad, flat areas currently in use for farming.

Holocene and Pleistocene alluvial deposits form low-lying, broadly-level terraces in the south-eastern portion of the study area on the southern side of the Mangawhai Estuary (Photos 9 and 10). The dune deposits to the south and east adjoin the level terraces as low rolling hills, increasing in relief to the south and beyond the study area boundary. Little evidence of historical slope instability was observed in this portion of the site due to access constraints, however soil creep was observed on dune slopes having angles of approximate 14 degrees.

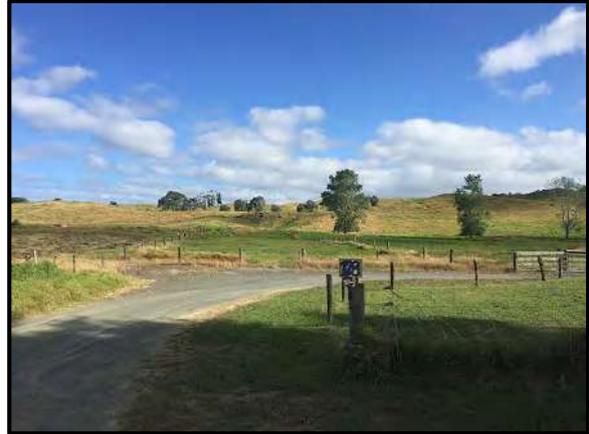
Photo 10: View south in south-eastern study area from low-lying Pleistocene dune deposits towards rising inland dunes.

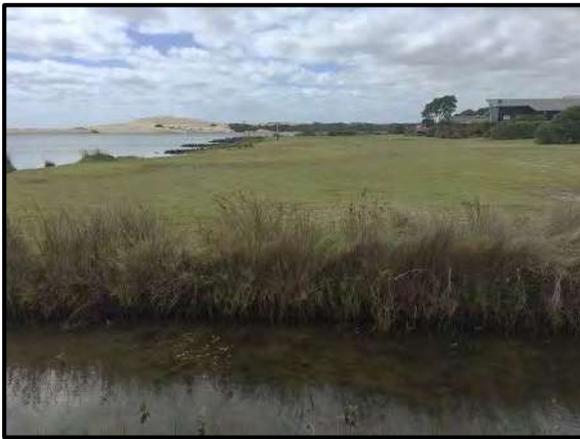
Photo 11: View south from low-lying Pleistocene dune deposits to the Holocene active dunes across Mangawhai Harbour.

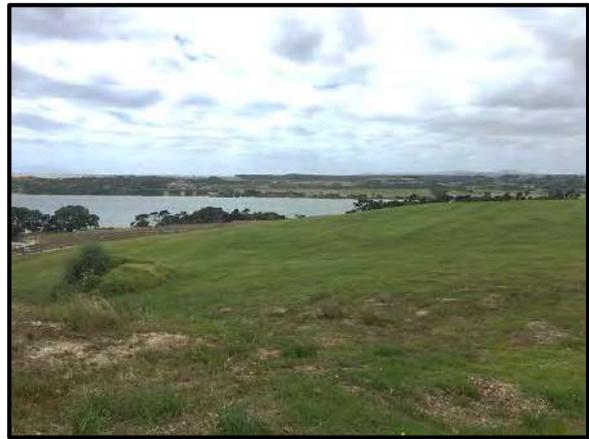
Photo 12: View south from atop the Pleistocene dune deposits forming the peninsula in Mangawhai Harbour, with flat Holocene alluvium deposits at rear.

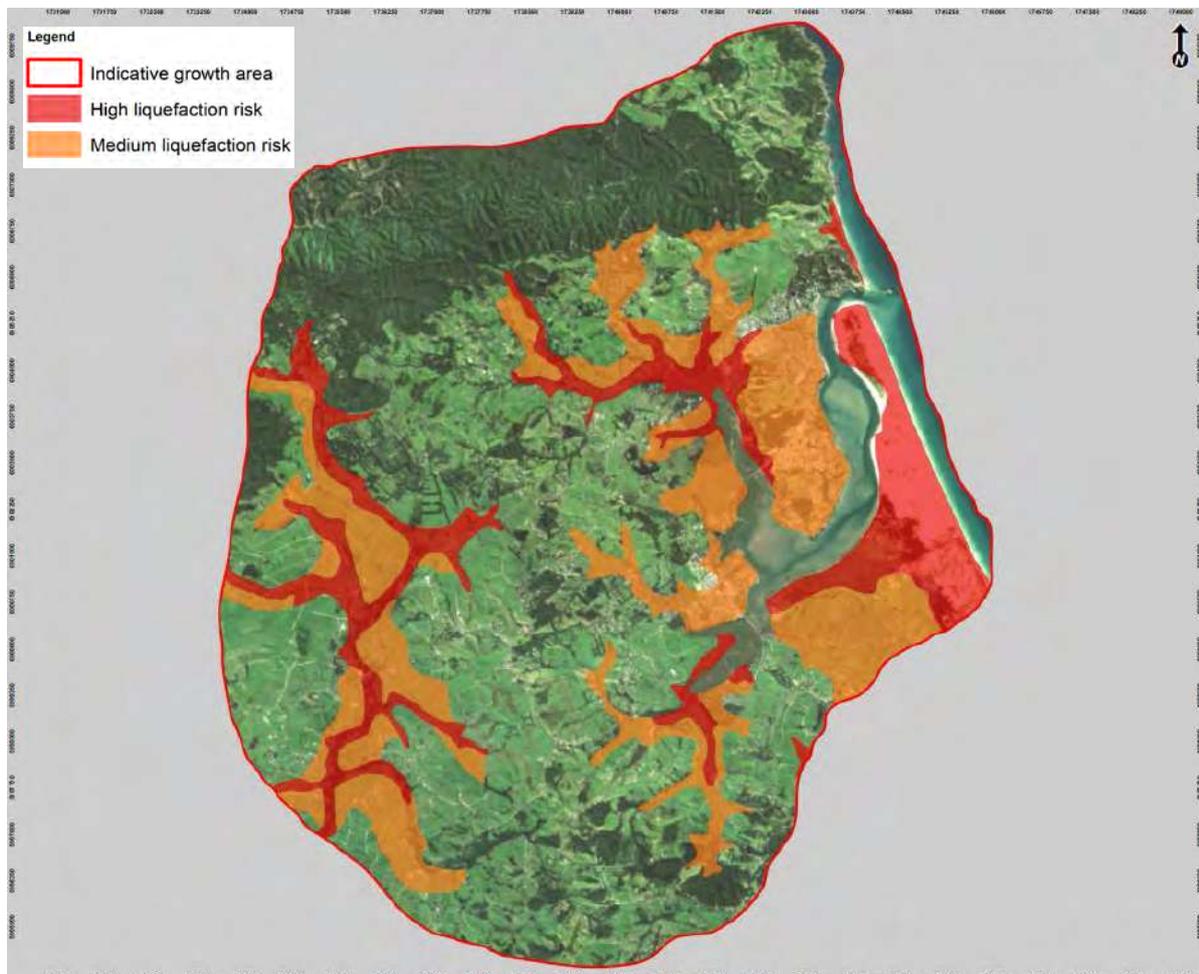
Figure 7: Liquefaction and Lateral Spread Susceptibility Plan

We consider these areas to have a potential to experience liquefaction under SLS conditions. Due to the granular nature of these soils and expected high groundwater, we consider the liquefaction and lateral spread potential of the Holocene deposits to be high.

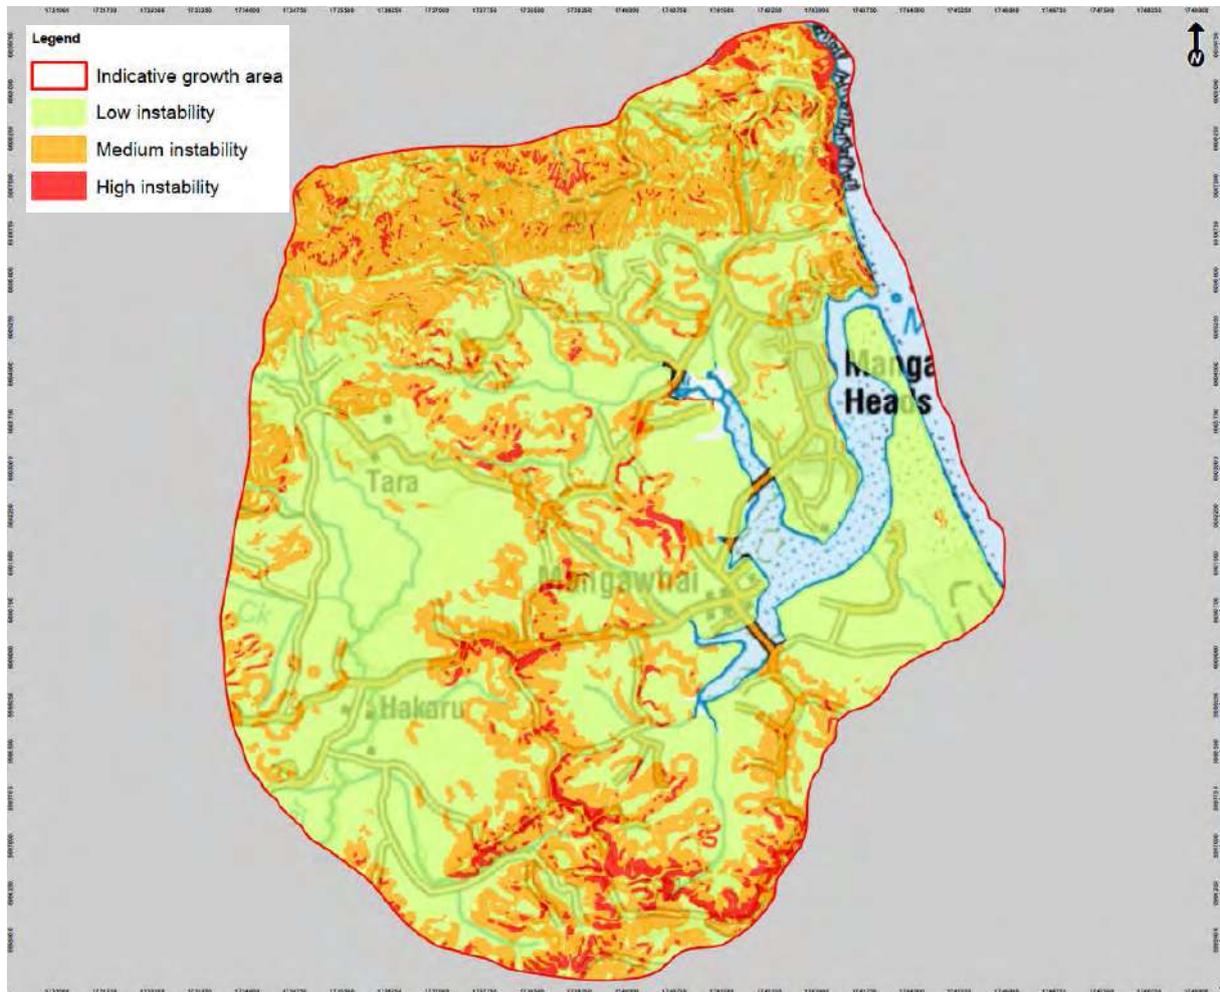
Figure 8: Slope Instability Potential

The slope profile ranges have been applied to the LiDAR contour and elevation data to generate the Slope Instability Potential plan presented in Figure 8. It is important to note that the “Low Instability Potential” category does not imply that instability will not occur on these slopes, particularly where underlain by Northland Allochthon strata. Rather, some of the slopes may have historically failed, which has resulted in the flatter slope angles observed today. Changes to the equilibrium of a slope through some combination of land modification earthworks, fill or building loading, or introduction of water, can trigger reactivation of previous landslides on any slope.

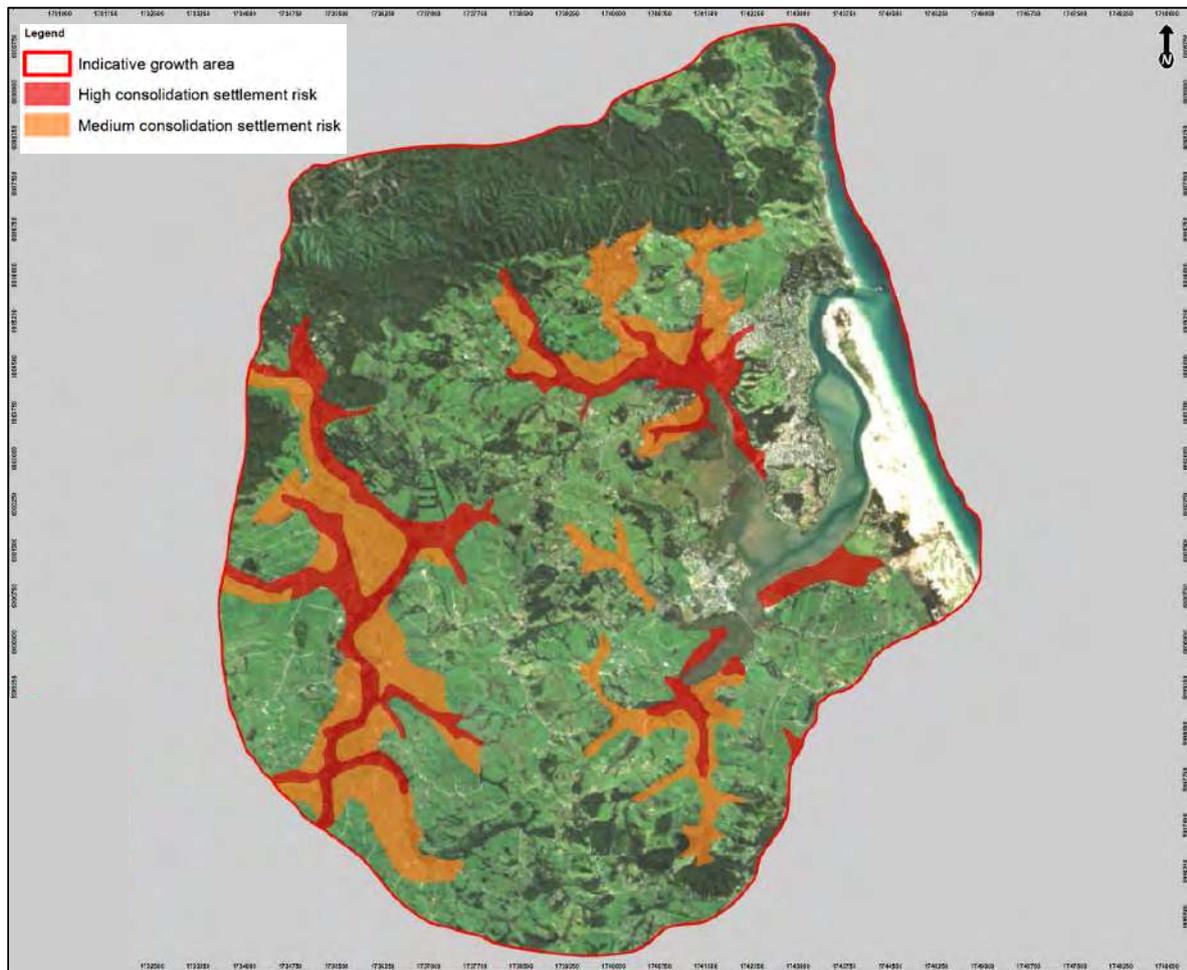
Figure 9: Settlement Susceptibility Plan

Given the likely presence of organic material and soft clay layers, we consider these areas to have a high potential to experience consolidation settlement under loading.

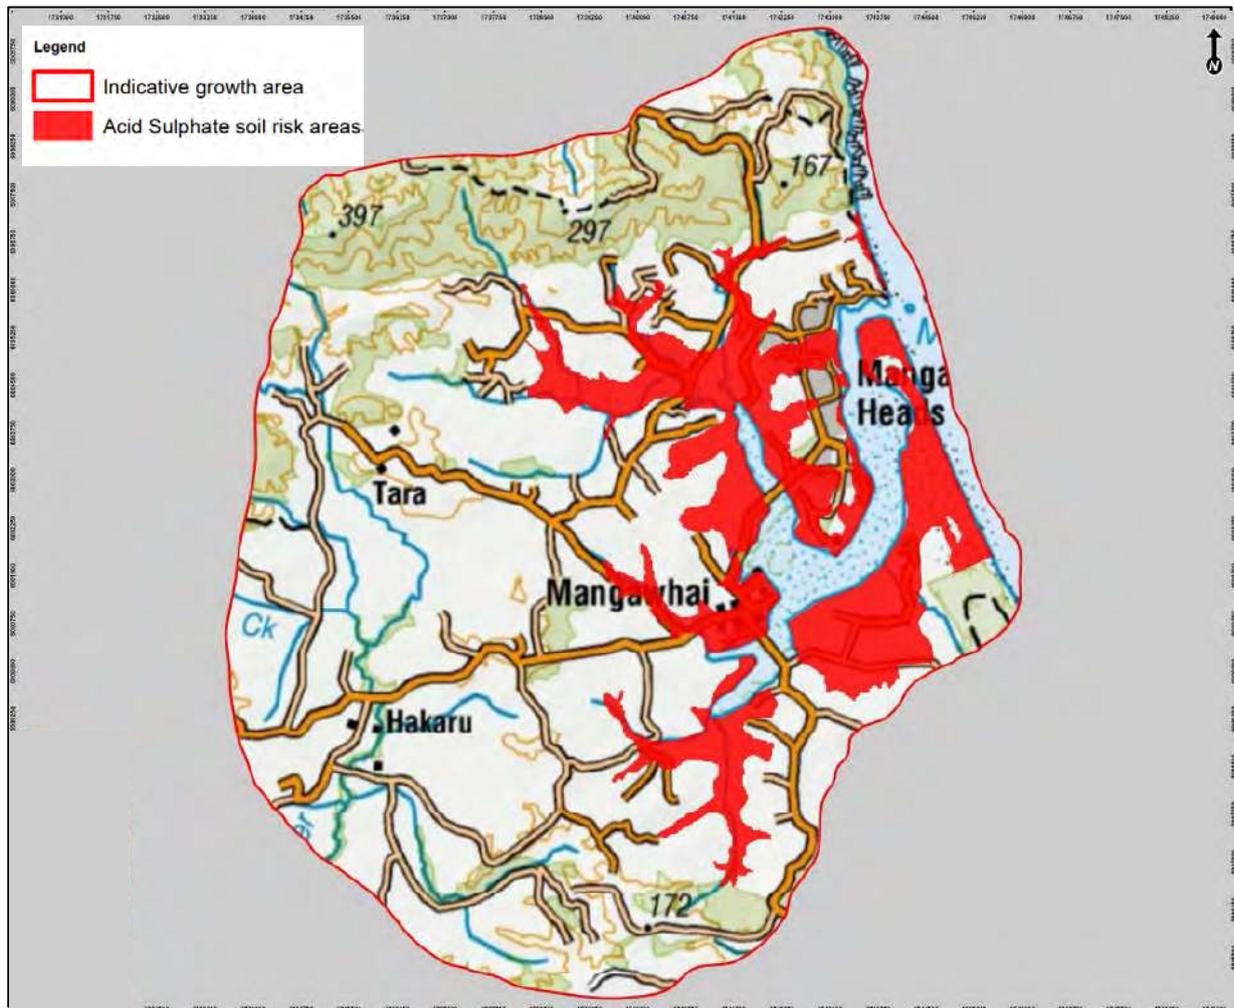
Figure 10: Acid Sulphate Soil Risk Plan

Discussion on risk levels and investigation methodology is provided in Kaipara District Council's Acid Sulphate Soils Policy Basic Planning Guide.

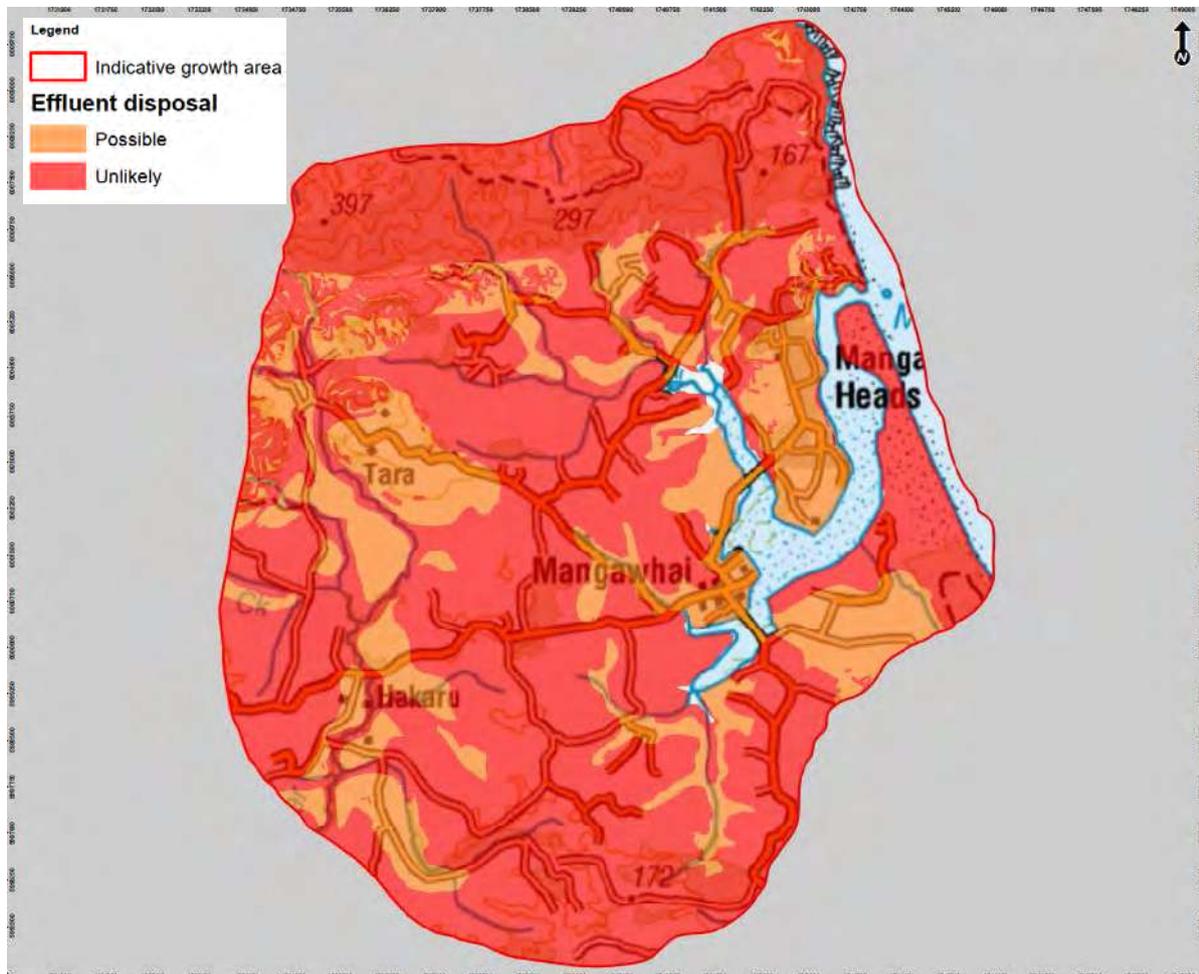
Figure 11: On-site Effluent Disposal Potential Plan

Due to their low-lying topography, typically near-surface groundwater table, and mandatory setback requirements from clean water sources, Holocene alluvium and dune sand units have low effluent disposal potential.
