Geotechnical Assessment

Dargaville

Kaipara District

10.05.2019

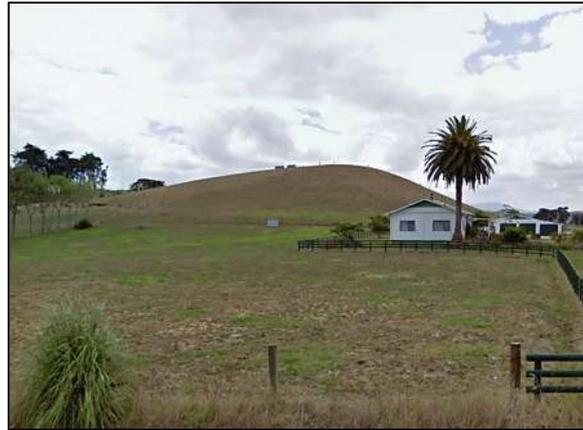
Photo 4: Elevated area of Pleistocene Alluvium (eQa) in the eastern part of the study area.

Pleistocene alluvial deposits are mapped within the central and northern parts of the study area. These areas were observed to generally form level to gently undulating terraces that are generally elevated several metres higher than the surrounding Holocene alluvial areas.

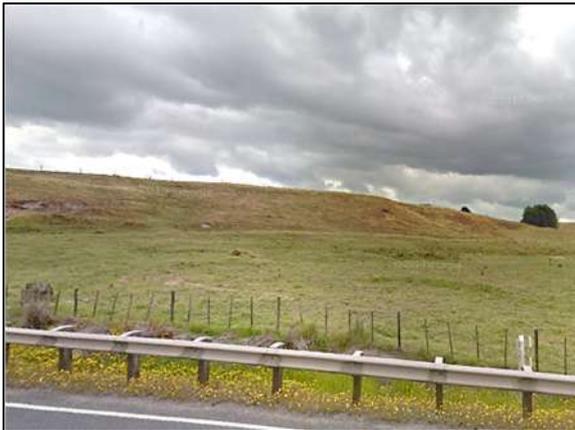
Photo 5: Elevated area of Awhitu Group dune deposits (Pad) located in the western part of the site.

Few areas were observed to have significant rock outcrop. Where exposed, we generally observed weak to extremely weak sandstone in road cuttings, particularly in areas mapped as being underlain by Awhitu Group fixed dune deposits. Although we did not gain site access the Turiwiri Quarry, we observed volcanic rock on the steep sided quarry walls.

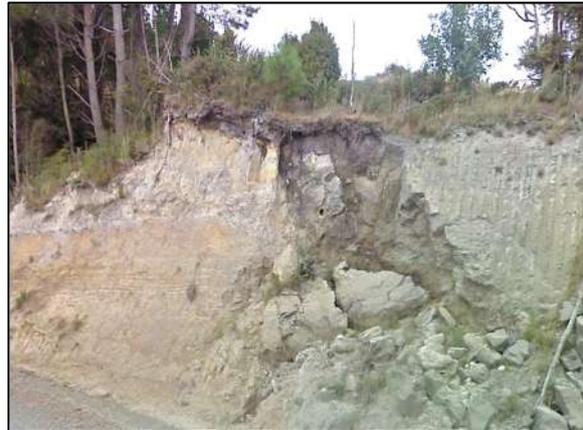
Photo 6: Awhitu Group dune material exposed in a road cutting north of Parore West Road in the northwest of the study area.

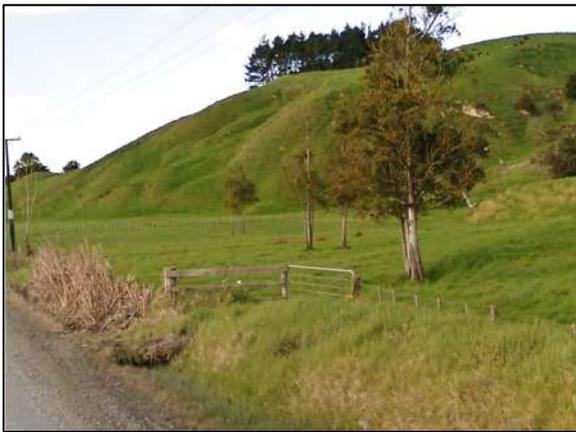
Photo 9: Hummocky ground and evidence of shallow instability in Undifferentiated Mangakahia Complex in the eastern part of the study area.

Steeper hill systems with medium to high relief are located in the northern and south-eastern parts of the study area. The hills in these areas are well vegetated and express widespread evidence of historical slope instability, as well as active slope instability. This is primarily expressed in the form of shallow rotational failures and hybrid rotational / translational failures. Mid-slope benches and arcuate head scarps were observed on several of the moderate to steep slopes, as well as widespread hummocky ground in lower slope areas. Active soil creep, particularly in the form of terracettes, was evident over much of the study area.

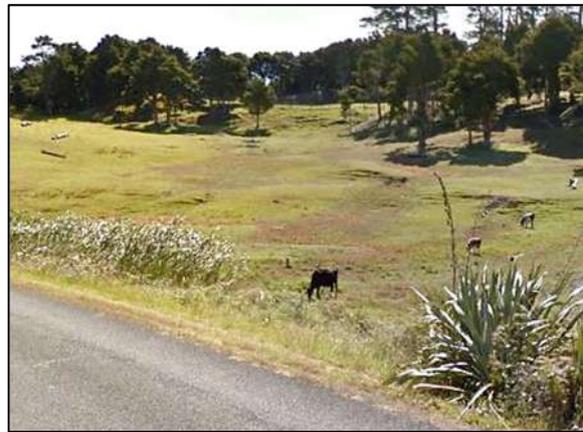
Photo 10: Hummocky ground and evidence of shallow soil creep in Undifferentiated Mangakahia Complex in the northwest of the site.

Shallow slumping and soil creep are generally caused by loose, unconsolidated sediments that have failed along over-steepened slopes or have slowly moved downslope through the action of gravity. These features are often difficult to observe at 1:25000 scale aerial photographs, and are best observed during geomorphological mapping. Features of slumping and soil creep often present as hummocky landmass and formation of terracettes (horizontal soil ridges).

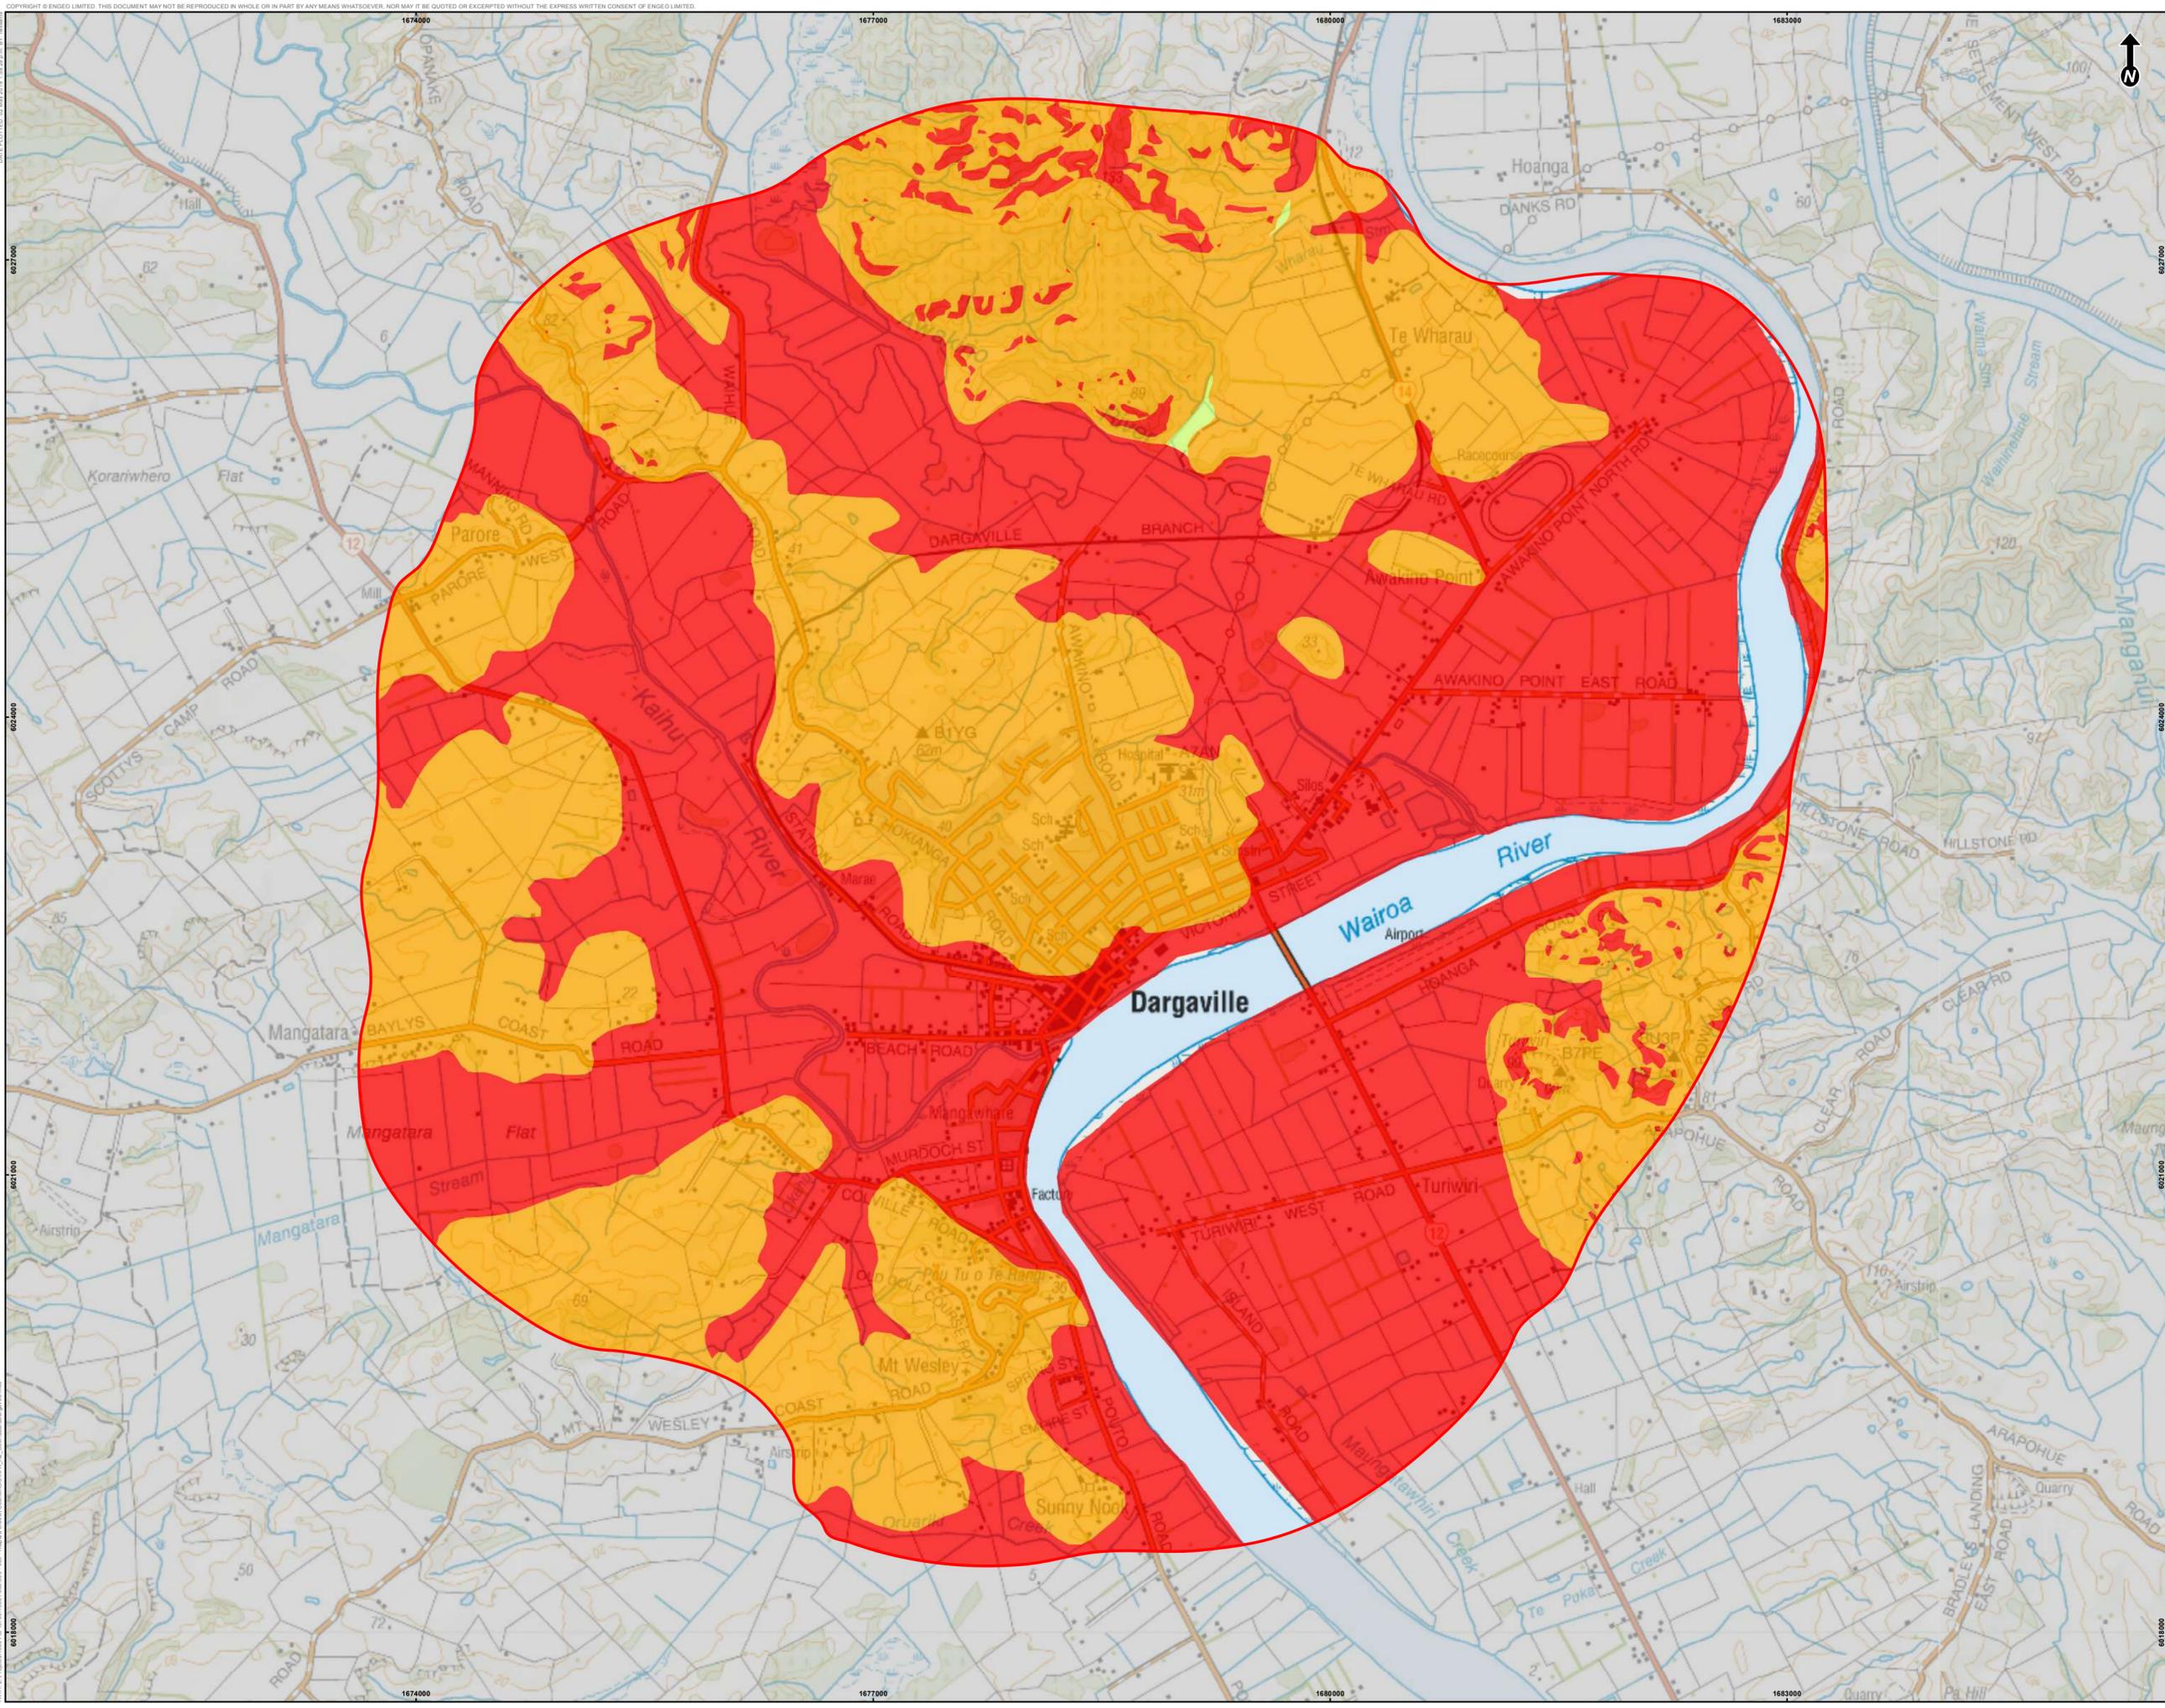
APPENDIX 1:
Geotechnical Hazard Map

As part of this geotechnical assessment, ENGEO has compiled a Geohazard Map (Appendix A) presenting the assessed low, medium and high hazard potential areas based on a summation of the primary geotechnical constraints considered for this area (slope instability, settlement due to liquefaction and settlement due to soft compressible soils). This map may not show all areas of potential geohazards, and potential geohazards mapped may not experience slope deformation or settlement at the levels estimated.
