Meeting:	Taharoa Domain Governance Committee
Date:	Thursday 09 February 2017
Time:	2.00pm
Venue:	Conference Room, Northern Wairoa War Memorial Hall (Dargaville Town Hall), Hokianga Road, Dargaville

File number: 4702.24.02.02 **Approved for agenda** ☒
Report to: Taharoa Domain Governance Committee
Meeting date: 09 February 2017
Subject: Taharoa Domain Operations Update: September 2016/January 2017
Date of report: 18 January 2017
From: Sue Hodge, Parks and Community Manager
Report purpose ☐ **Decision** ☒ **Recommendation** ☐ **Information**
Assessment of significance ☐ **Significant** ☒ **Non-significant**

Northland Lakes Annual Report 2016

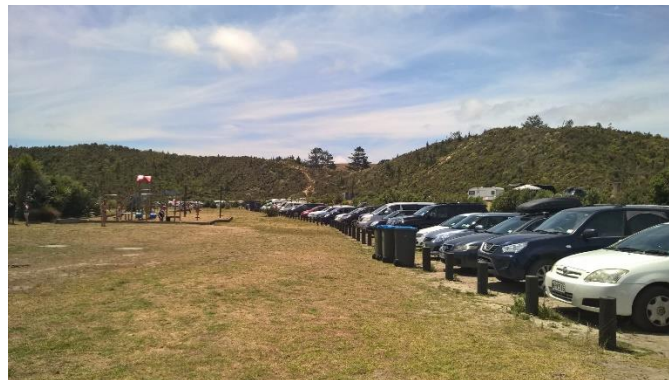
Bollards separating day visitor cars and play areas to improve safety

In the camp ground the stormwater improvements have now been completed along with additional bollards to separate day visitor cars from the play areas.

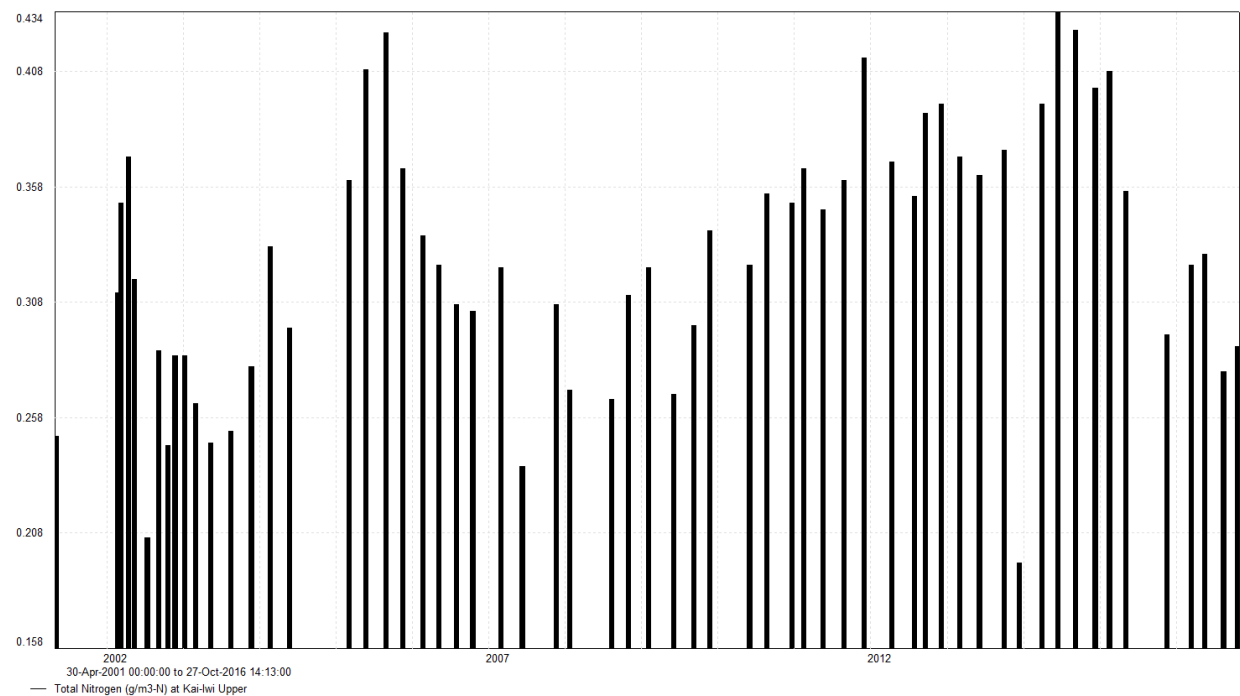
2017. The graph below shows comparative nitrogen values recorded in Lake Kai Iwi between 30 April 2001 and 27th October 2016.

The State of Environment (SOE) monitoring team carried out regular groundwater and lake water quality monitoring in October last. Lake Kai Iwi continues a trend of lower nitrogen levels since the peak value recorded in June 2014. Regular lake and groundwater monitoring is scheduled again for late January

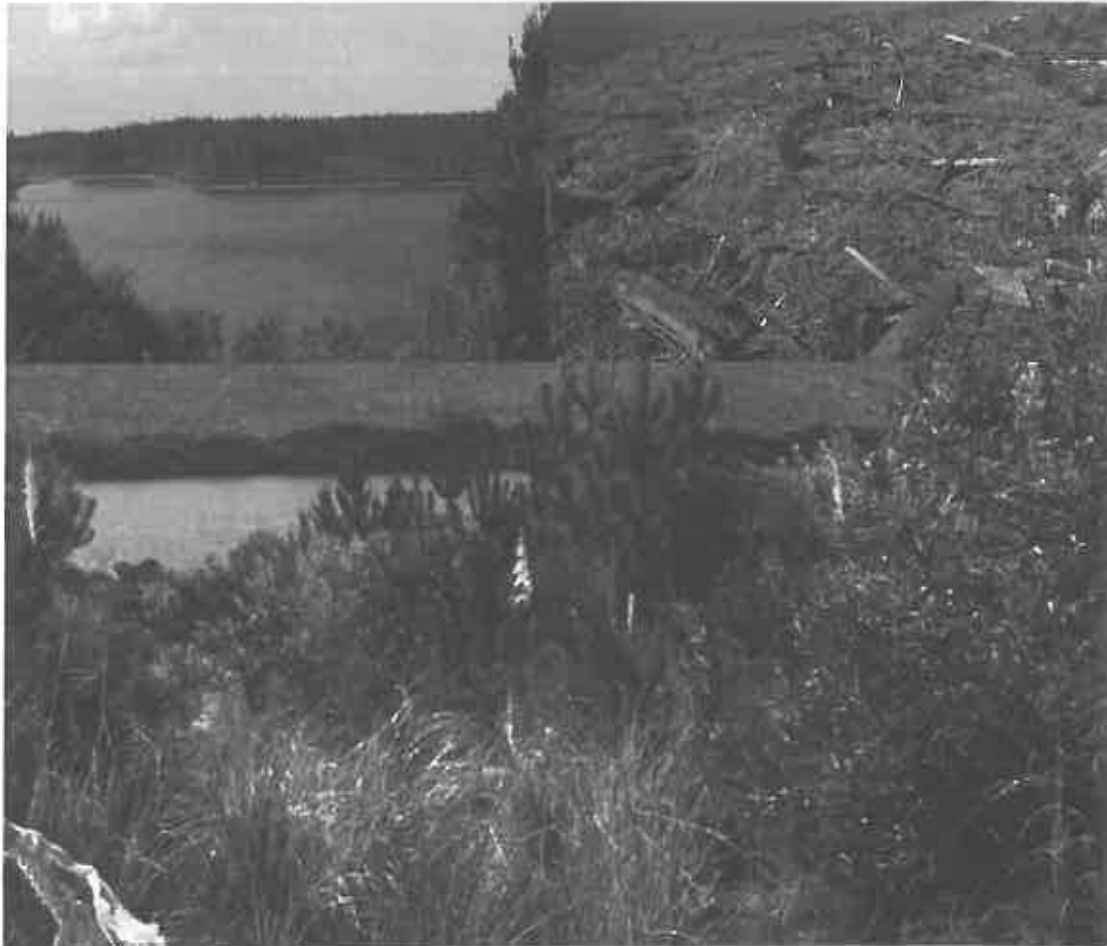
Plate 1: Lake Morehurehu catchment has recently undergone significant change following the first harvest of mature plantation pine (top left 2009), with subsequent re-planting (top right 2013) and growth of young trees (below in 2016).

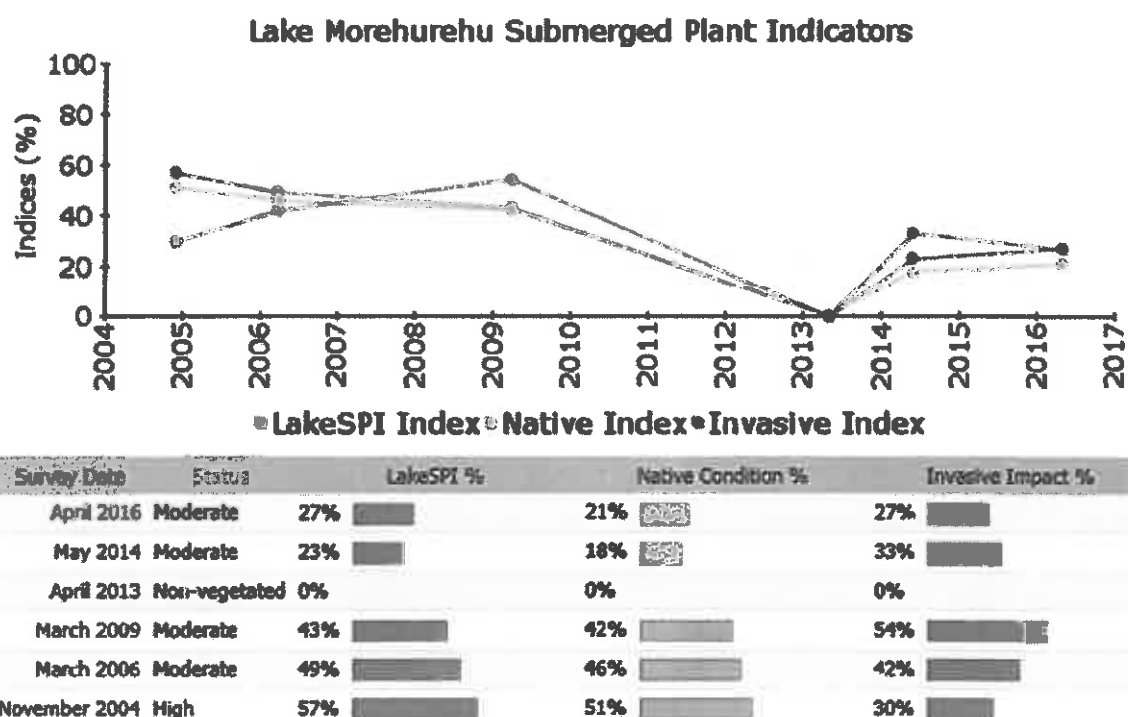
Figure 1: LakeSPI for Lake Morehurehu. Six LakeSPI surveys are recorded. 2013 scored 0% due to very low abundance of submerged vegetation, followed by minor recovery in 2014 and 2016.

A decrease in LakeSPI score from 57% in 2004 to 27% in 2016 was a result of a decrease in submerged vegetation relating to a decline in water quality that occurred around 2013. This also resulted in a decrease of both the Native Condition Index and the Invasive Impact Index (invasive impact from *U. gibba*).

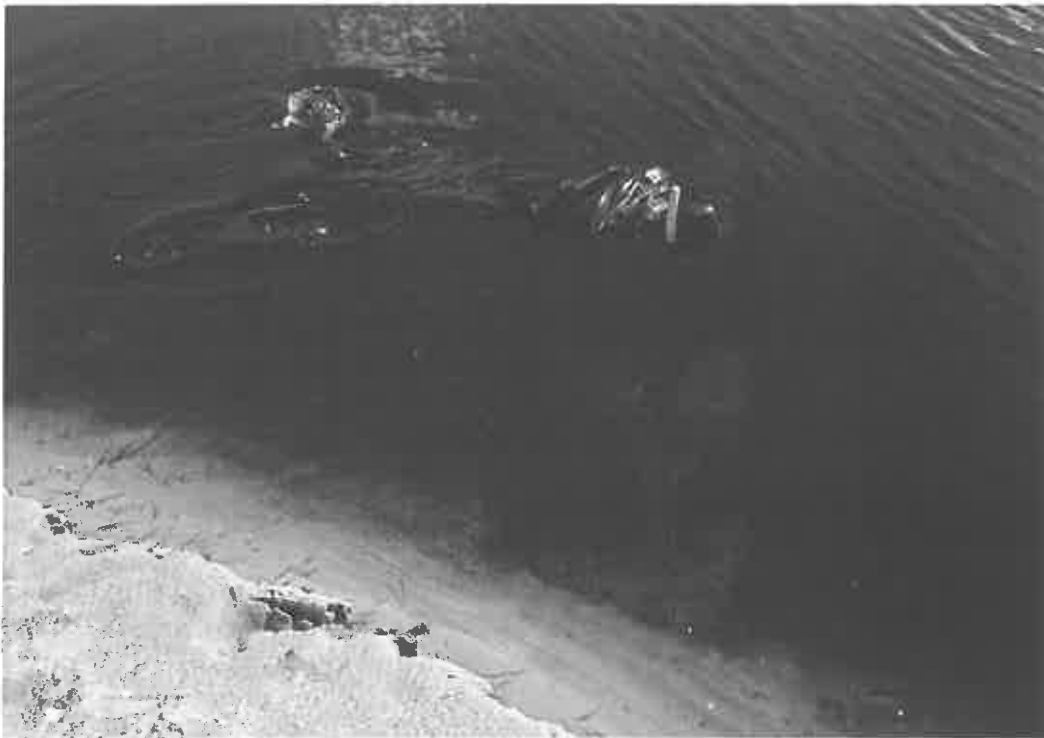
Plate 2: Morehurehu South, showing low clarity due to very dark coloured water, 2016. No submerged plants were recorded.

In 2016 water clarity was very low and no submerged species were recorded.

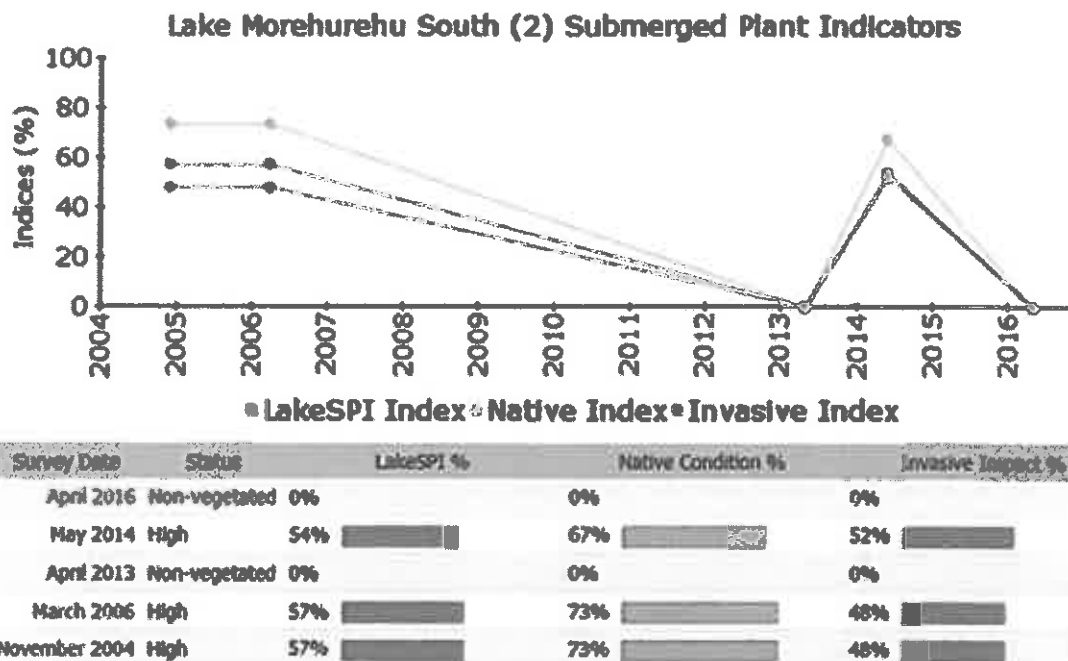
Figure 1: LakeSPI for Lake Morehurehu South 2. Five LakeSPI surveys are recorded. 2013 and 2016 scored 0% due to very low abundance of submerged vegetation.

A decline in water quality occurred around 2013. Since that time, Lake Morehurehu South 2 has fluctuated between a devegetated condition (as was the case in 2016) and re-establishment of submerged vegetation.

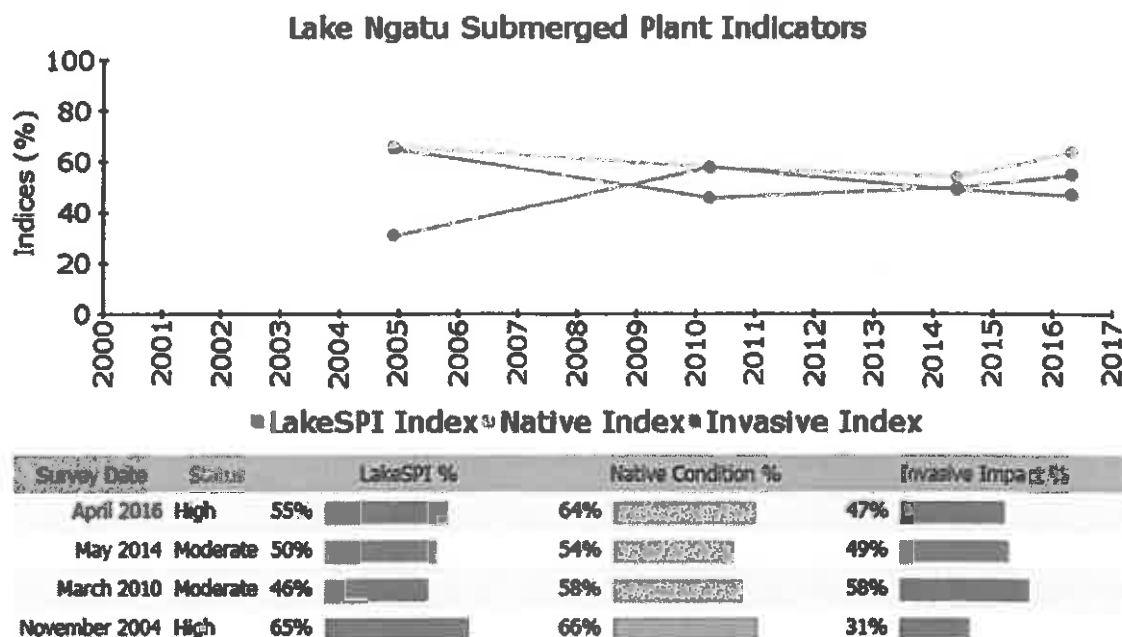
Figure 1: LakeSPI for Lake Ngatu. Four LakeSPI surveys are recorded between 2004 and 2016.

Lake Ngatu is categorised as being in high ecological condition with a LakeSPI Index of 55%.

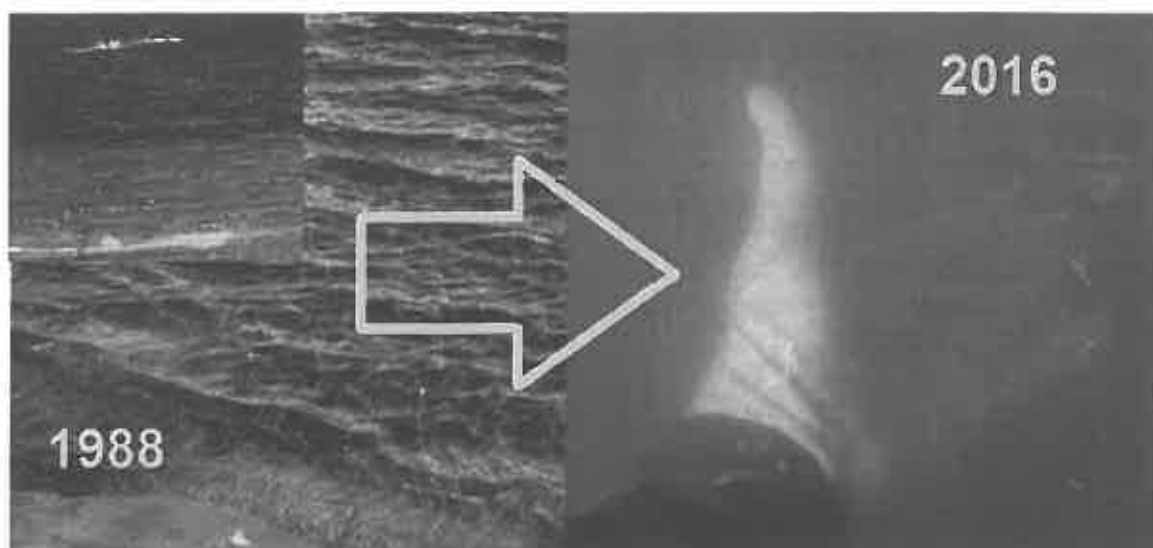
Plate 2: Lake Ngatu 1988 left 2016 right, showing deteriorating water clarity and appearance from the surface.

Lake Ngatu charophyte species composition has changed over the monitoring programme and since 2010, charophyte abundance has markedly diminished lake wide, indicating that nutrient enrichment stress is likely. Similar declines in kuta have also been recorded. No trends in degrading water quality using TLI have been detected. The lake is classified as mesotrophic and trend analysis showed water quality declined over the 5 years prior to 2011 with water clarity decreasing at a rate of 0.31 m per year and TLI degrading 1.64% per year. Since then the TLI has improved. No trend are now evident, but it is clear that water quality fluctuates markedly. Nitrogen levels have been close to all-time highs for more than a year. Despite these changes the ecological value rating of Lake Ngatu remains "Outstanding". However, on a broader time scale 1988 to 2016 the appearance of the lake has changed markedly (Plate 2).

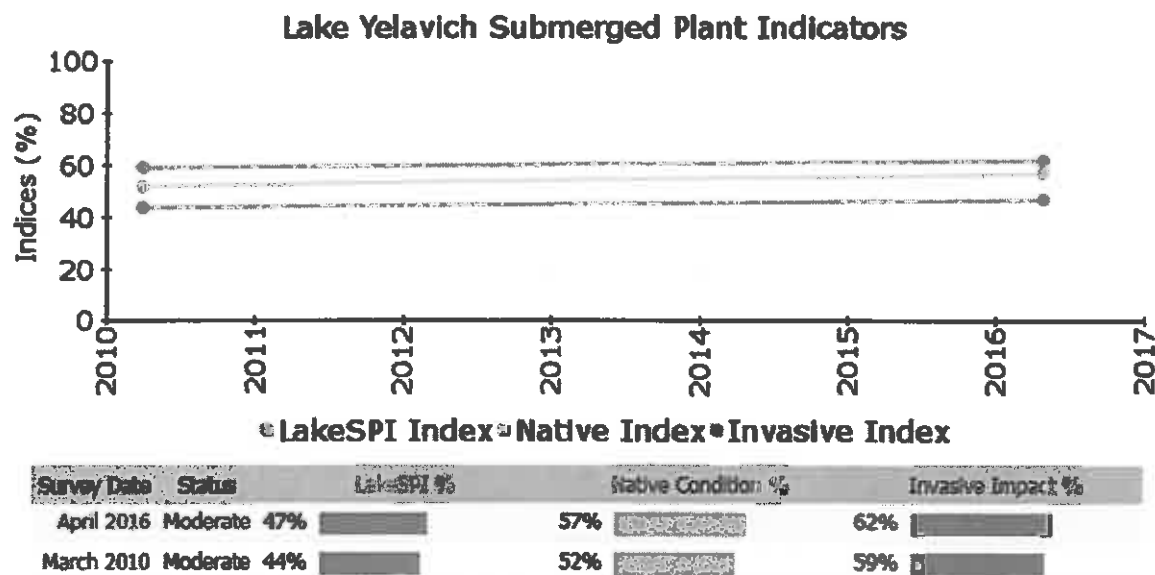
Figure 1: LakeSPI Index as % of potential score, Native Condition Index, and Invasive Impact Index (graphed above and as bar diagrams from left to right below).

The LakeSPI Index of Lake Yelavich was moderate (47%), with limited (shallow) development of native submerged vegetation that is highly impacted by the invasive species *Utricularia gibba*.

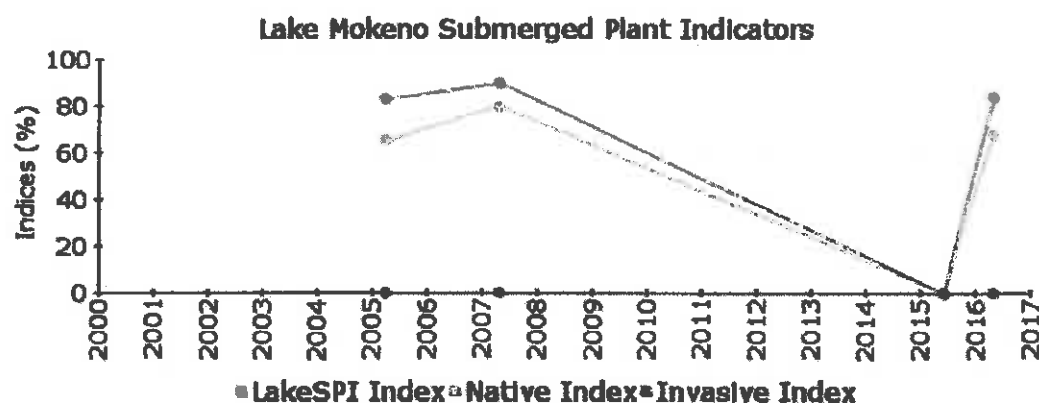
Survey Date	Status	LakeSPI %	Native Condition %	Invasive Impact %
April 2016	Excellent	84%	68%	0%
May 2015	Non-vegetated	0%	0%	0%
April 2007	Excellent	90%	80%	0%
March 2005	Excellent	83%	65%	0%

Figure 1: LakeSPI Index as % of potential score for Lake Mokeno with Native Condition Index, and Invasive Impact Index shown for 2005; 2007, 2015 and 2016. The lake deteriorated from excellent to non-vegetated and has returned to excellent again.

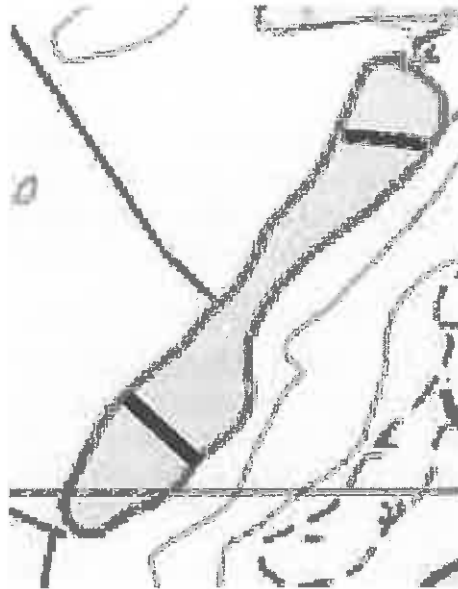
Figure 1: Lake Heather showing the location of the 2 profiles monitored, with one in each basin.

The two baseline profiles recorded prior to grass carp release in 2010 have been repeated annually (Figure 1 below).

No plants of either pest species were detected in October 2014 or 2016. A final assessment should be undertaken in 2017 and then should no hornwort or egeria be detected, removal of grass carp can be contemplated.

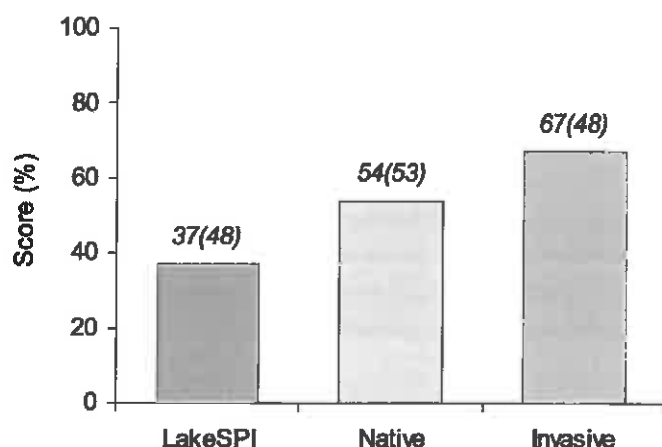
Figure 1: 2010 LakeSPI Index as % of potential score, Native Condition Index, and Invasive Impact Index (from left to right). 2005 score in brackets.

The low LakeSPI score of 37% reflects the increased impact (growing in deeper water) of the invasive alien species *E. densa* and *L. major* in 2010 compared to 2005. No LakeSPI was generated in 2016 as only one profile was swum.
