Kaipara District Council

Baylys Beach Access

Beach Erosion Assessment Report

March 2018

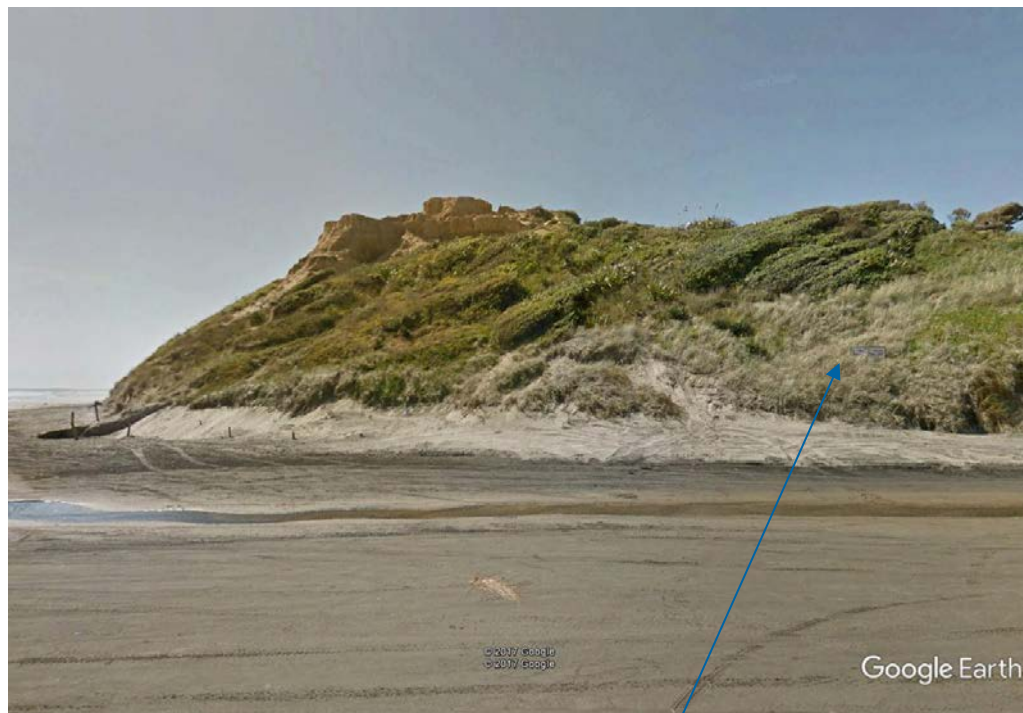
Figure 2 Where Seaview Road meets the coast (Google image 2012)

Note: Same sign on hill from 2012 and 2017

As shown in Figure 3 above, revetment protection has been placed on the True Right Bank. This is now in poor condition and the bank has failed. This Figure 3 photo can be compared to the Figure 2 photo taken approximately 5 years earlier.

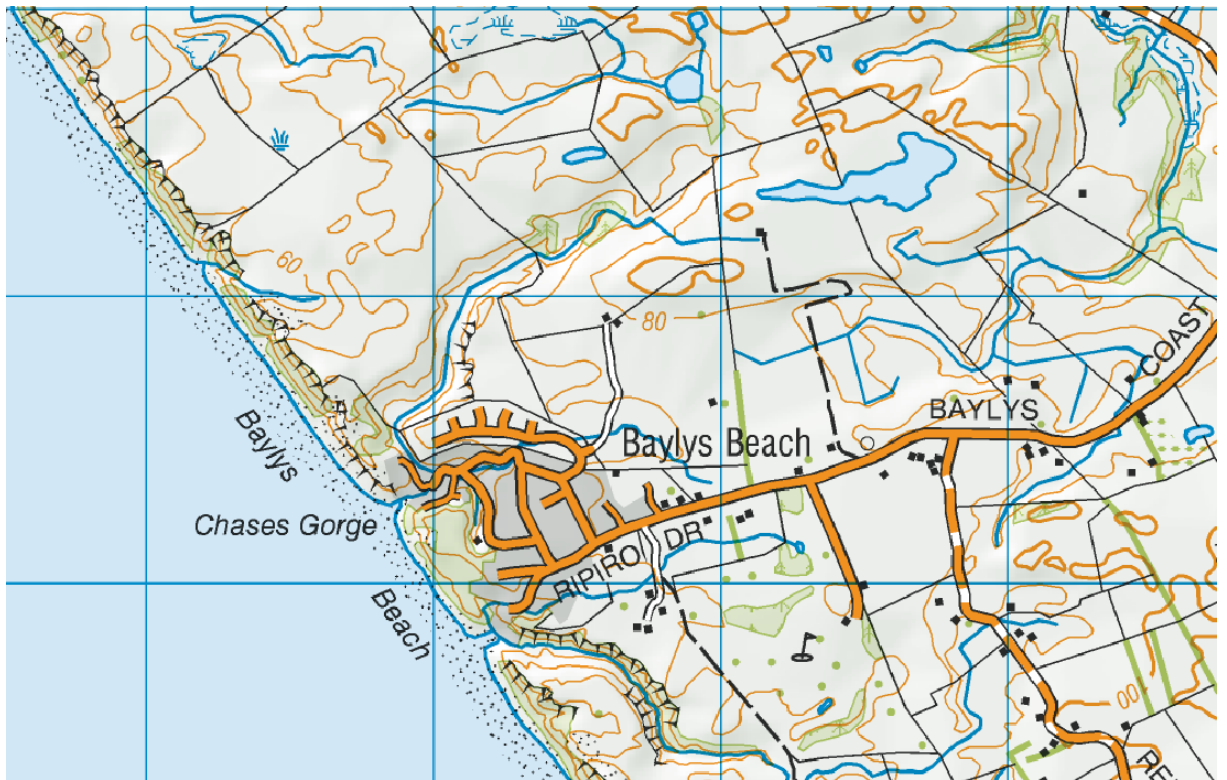
Figure 4 Site plan as copied from LINZ Topo Map 1:50,000 series

The key issue relating to the brief from KDC to GHD is the condition of the True Right Bank of the Chases Gorge Stream (as shown in Figure 4 below - LINZ Topo 1:50,000 map).

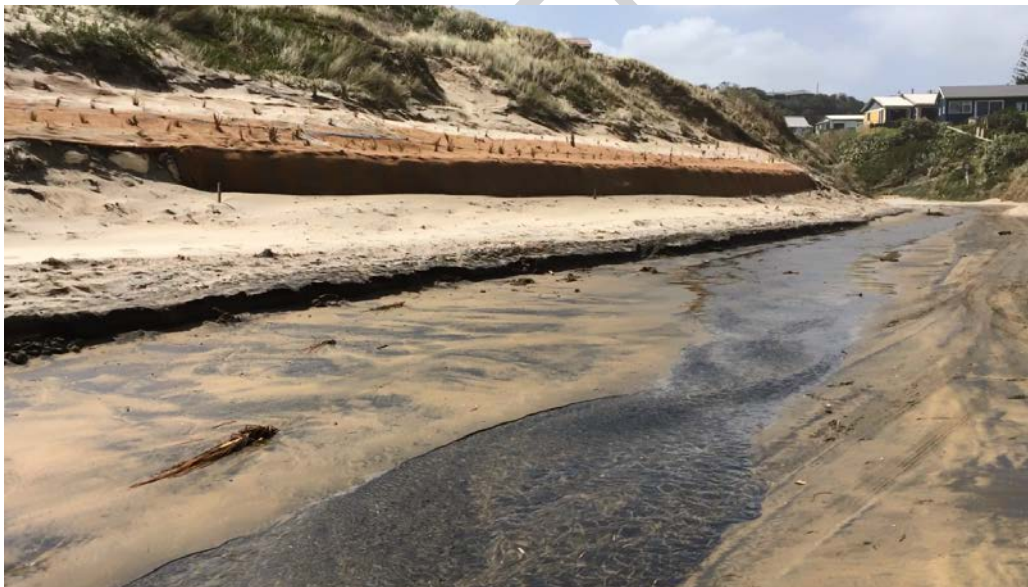
Figure 5 Photo of wall not long after initial construction complete (~2015)

According to the explanation provided by Mark Bell, the supplier had the bags pre-treated with a product to extend the UV life of the bags. In addition, a light hessian type cloth/netting was provided to provide additional UV protection to the bags as seen in Figure 5 below.

The bags as observed in August 2017, are in poor condition. A number of the bags are undermined and have rotated. The bag material condition is poor with perhaps 30% of total bags with a hole and some of the bags had multiple holes or had split open.

Gary Treadgold from the Regional Council advised that over the first winter following installation, the bags appeared to have performed well. However, the latest sand levels and their drop relative to recent winters have caused a significant undermining of the bags. This in conjunction with bag material degradation has led to the current failures.

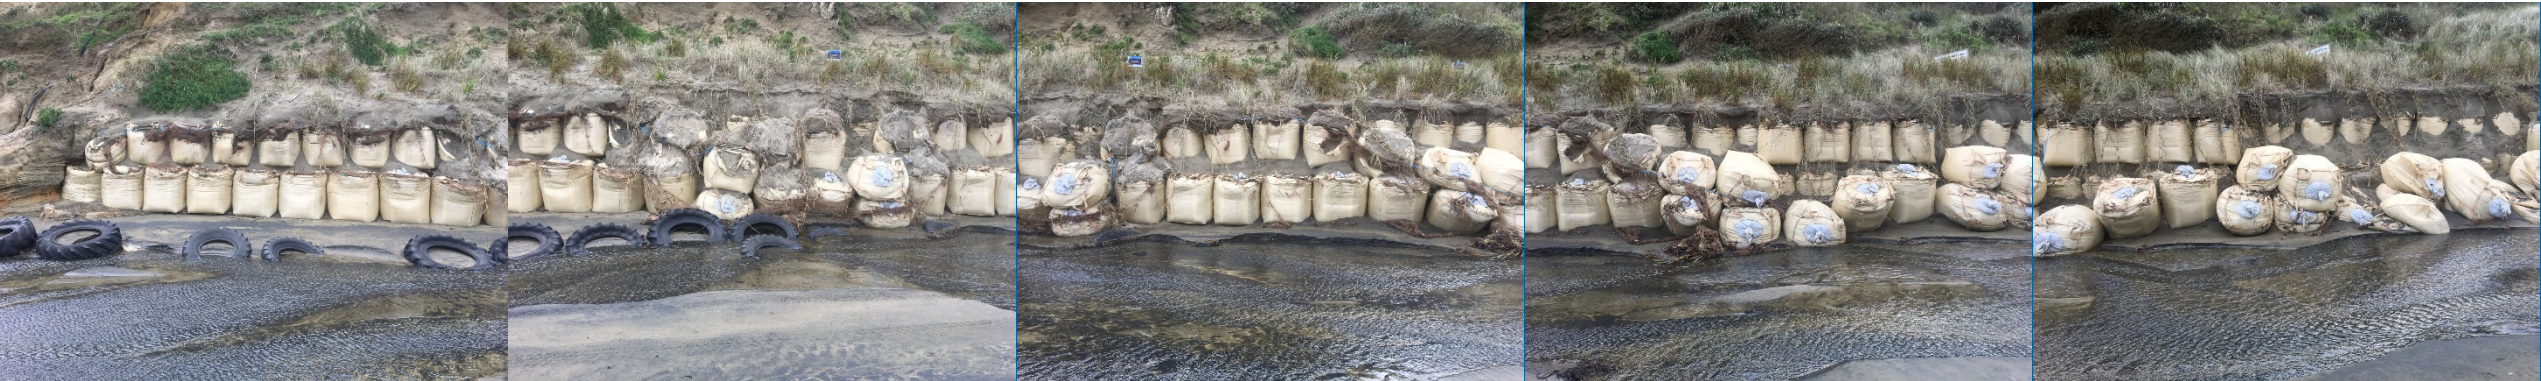
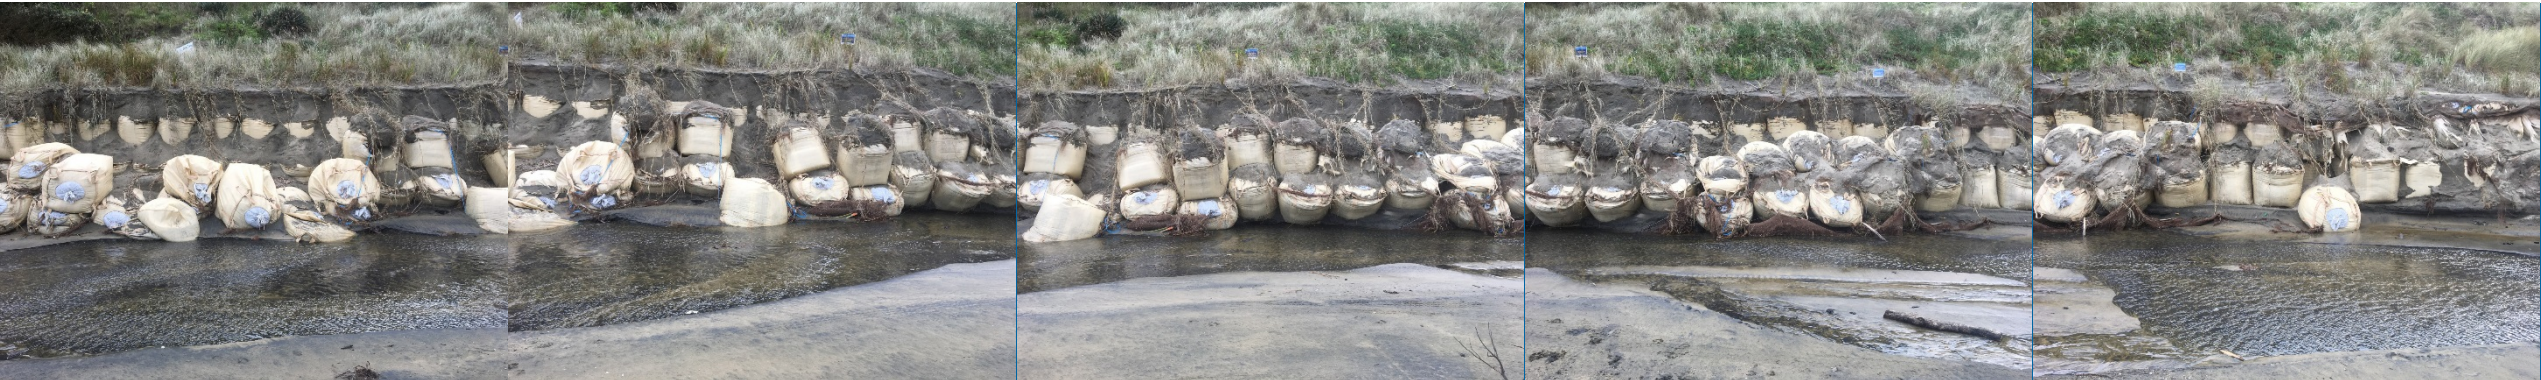
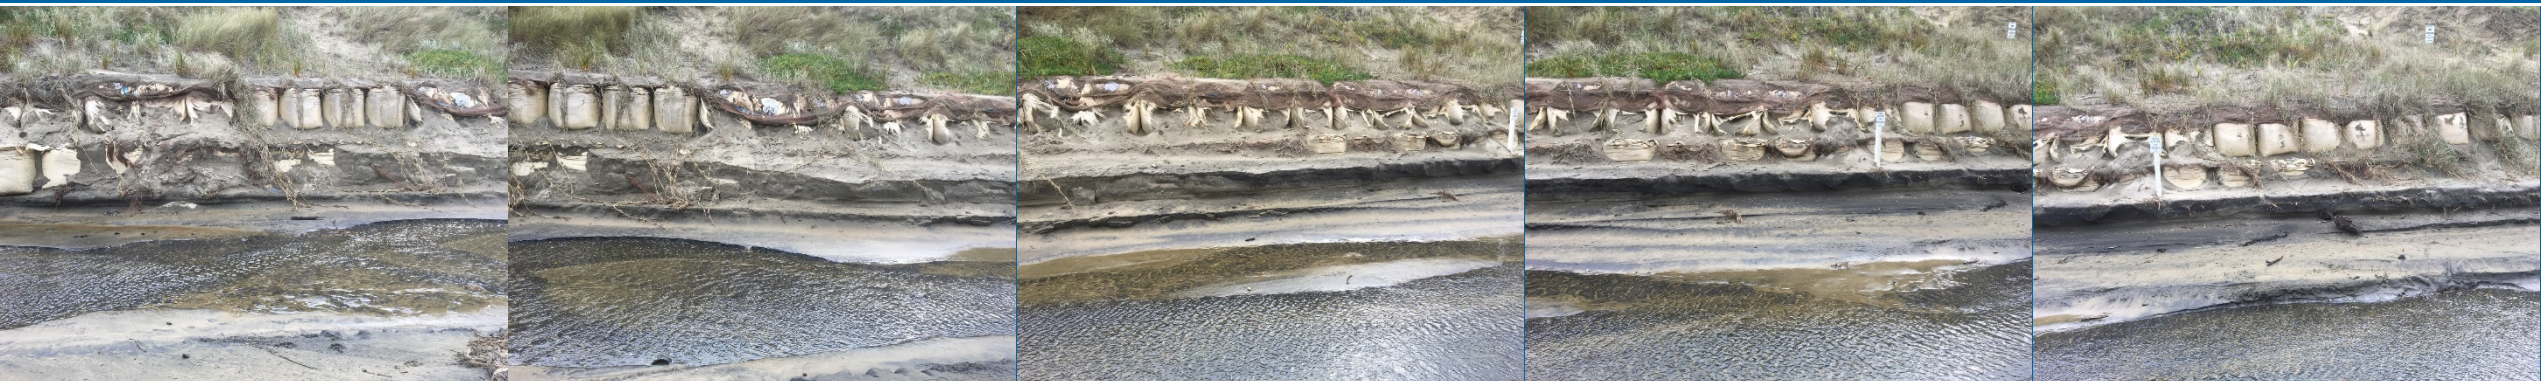
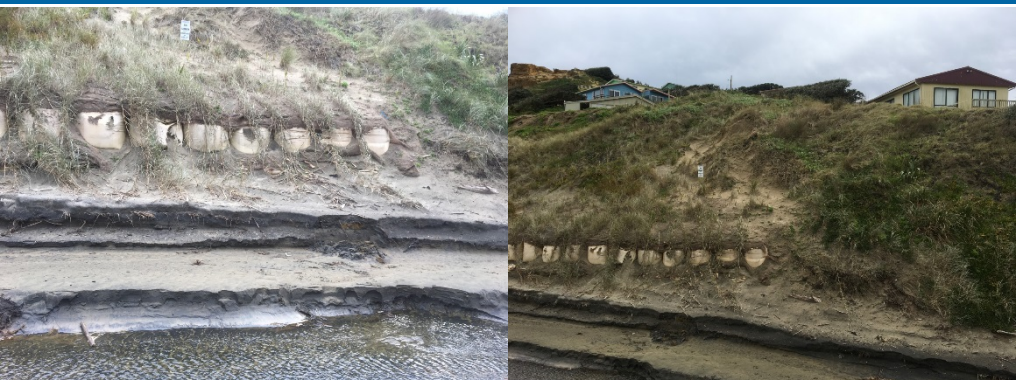
A count of sand bags that have failed show that 60 out of 90 have bags that have moved in some manner. There are further bags that have holes or substantial rips in them.

Photos taken approximately every 5 m showing existing state of wall at state of wall and failures

~0 to 9m ~7 – 17m ~13 – 21m ~19-26m ~23-30m

~25 to 35m ~32 – 40m ~36 – 43m ~40-49m ~45-55m

~52 to 63m ~58 – 67m ~63 – 73m ~67-77m ~64-74m

~76 to 84m ~75 – 84m
