## GEOTECHNICAL REPORT

*For Sandways Developments Ltd*

**25 October, 2005**

**Project Number: 10416**

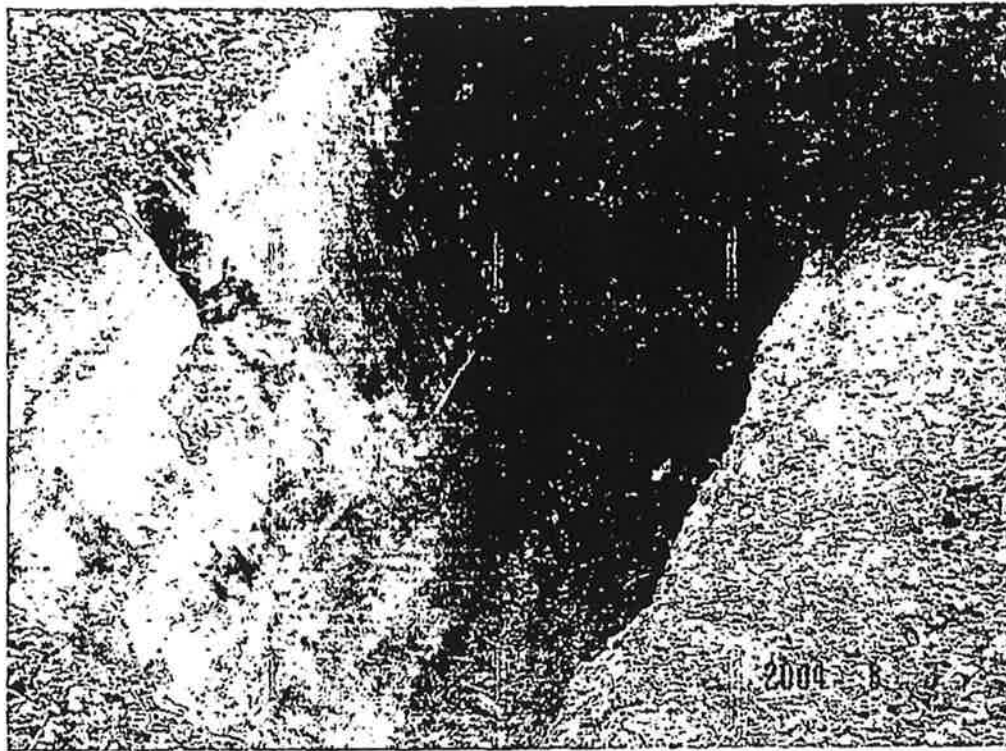
*Photo 1: Test Pit 1*

Test pit 1 was excavated on the northern side of Lot 1 near Molesworth Drive. The test pit revealed silty SAND to a depth of about 0.4m. From 0.4-0.8m was a dark grey gravelly SAND, dry, loosely packed, gap graded. The layer is a mixture of fill material with blue metal mixed amongst it. It is believed to be fill material placed along the roadside berm when Molesworth Drive was

constructed. From the depth of 0.8-2.0m is a dark brown/black Sandstone, tightly packed, slightly weathered, dry. The watertable was located at depth 0.5m.

Soil Description	Legend	Soil Symbol	Depth (m)	Water Level	Vane Shear Strength maximum/residual corrected - kPa	Soil Sensitivity	Sample Number	Other Tests
Dark grey silty SAND, loosely packed, dry, uniformly graded, slightly weathered, sub horizontal, very thick bedded		SP	0.0					
Dark grey gravelly SAND, loosely packed, dry, uniformly graded, slightly weathered, sub horizontal, very thick bedded		SW	-0.4 -0.5					
Dark brown/black, SANDSTONE tightly packed, dry, uniformly graded, freshly weathered, sub horizontal, assumed very thick, angular		SP	-0.8 -1.0 -1.5 -2.0					
EOD								
Remarks: Water table at 0.5m.					Topsoil		Sand	
					Fill		Gravel	
					Clay		Peat	
					Silt		Rock

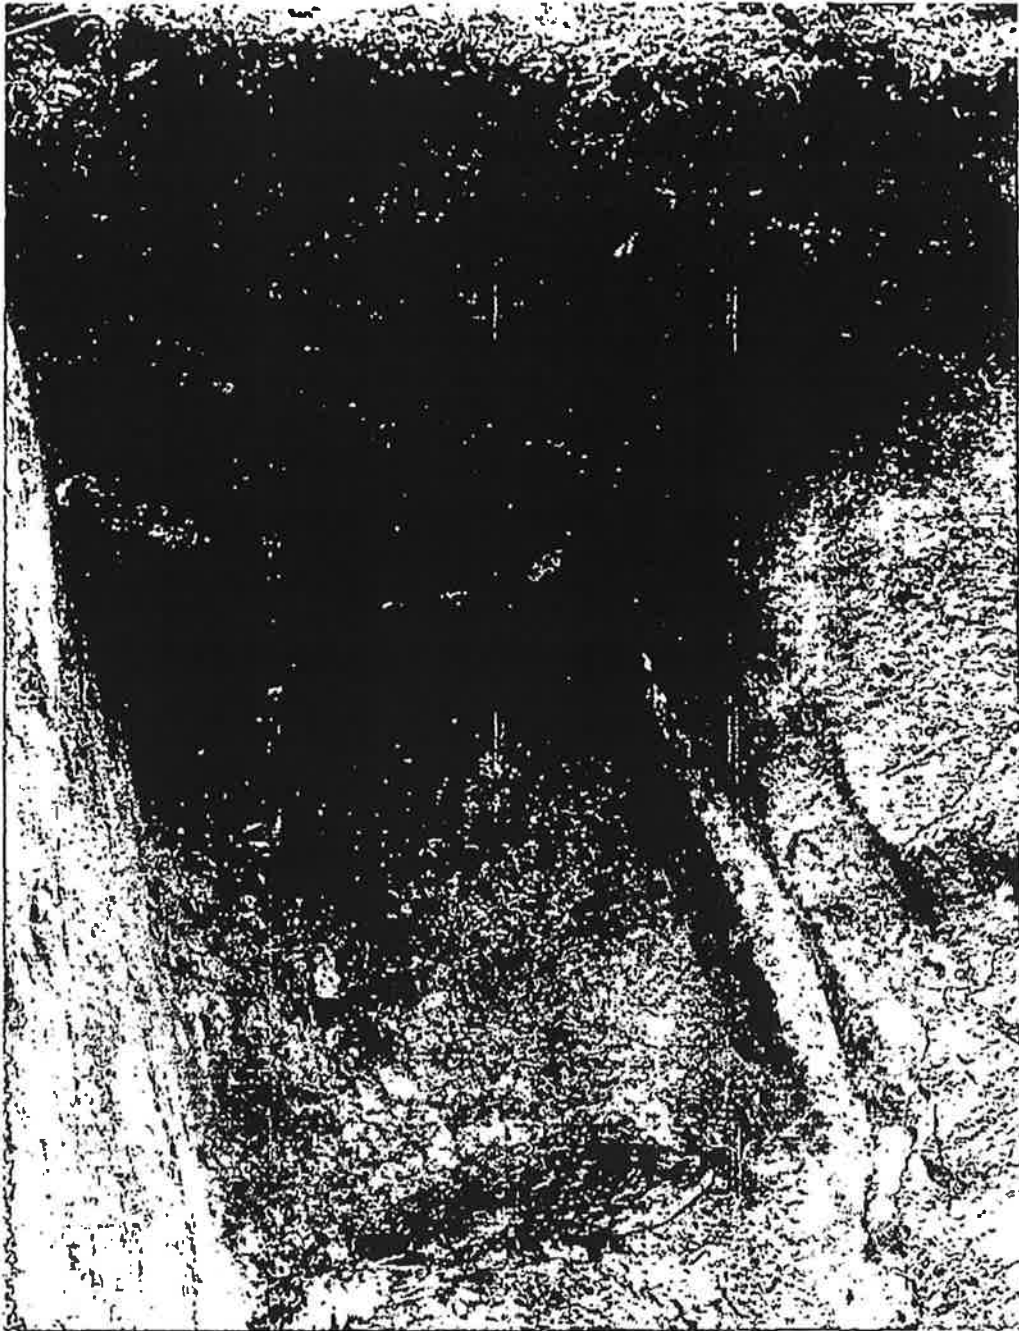
*Photo 2: Test Pit 4*

Soil Description	Legend	Soil Symbol	Depth (m)	Water Level	Vane Shear Strength maximum/residual corrected kPa	Soil Sensitivity	Sample Number	Other Tests
Dark grey silty SAND, loosely packed, dry, uniformly graded, slightly weathered, sub horizontal, very thick bedded		SP	0.0					
Dark grey gravelly SAND, loosely packed, dry, uniformly graded, slightly weathered, sub horizontal, very thick bedded		SW	-0.4					
Dark brown/black, SANDSTONE tightly packed, dry, uniformly graded, freshly weathered, sub horizontal, assumed very thick, angular		SP	-0.8					
			-1.0					
			-1.5					
			-1.9					
EOD			-2.0					
Remarks: Water table at 1.9m.					Topsoil		Sand	
					Fill		Gravel	
					Clay		Peat	
					Silt		Rock

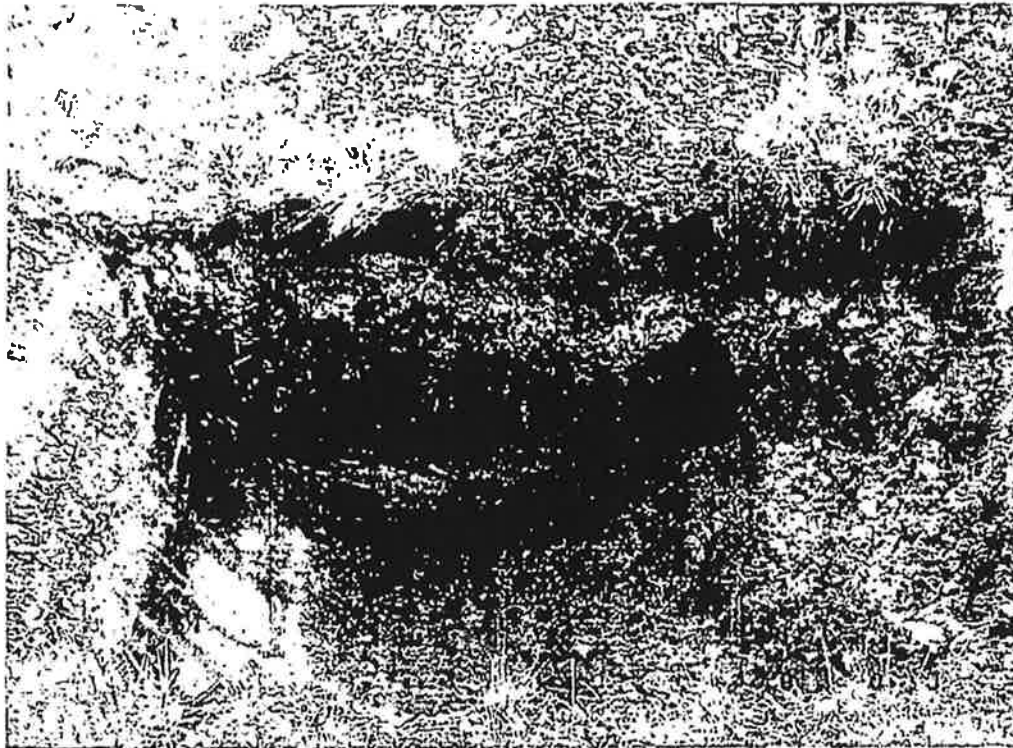
*Photo 3: Test Pit 11*

Soil Description	Legend	Soil Symbol	Depth (m)	Water Level	Vane / Shear Strength maximum (residual) corrected kPa	Soil Sensitivity	Sample Number	Other Tests
Dark grey silty SAND, loosely packed, dry, uniformly graded, slightly weathered, sub horizontal, very thick bedded		SP	0.0					
			-0.5					
Dark brown/black, SANDSTONE, tightly packed, dry, uniformly graded, freshly weathered, gently inclined, assumed very thick, angular			-0.9					
			-1.0					
			-1.3					
			-1.7					
			-1.8					
EOD			-2.0					
Remarks: Water table at 0.9m.					Topsoil		Sand	
					Fill		Gravel	
					Clay		Peat	
					Silt		Rock
