In reply please quote: 13124 Revision 1

9th April 2024

MANGAWHAI HILL LIMITED PROPOSED PLAN CHANGE PPC84
GEOTECHNICAL ASSESSMENT REGULATORY REVIEW

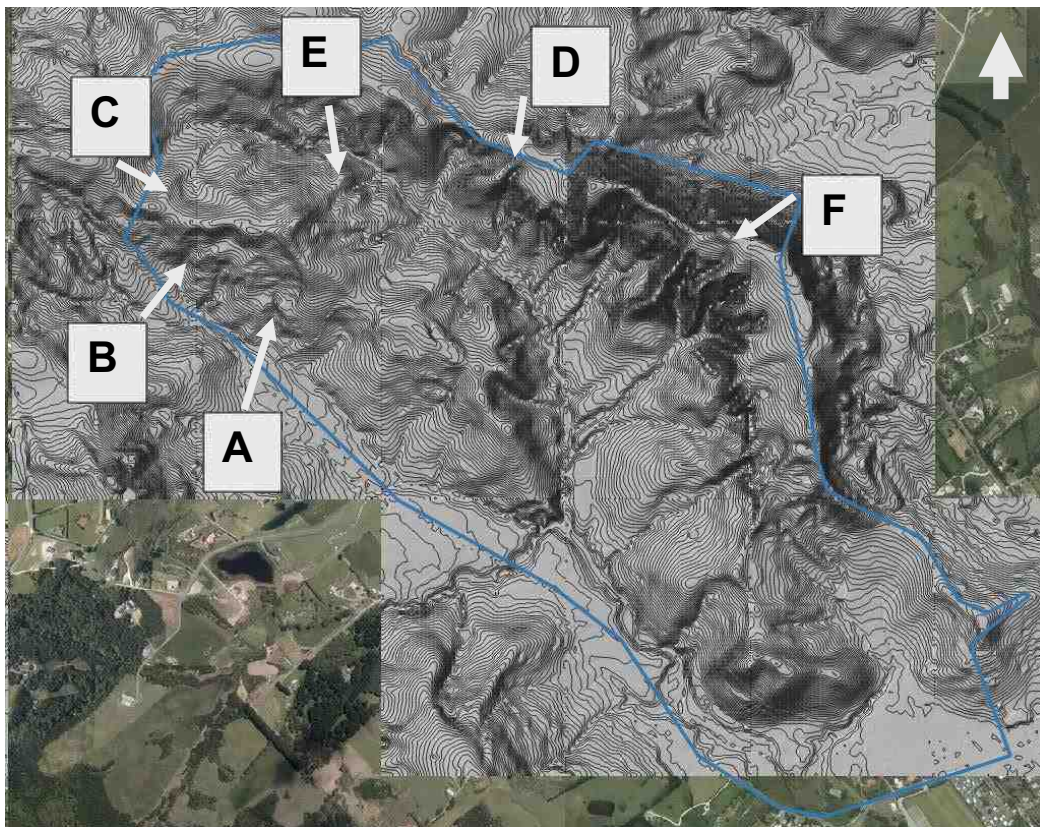
Figure A – GIS model of the subject site with 1.0m contours and hill-shade modelling. (Source: QGIS and Northland LiDAR data). The blue line indicates the extent of the PPC84 boundary.

Figure A above presents the QGIS hill-shade model used to visually assess the subject property. Steeper slopes are observed by dark shadowing and tightly spaced contour lines. Shading in the model also aids in highlighting the property topography i.e. gives shape to historic slope movement, hummocky/undulating ground, and locates gullies. The locality of the slope instability features observed in this model and during my site walkover are highlighted in Figure B below. It is noted that slope instability features are generally concentrated to steeper slopes over the head of gullies, and towards the toe of the slopes. These feature vary from active to historic movements.

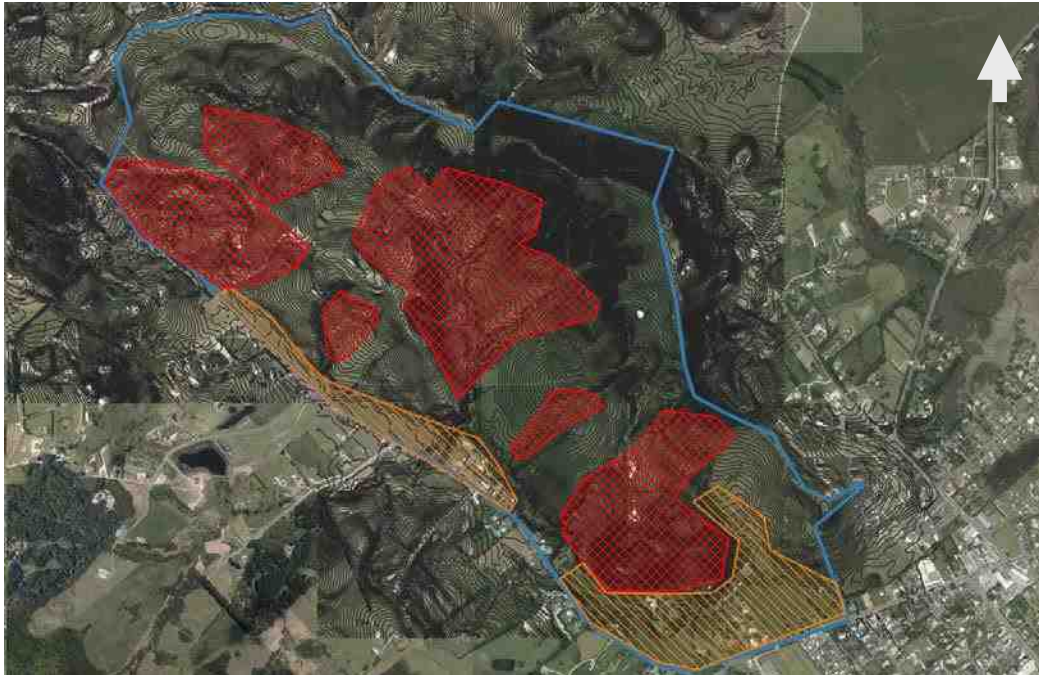
Figure C below indicates areas of the site that are within the *Proposed Residential Area* on the Mangawhai Hills Structure Plan that are considered to be prone to moderate to high slope instability and should be subject to further geotechnical assessment. Also indicated are areas of low-lying land that may be subject to settlement, and/or liquefaction. These areas are assessed based on site observations and the QGIS model.

Figure C – GIS model of the subject site with 1.0m contours. (Source: QGIS and Northland LiDAR data). Red hatching indicates areas potentially prone to high slope instability hazard, and orange low-lying land susceptible to moderate settlement/liquefaction (subsidence) hazards.

Further investigation, associated assessment, and reporting are recommended to be undertaken in the areas denoted as *high and moderate geotechnical hazard risks*, on the attached Figure C. It is recommended that KDC request the applicant undertake further engineering assessment, to better support the PPC84 application and address the following points:

It may also be beneficial, in the areas denoted as *high geotechnical hazard risk*, on the attached Figure C, to undertake deep subsoil testing to define the nature and continuity of the strata over areas deemed prone to slope movement, with the investigation terminating at a depth below which slipping is most likely. This may be undertaken by means of test pits and/or continuous recovery core drilling to inform appropriate residential development density.

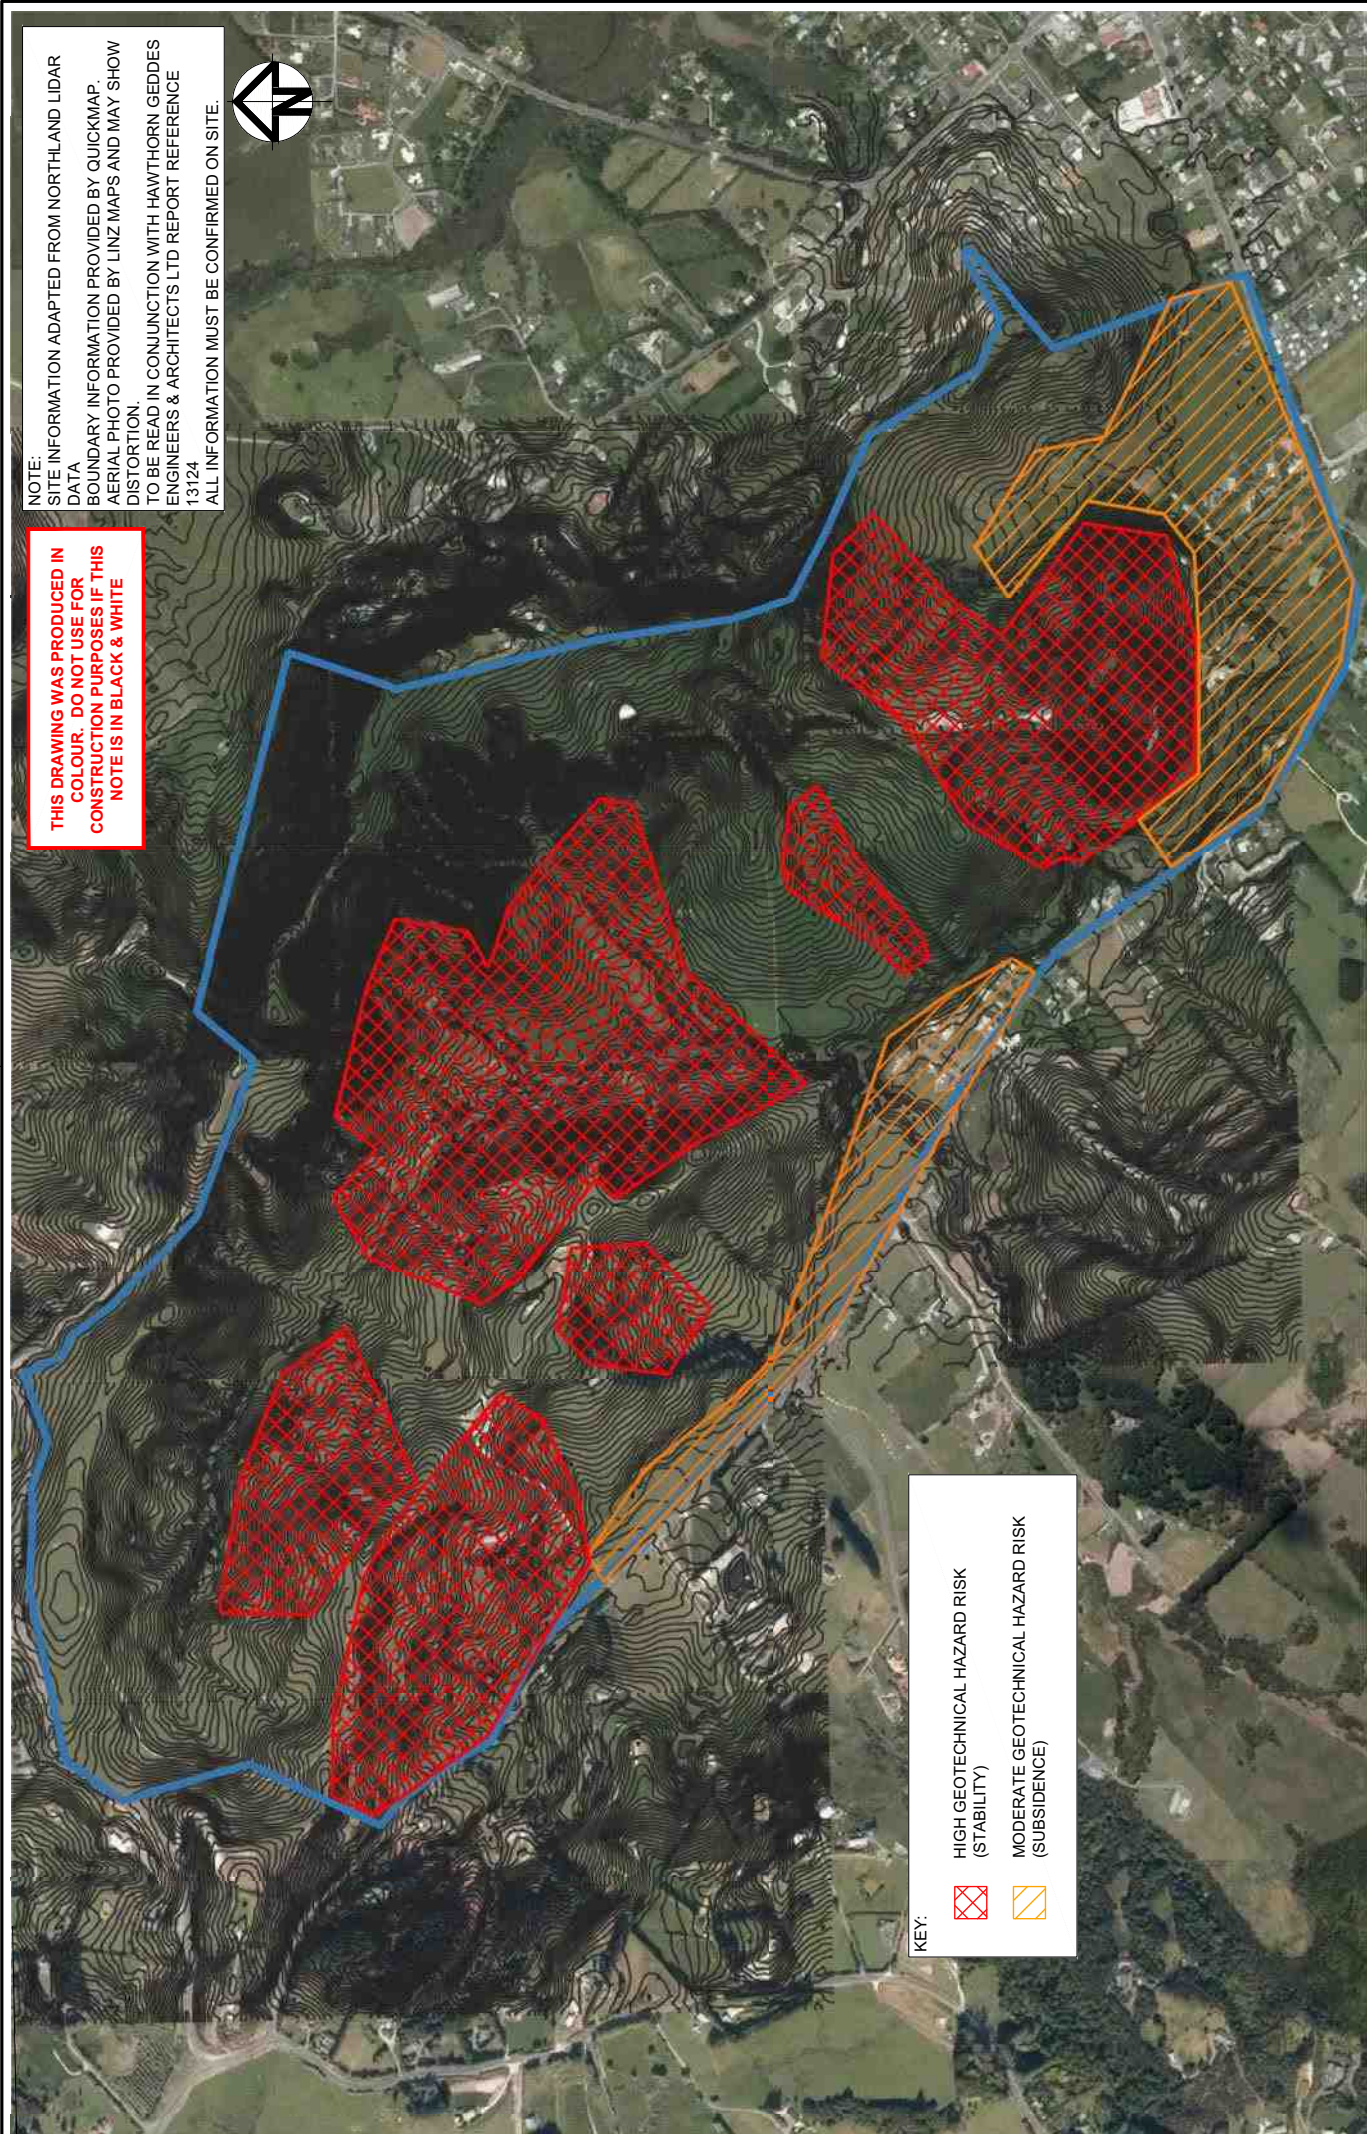
SCALE @ A3	1:8000
PROJECT No.	13124
FIGURE No.	01
REV	~

HIGH GEOTECHNICAL HAZARD RISK (STABILITY)

MODERATE GEOTECHNICAL HAZARD RISK (SUBSIDENCE)

CLIENT **KAIPARA DISTRICT COUNCIL**
PROJECT **PROPOSED PLAN CHANGE 84**
MANGAWHAI HILLS LTD
DRAWING **AREAS OF GEOTECHNICAL HAZARDS**

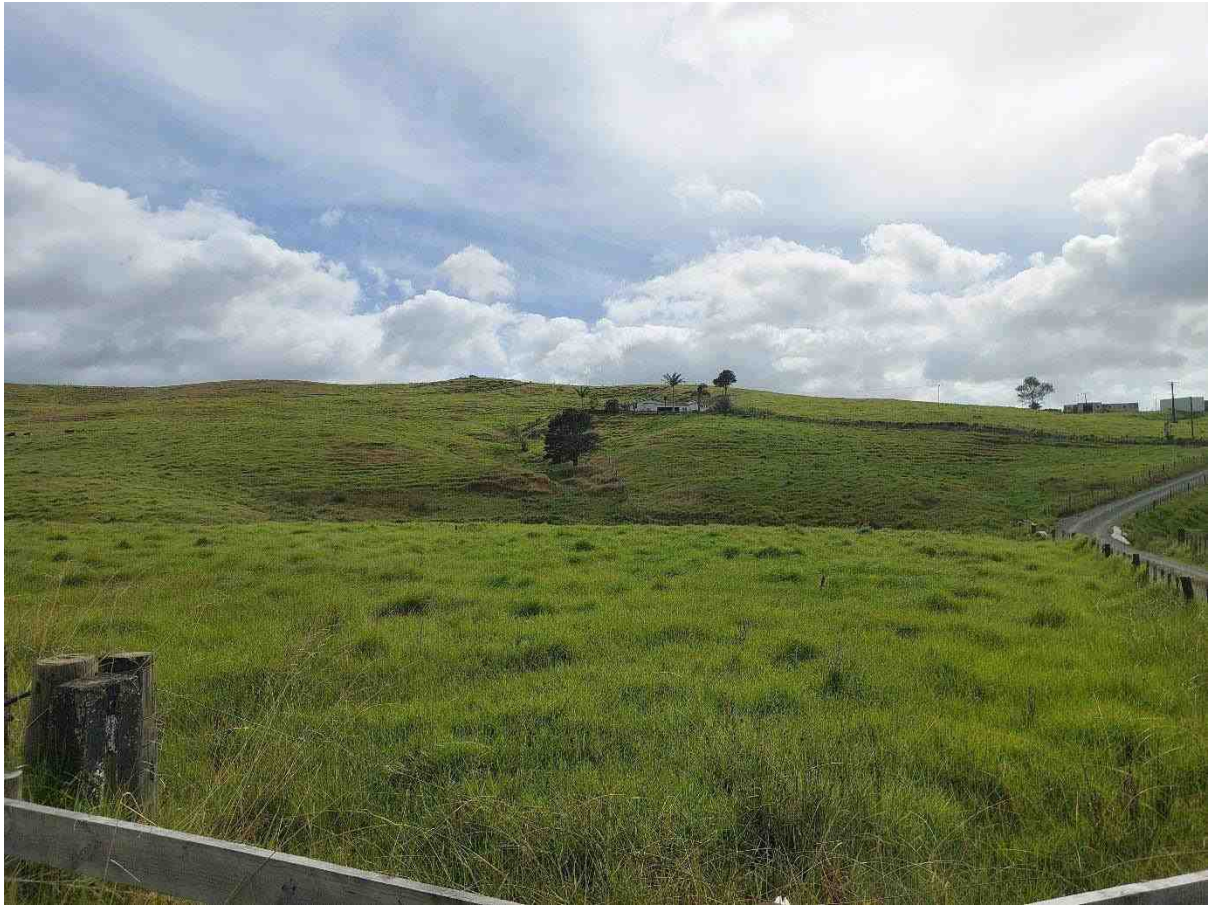
Photograph A – Hummocky ground and incised overland flow paths.

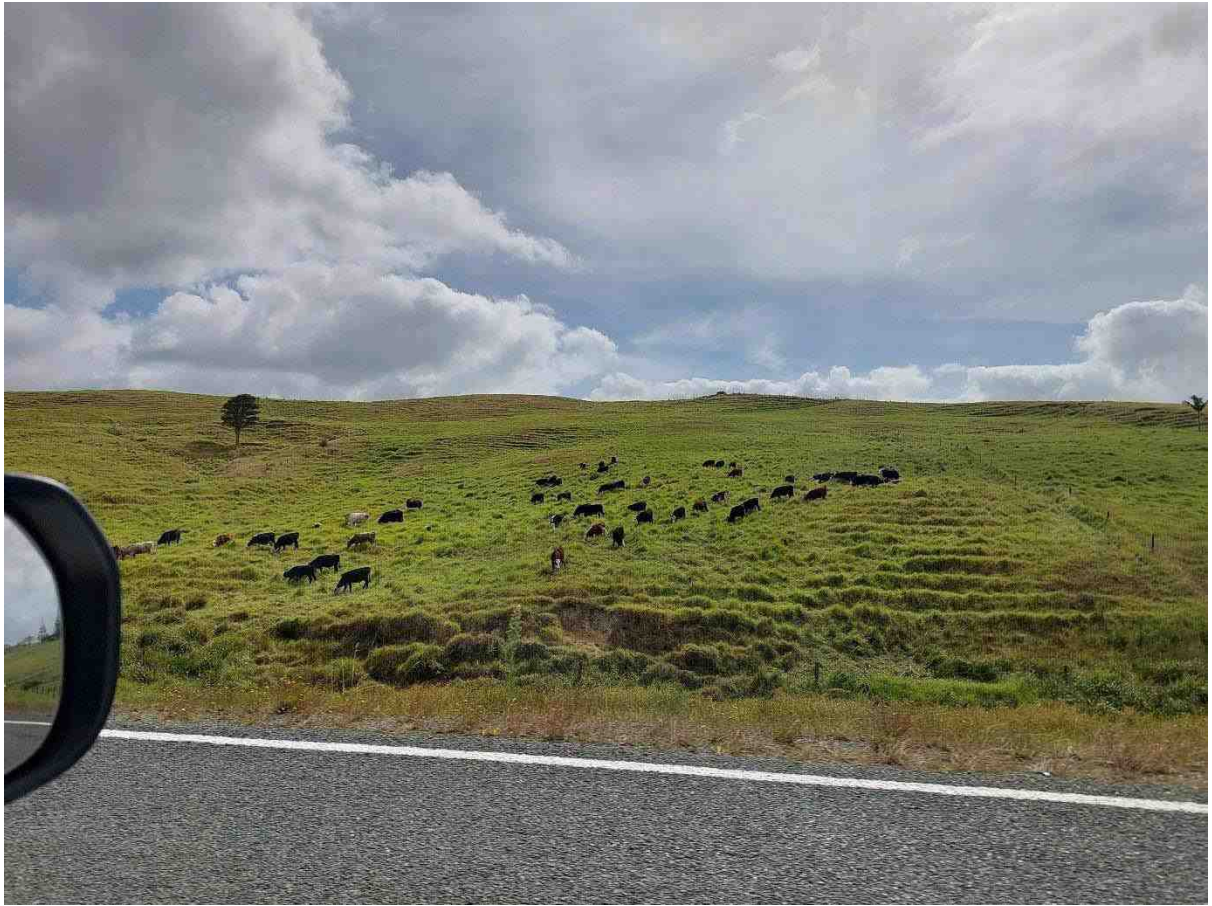
Photograph B – Hummocky/undulating ground, as well as soil creep.

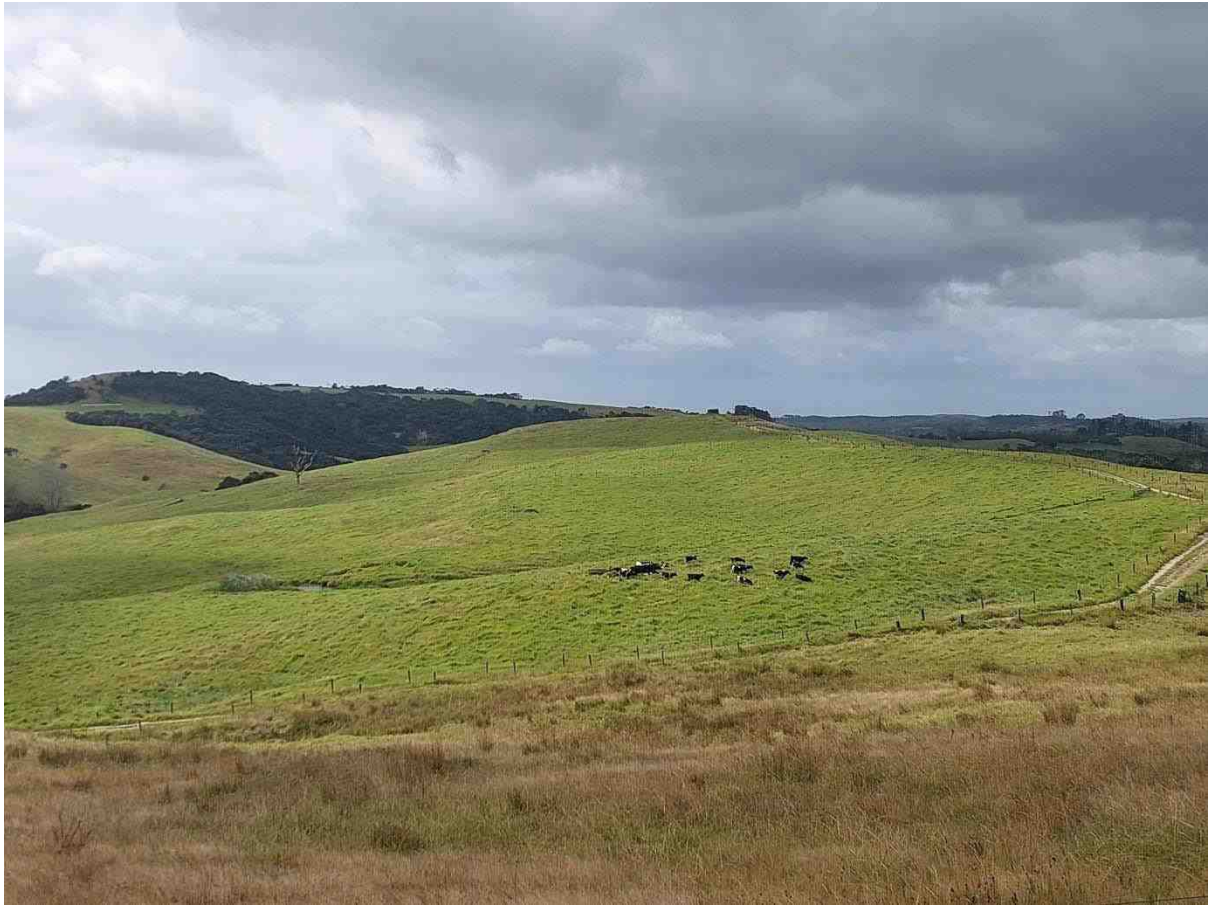
Photograph C – Planar slopes over the crest of the ridge and shallower sloping ground

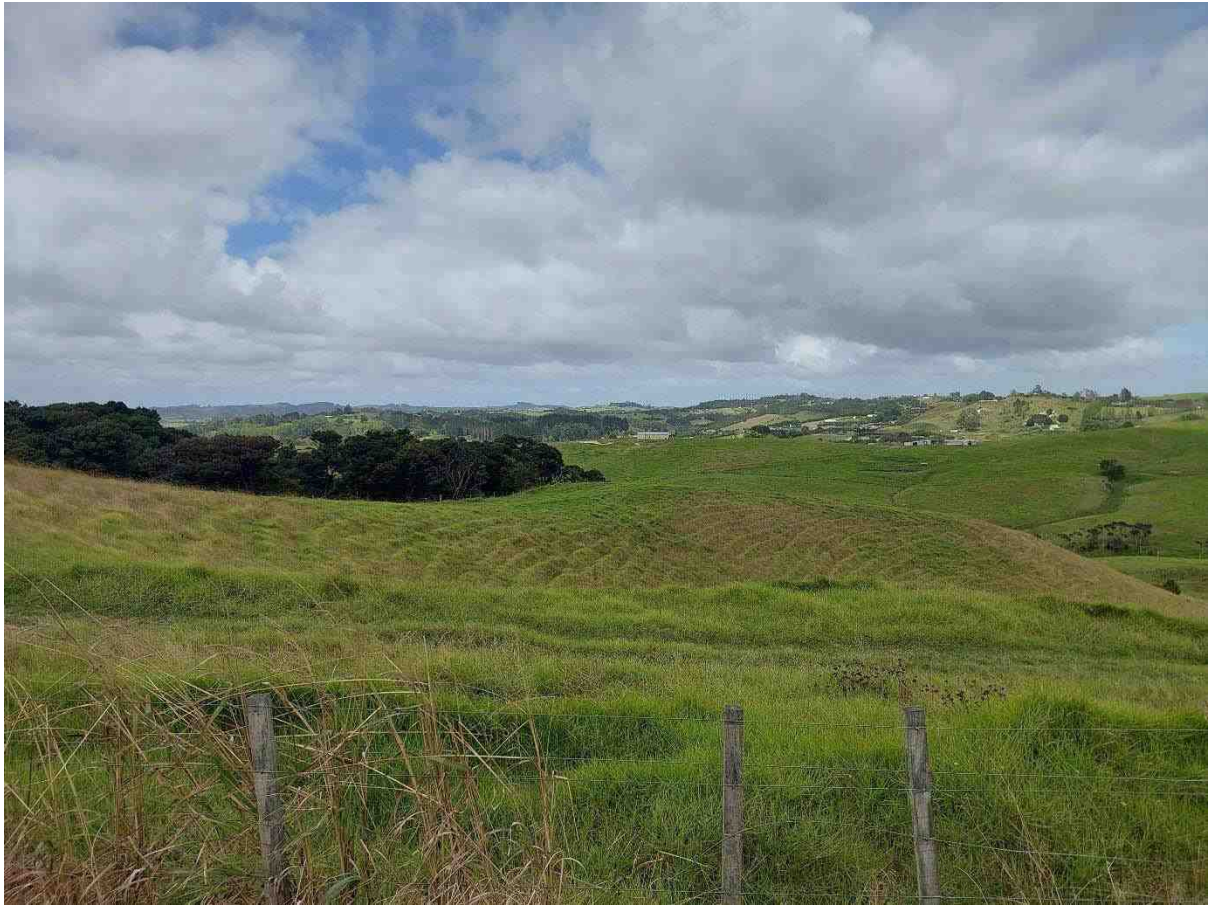
Photograph D – Steep slopes subject to soil creep, evident by terraces. Locality over the head of a gully.

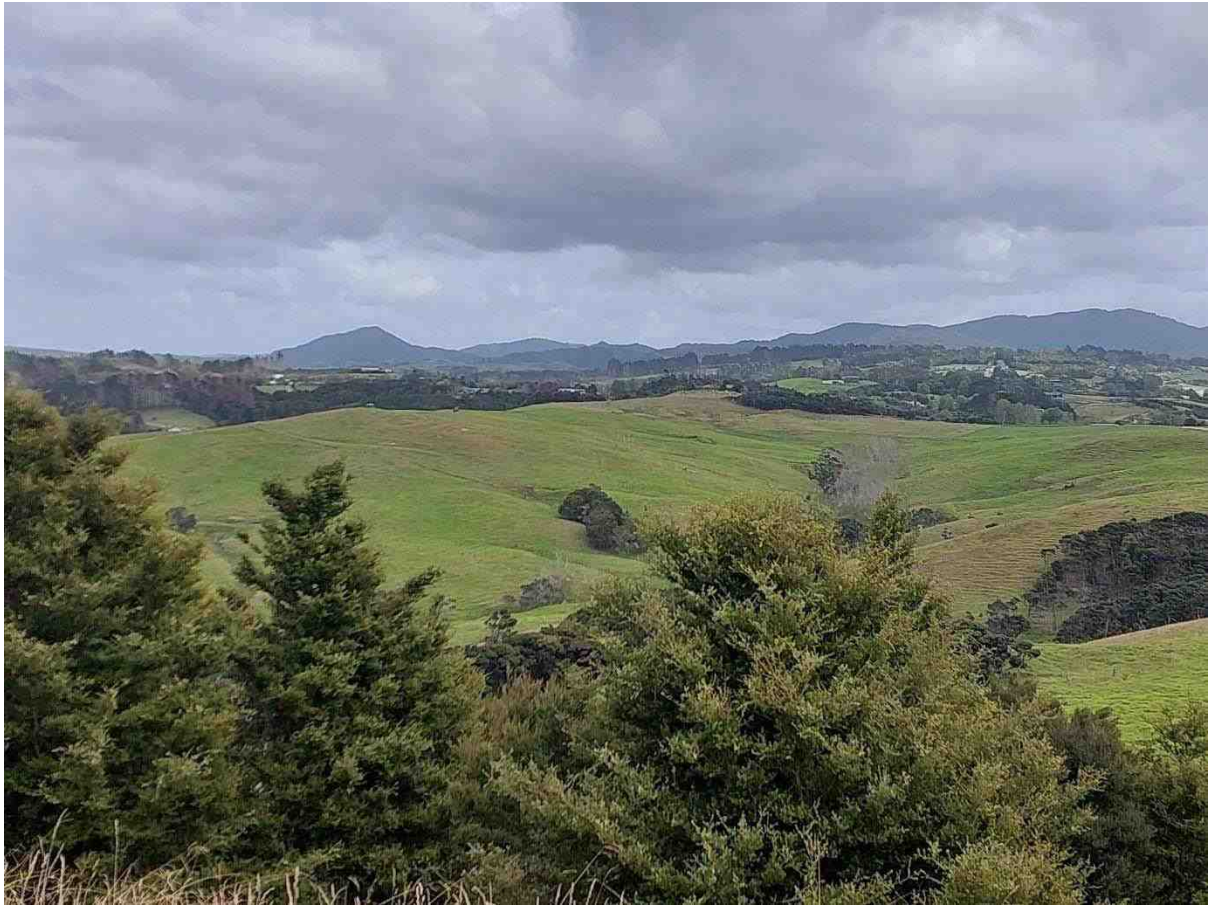
Photograph E – Generally Planar slopes over the crest of ridgelines, becoming hummocky towards the centre of the Gully.

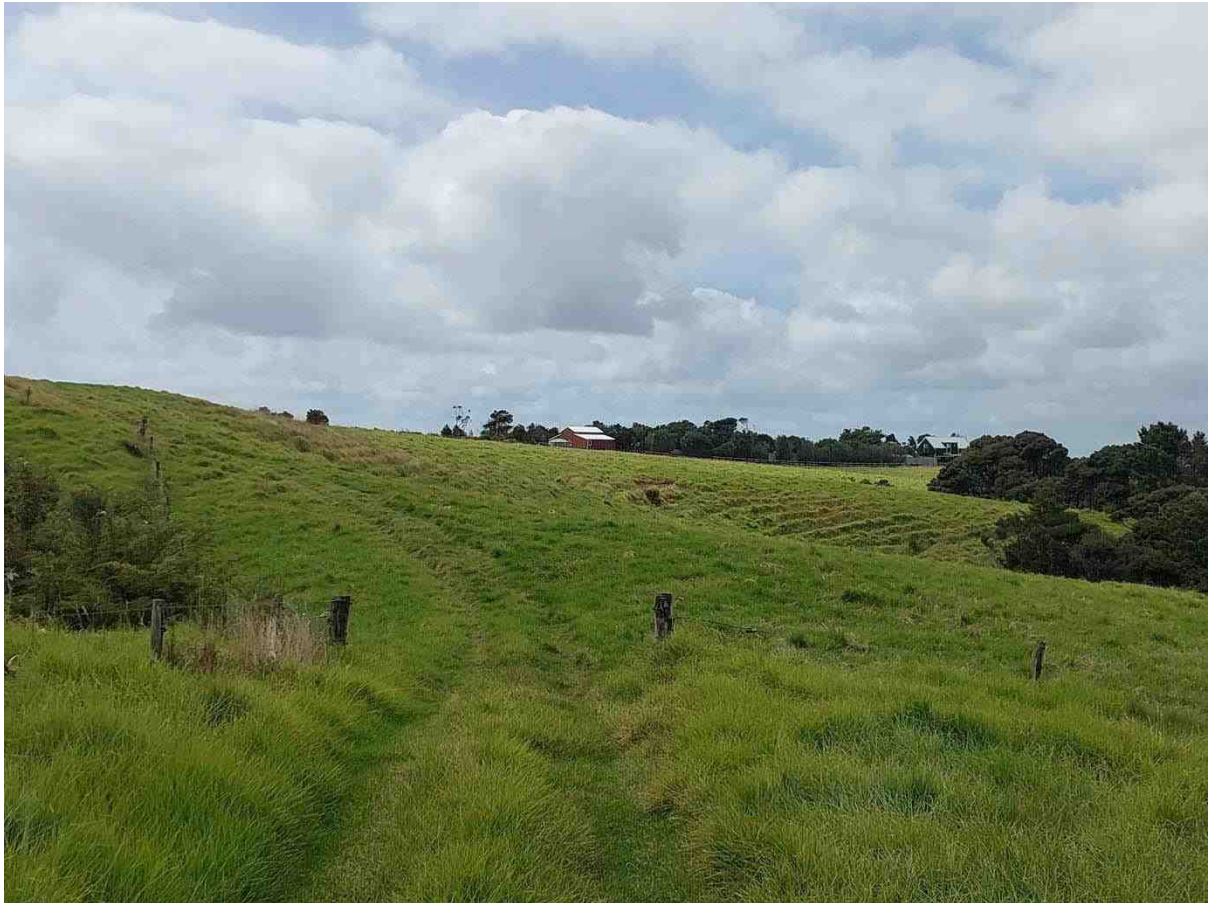
Photograph F – Well-defined head of steep-sided and sloping gulley just below the crest of the ridgeline. Terraces are evidence of shallow surface movement/soil creep.
