RE: Geotechnical Investigation for Proposed Plan Change at 18A Black Swamp Road, Mangawhai (Lot 2 DP 29903 & Section 25 Block IV Mangawhai SD).

Wiley Geotechnical Limited (WGL) was requested by Jackson Worsfold to provide a geotechnical investigation to support an application to Kaipara District Council for a proposed plan change.

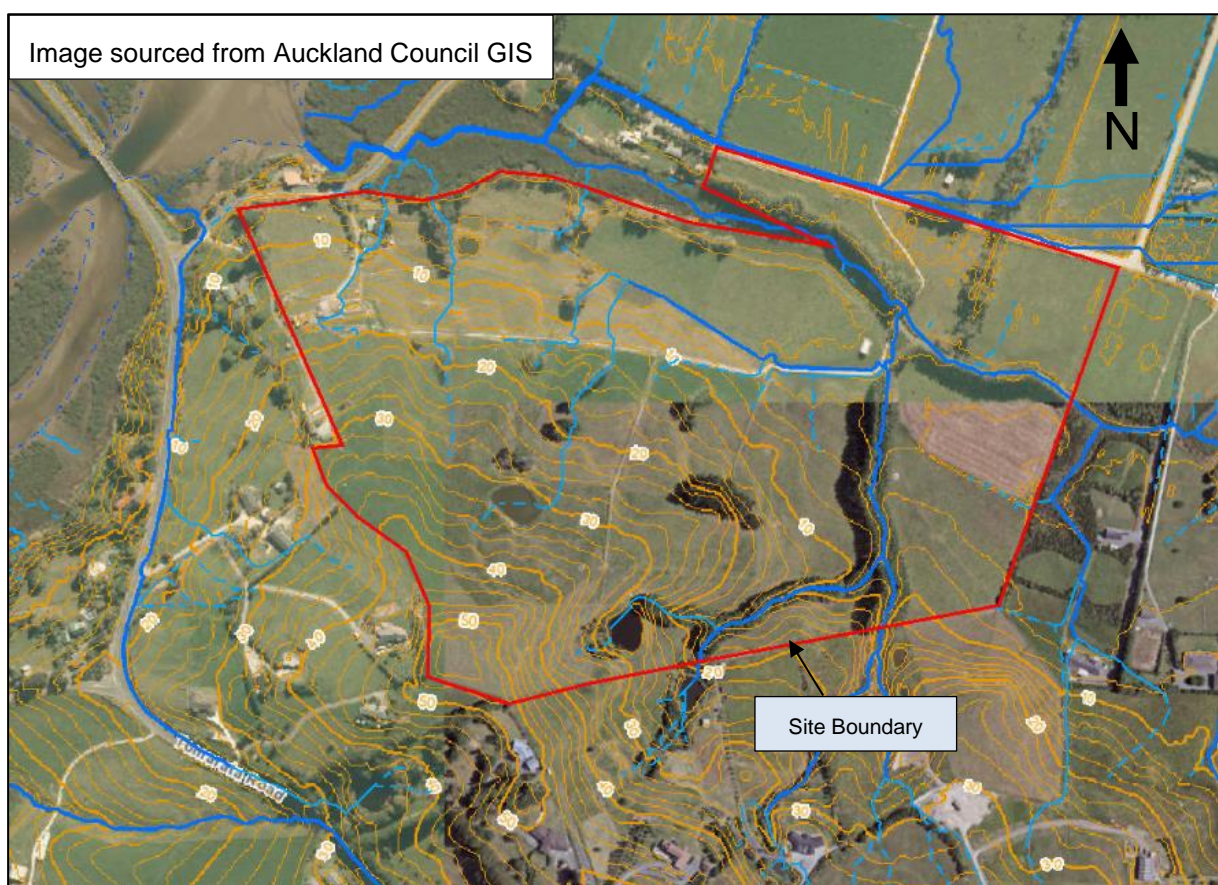
Figure 2: Contour (1m) and Overland Flowpath map (Auckland Council GIS GeoMaps)

The site is north-northeast facing with a high point of RL 55 at the southernmost location, down to RL 0 at the estuary on the northern boundary.

There is a north-trending ridge along the western boundary and a north-eastern trending ridge in the centre of the site, both ridges start at the RL 55 high point.

As shown in Figure 2 below there are a number of overland flow paths across the site flowing in the general direction of the landform. Man-made farm ponds are also located at a number of locations across the site feeding the overland flow paths.
