# Preliminary Site Investigation (PSI)

## Black Swamp Road PPC, Mangawhai

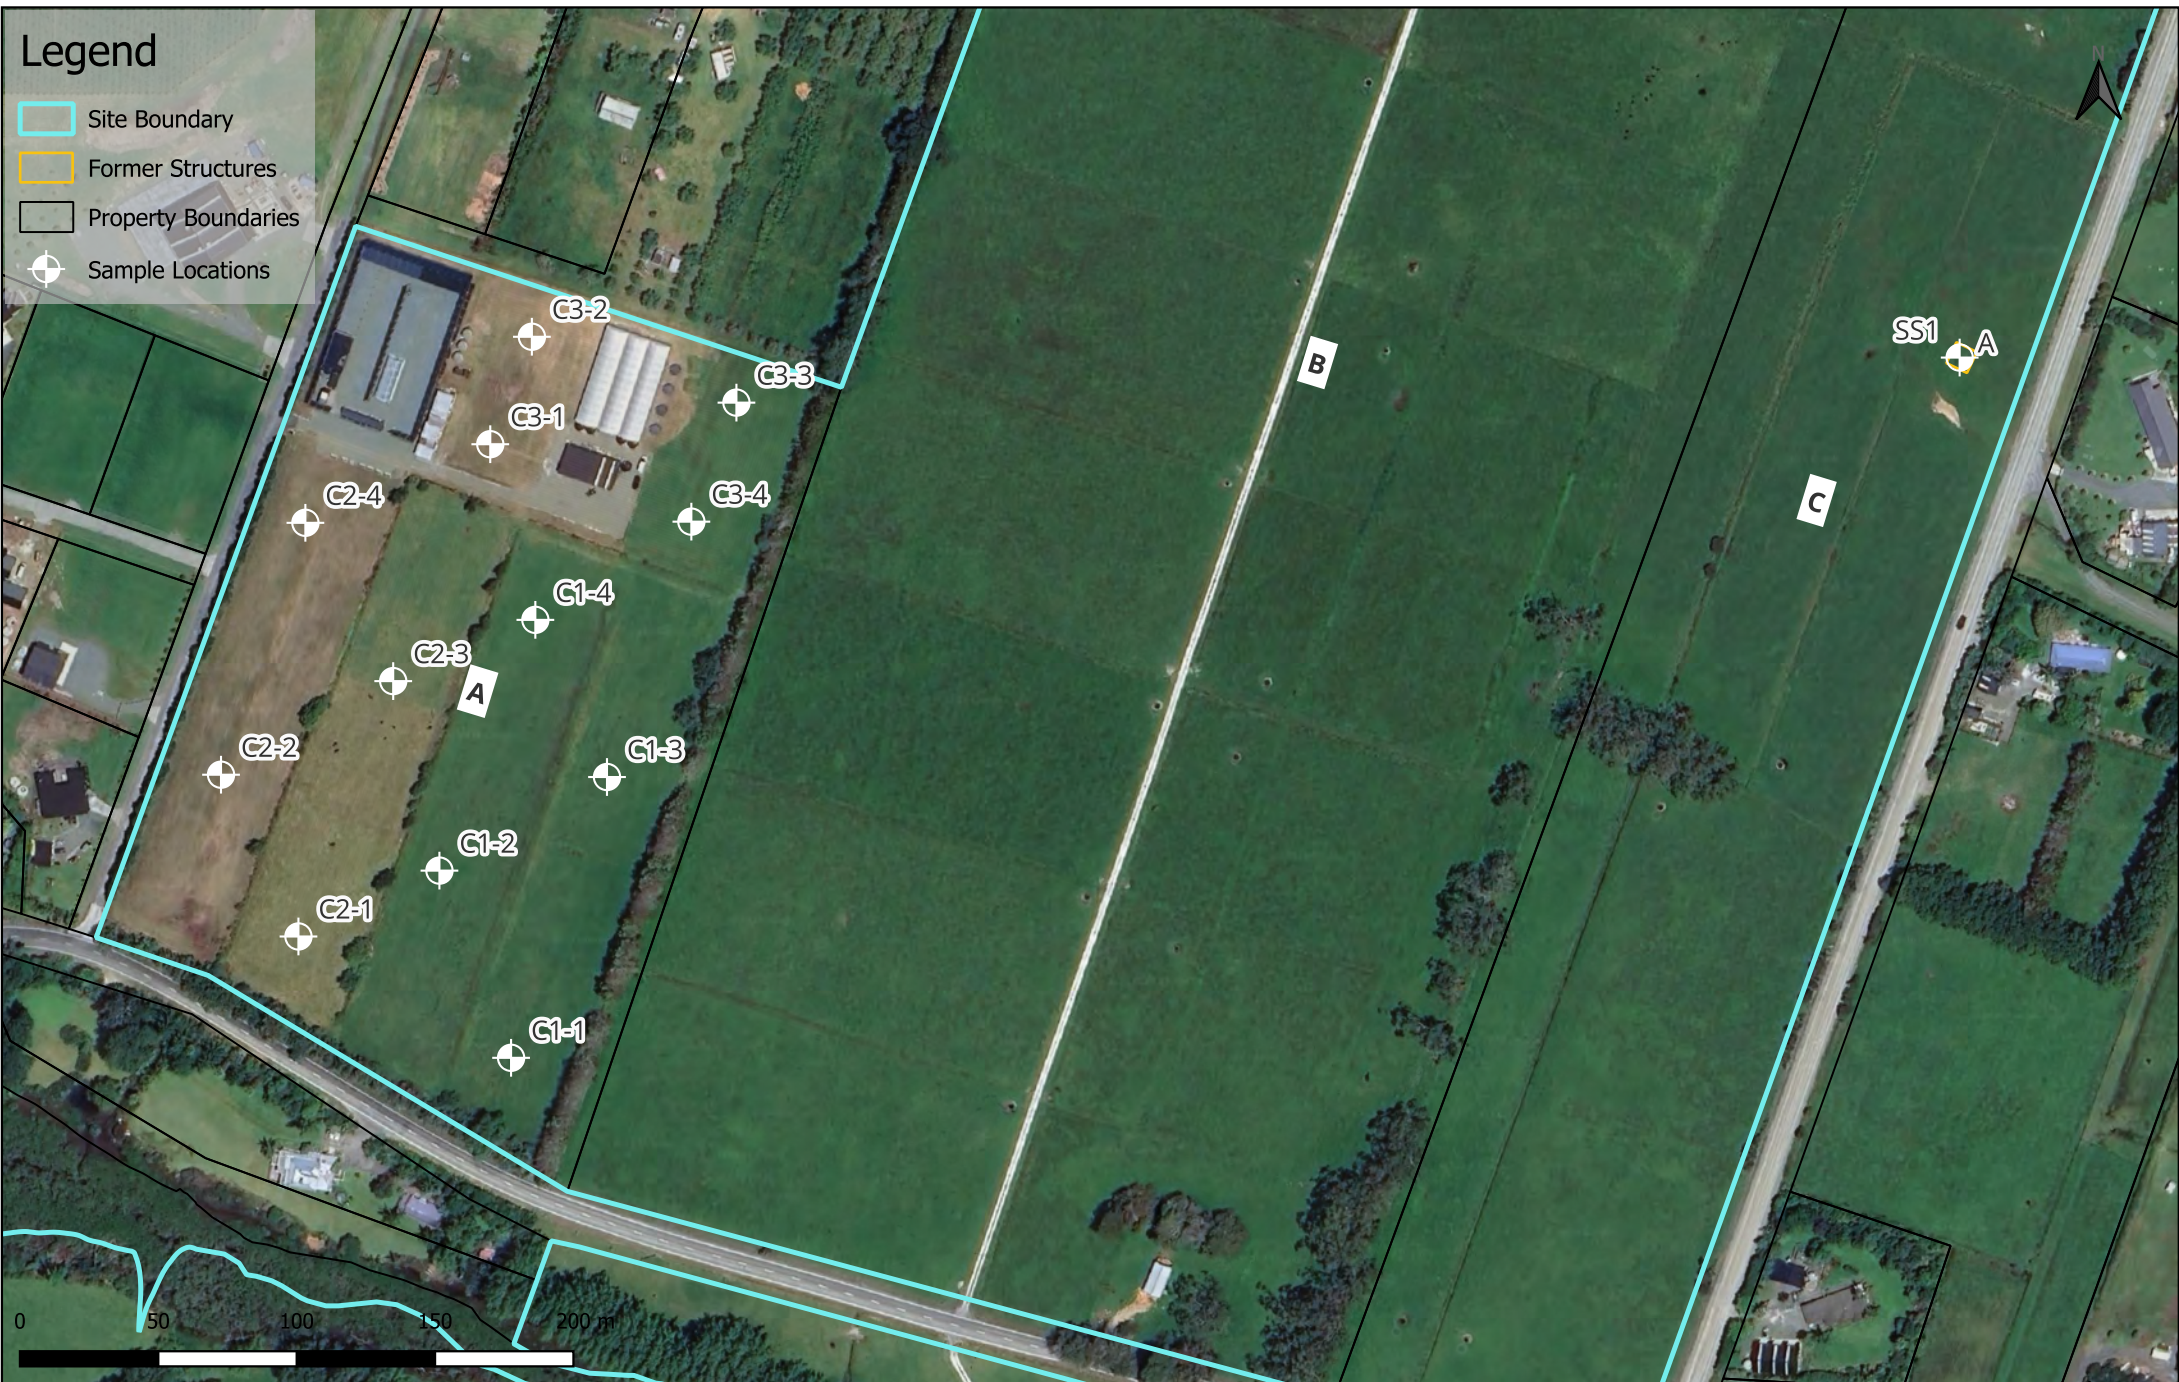
- Demolished Building (HAIL I)
- Deteriorated Building (HAIL E1 & I)

Former Structure
A	Shed (ca.1960)
B	Shed (ca. 1961)
C	Shed (ca. 1961)
D	Shed (ca. 1977)

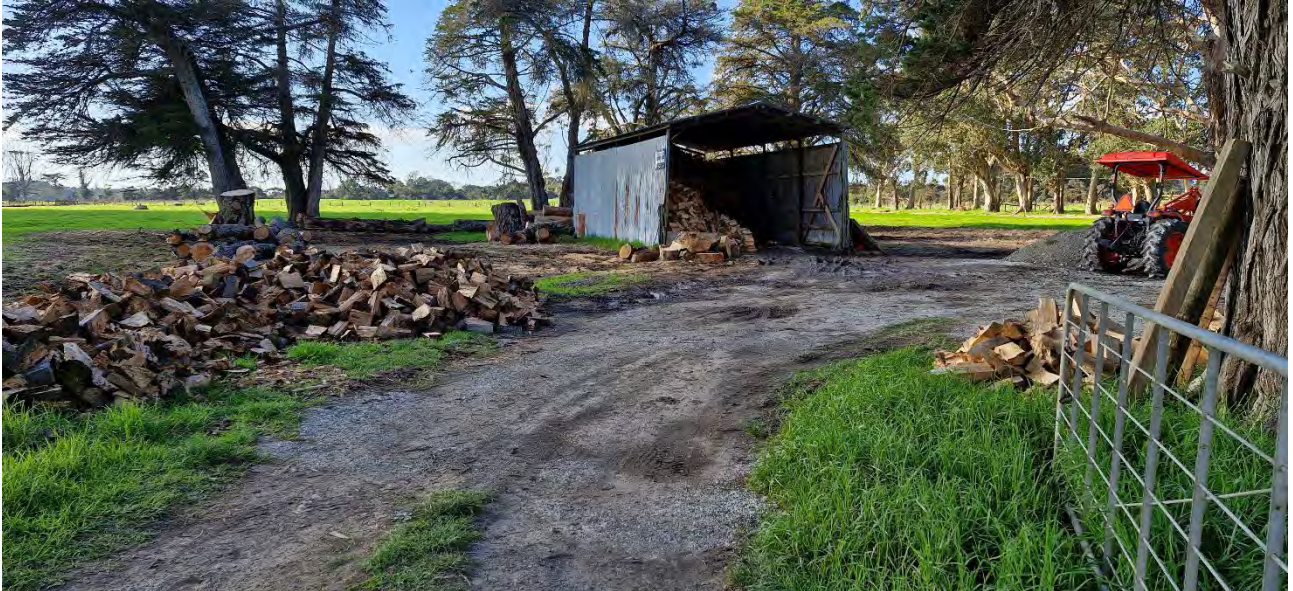
- The property comprised vacant paddocks, with an access track extending through the centre of Property B.
- A large unpainted steel barn was located along the southern boundary. The barn contained chopped wood. No stored hazardous substances were identified within the barn.

**PLATE 11:** View of the barn along the southern boundary of Property B, facing northeast.

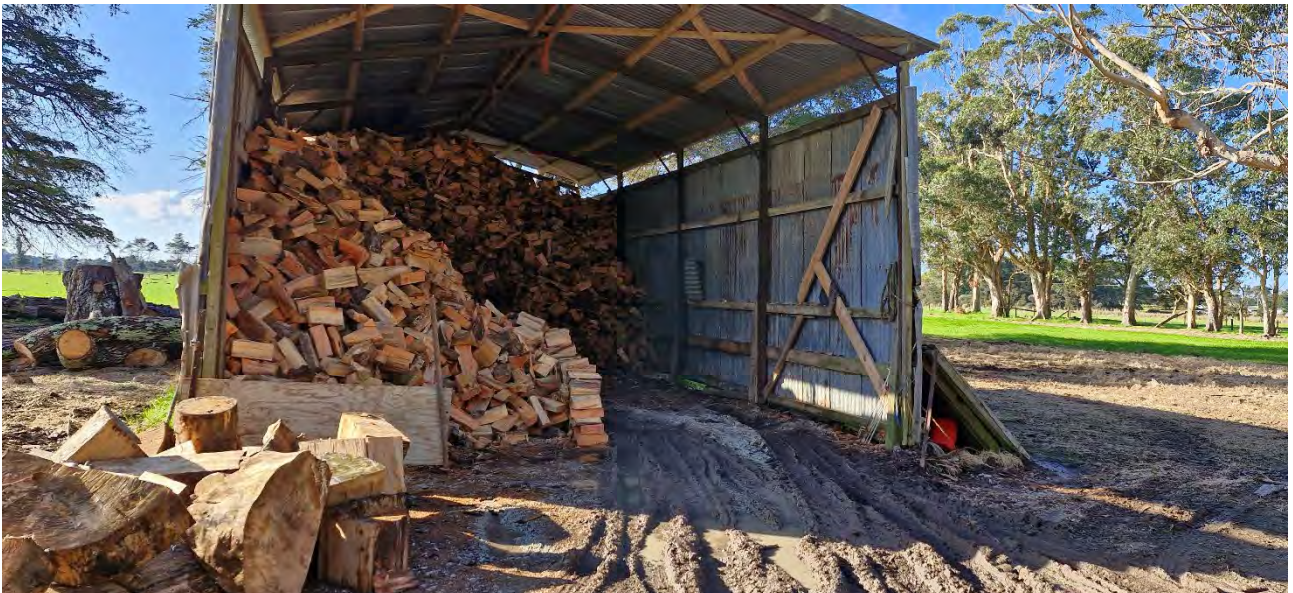
**PLATE 12:** View of contents of the barn, facing northeast.

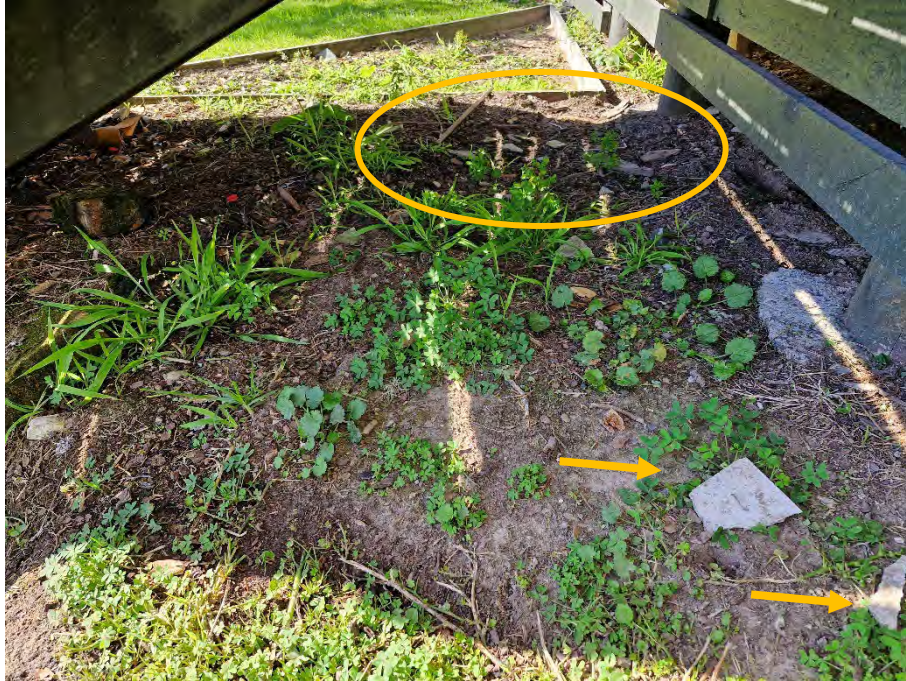
All potential ACM building material on the current site structures appeared to be good condition, with no significant signs of damage or deterioration noted. Potential ACM fragments were identified beneath the northern stairs of the dwelling; however, these do not appear to be associated with damage to any current site structures and the source of the fragments could not be determined. Therefore, HAIL E1 is limited to the area of potential ACM identified beneath the dwelling stairs, and the former sheds (A-D).

**PLATE 17:** View of potential ACM beneath the dwelling stairs.

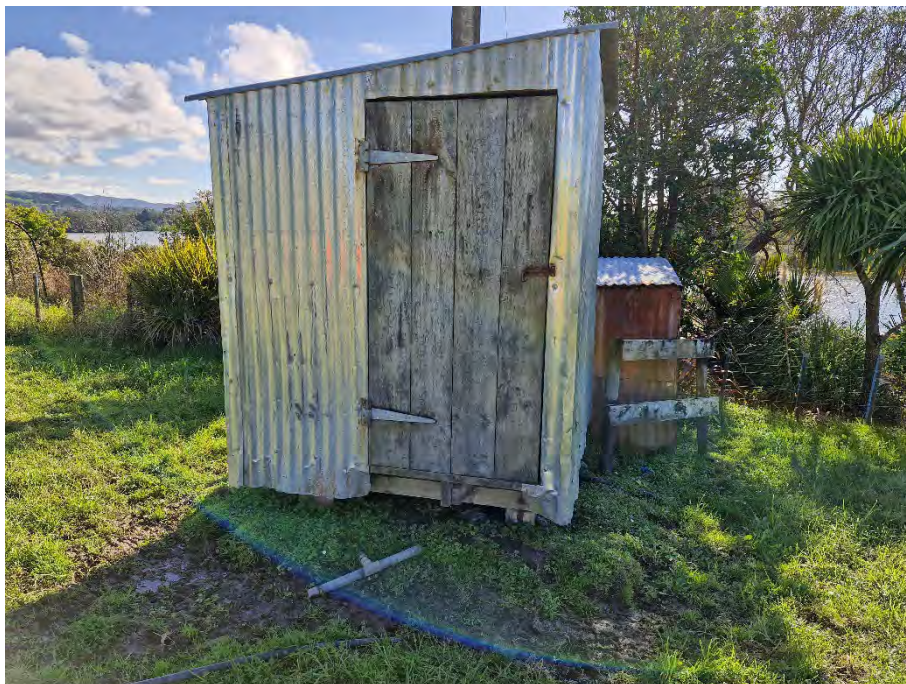
- The buildings were in good condition, with minimal deterioration/damage noted.
- Three small metal sheds (one painted) and a rain tank were located northwest of the dwelling.

**PLATE 20:** View of sheds (4 & 5), facing north.

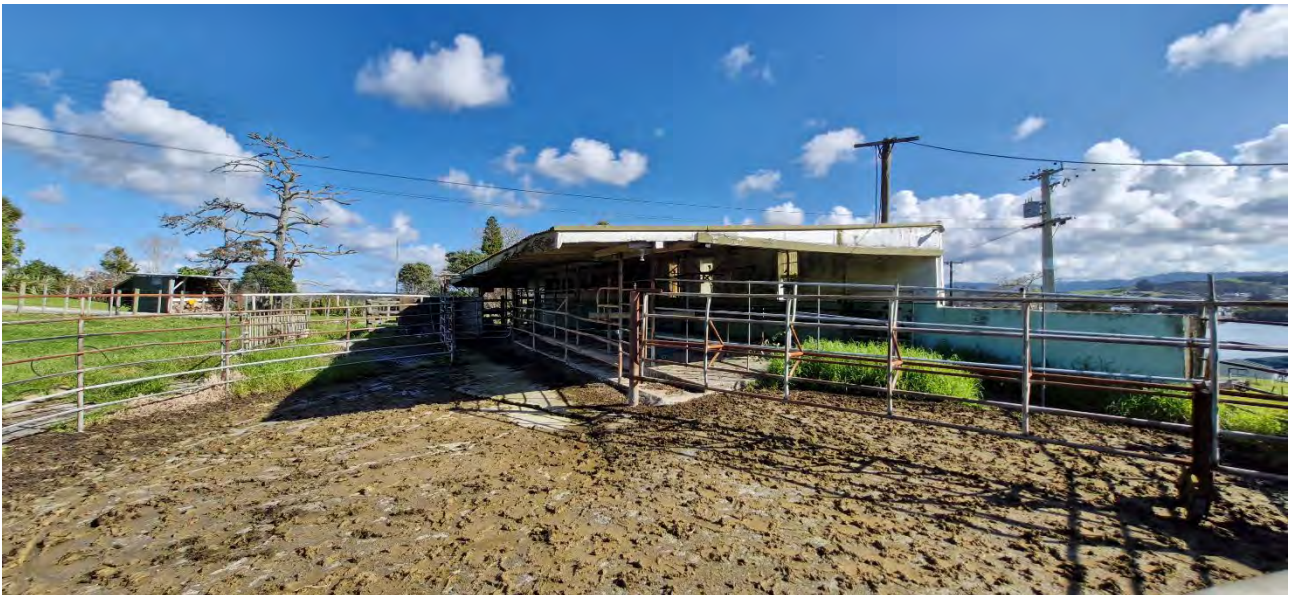
- The milk shed was constructed of painted concrete, corrugated metal, timber and fibre cement (potential ACM).
  - The buildings were in moderate condition, with some deterioration to the paintwork noted, and minimal damage the potential ACM.

**PLATE 24:** View of milking shed, facing west.

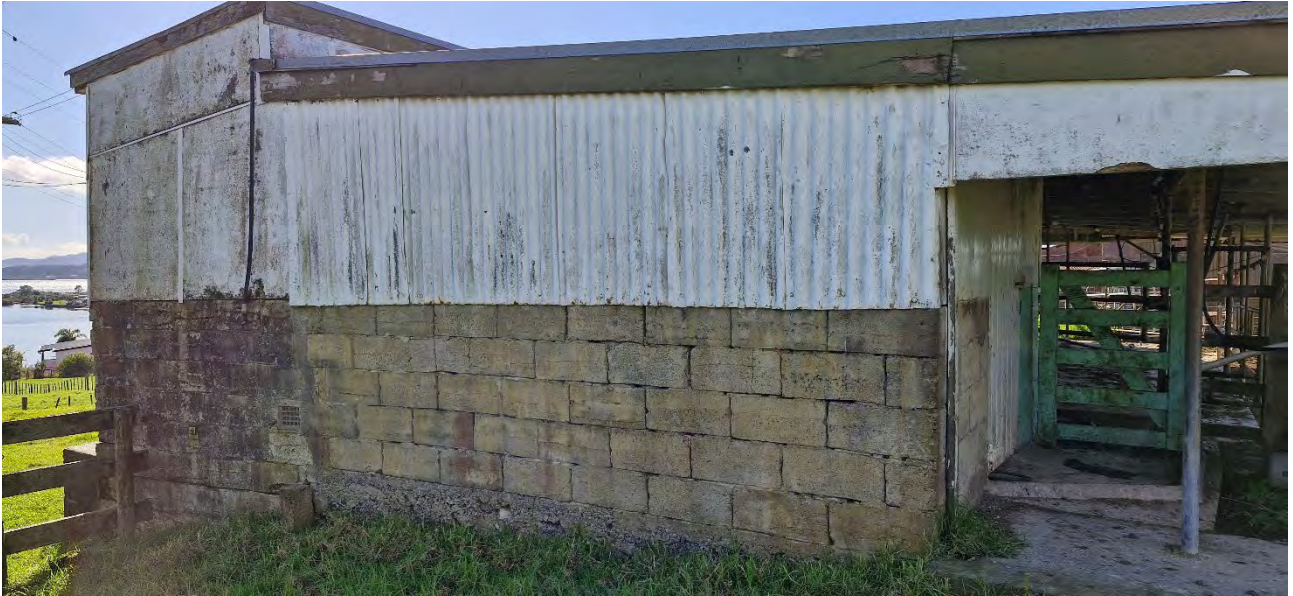
**PLATE 25:** Western aspect of the milking shed.

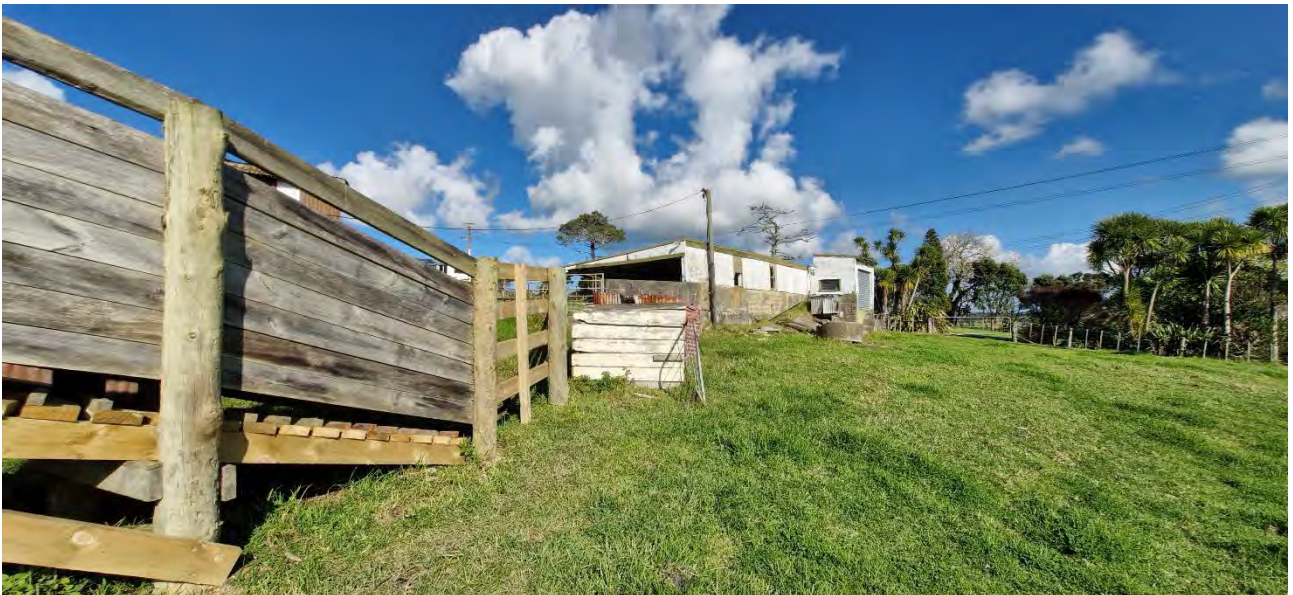
- A concreted animal thoroughfare and holding pens were located north of and between the barn and milk shed.
- A small (2 m radius) burn patch was noted northwest of the barn. Charcoal, nails and partially burned timber were noted within the area. The property owner indicated that 'untreated' pine timber from a former cattle loading race was burned.
- Two effluent ponds were located east of the residence.
- An unpainted corrugated steel haybarn was located in the north-eastern portion of the site. The barn was constructed on a concrete slab and was utilised for the storage of hay and timber. A locked shipping container and a large timber pile were located to the west of the barn. The timber pile appeared to predominantly comprise felled trees.

**PLATE 26:** Animal loading ramp and northern aspect of the milking shed.

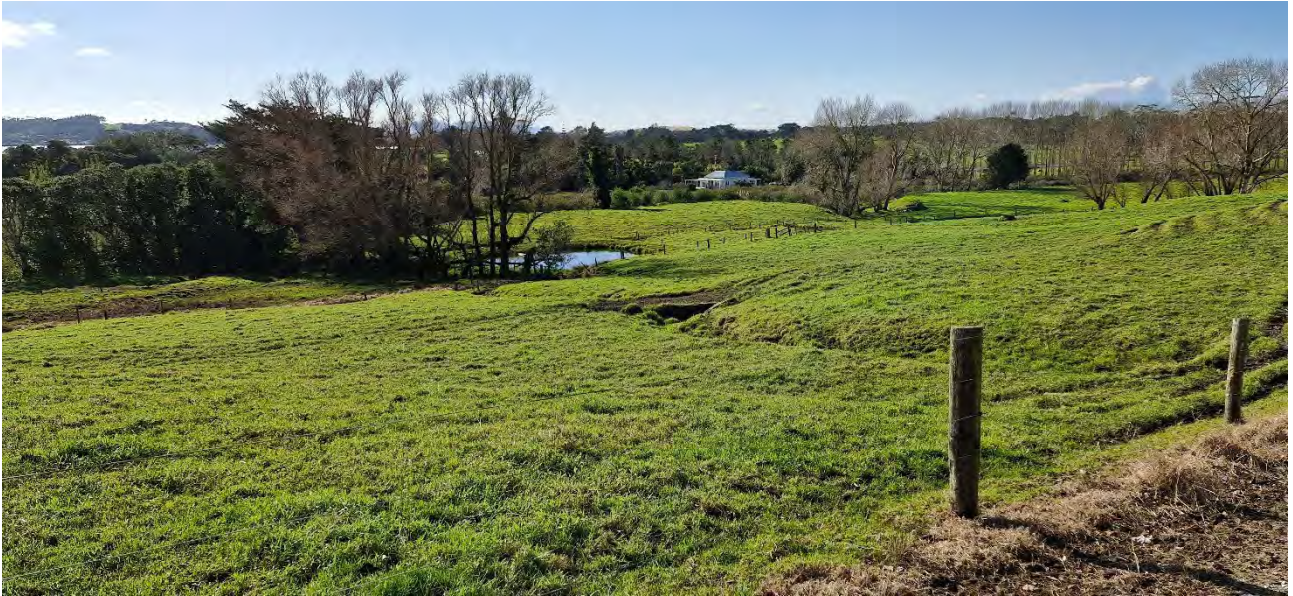
**1982-2003** Horticultural market gardens are present across Property A and the surrounding land to the west and north. Effluent ponds (11 & 13) are visible in the north-western development of Property D. Land clearing to the north of the residence can be observed.

**PLATE 27:** Effluent ponds and northern paddocks, facing north.

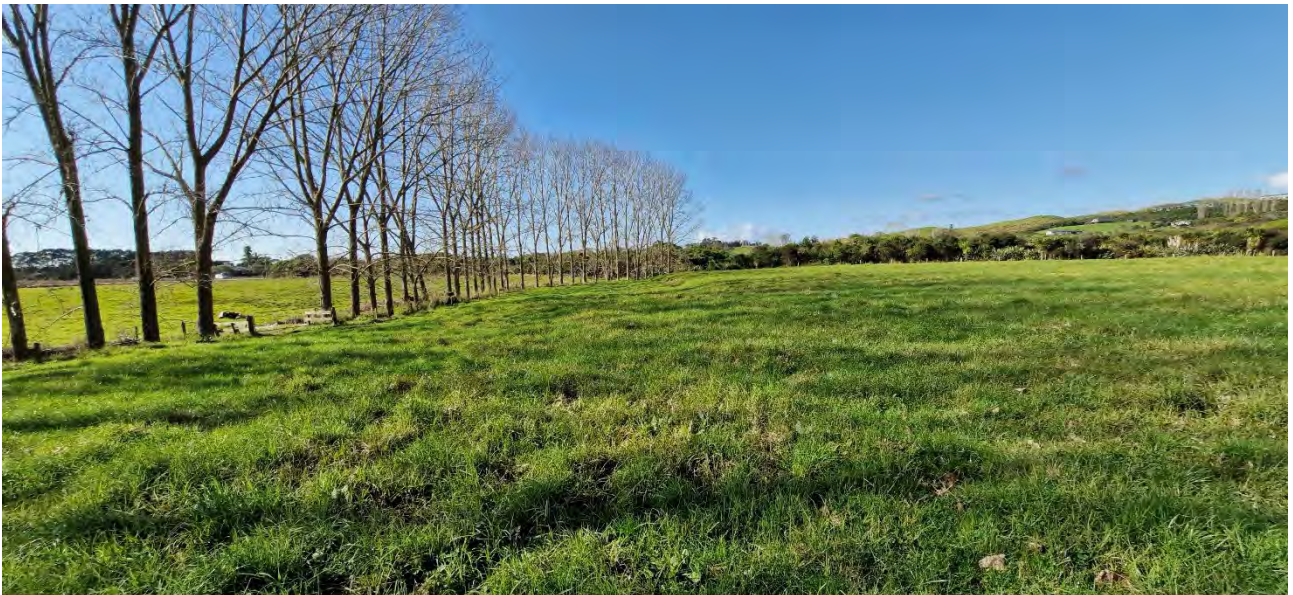
**PLATE 32:** Location of former shed in eastern portion of the site, facing east.
