Project Number: 1-14129.20

Mangawhai Water Reuse

HYDROGEOLOGICAL STUDY - SOILS

20 May 2021

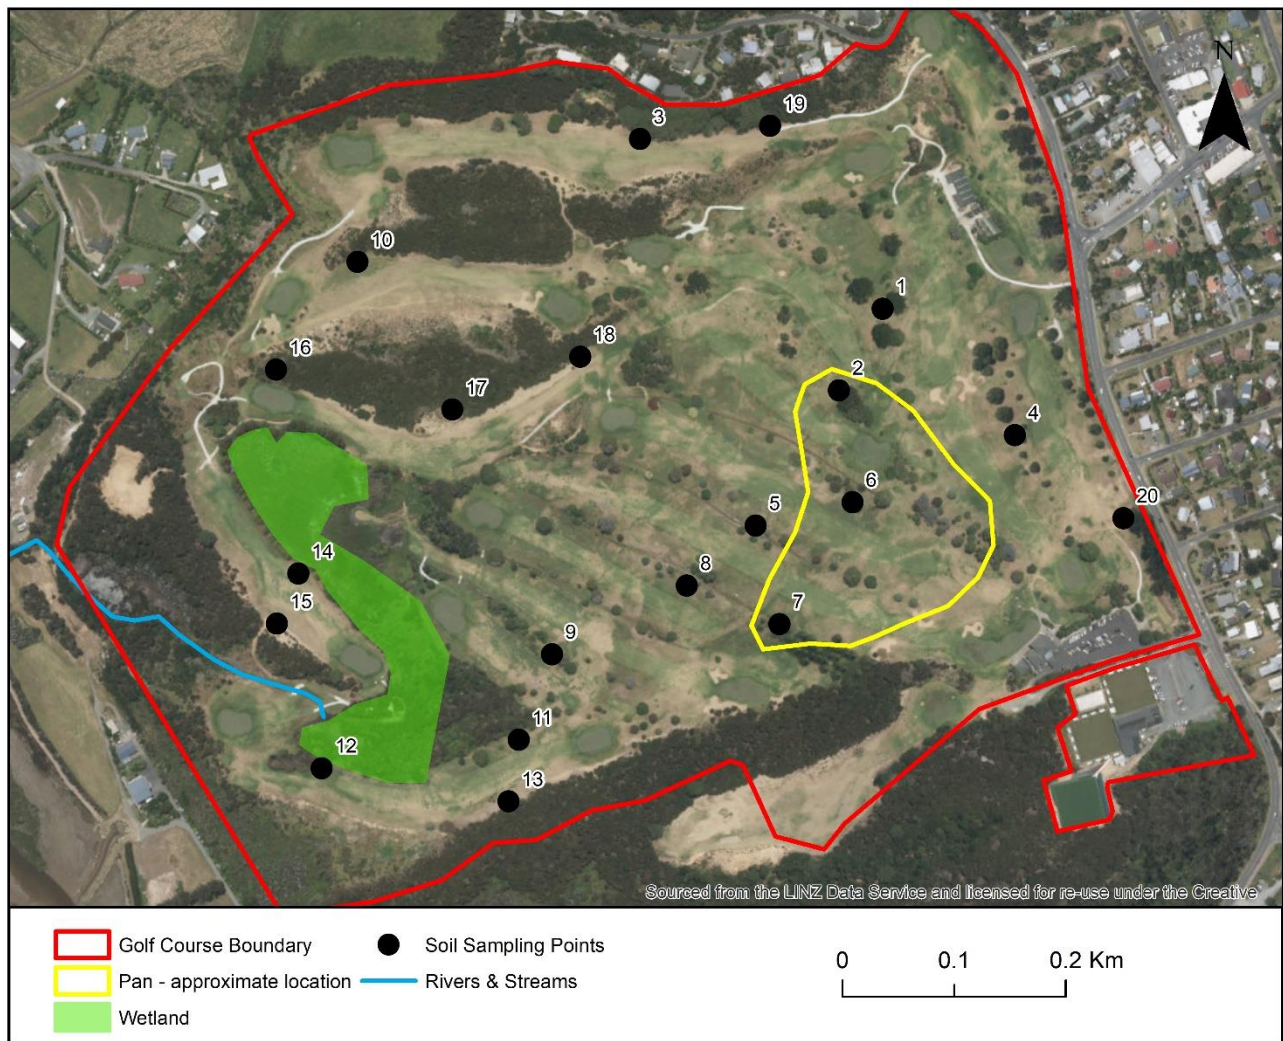
Figure 2-1: Soil sampling and infiltration sites.

Soil profiles were exposed from holes dug by spade and auguring at 20 locations across the course; observations occurred at track cuttings and other places where the soil could easily be exposed. Representative profiles were described in general accordance with Milne et al 1995 and photographed. Figure 2-1 highlights where each soil hole was located. Of the 20 holes, 13 were infiltration tested to provide infiltration rates to help assess the application rates of irrigation onto the soil.

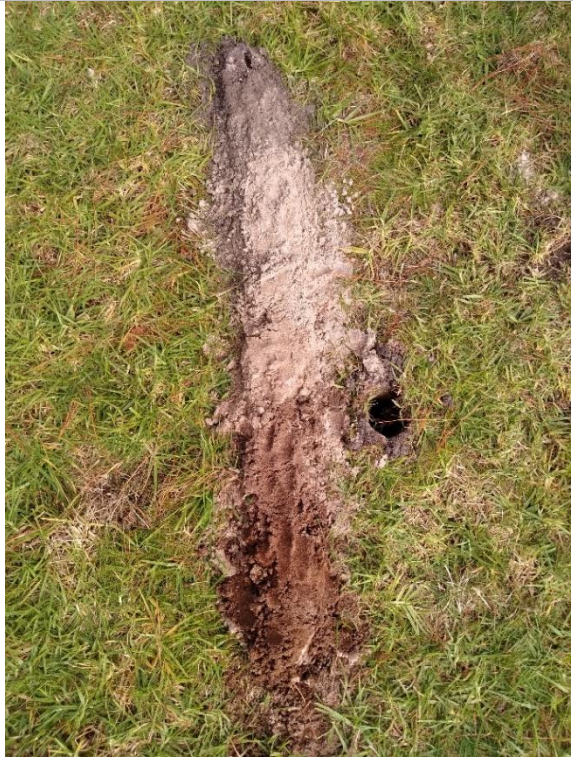
| Soil description | Photo |
|--|---|
| <p>Sandy loam</p> <p>A 0 - 15cm Top soil Very friable Fine textured No mottling or gleying</p> <p>B 15cm – 80cm Yellow brown sandy loam Very friable No signs of iron oxides Coarser texture No mottling or gleying</p> <p>C 80cm – 95cm Brown sandy loam Fine textured No mottling or gleying</p> <p>Site 1,2,4</p> | |

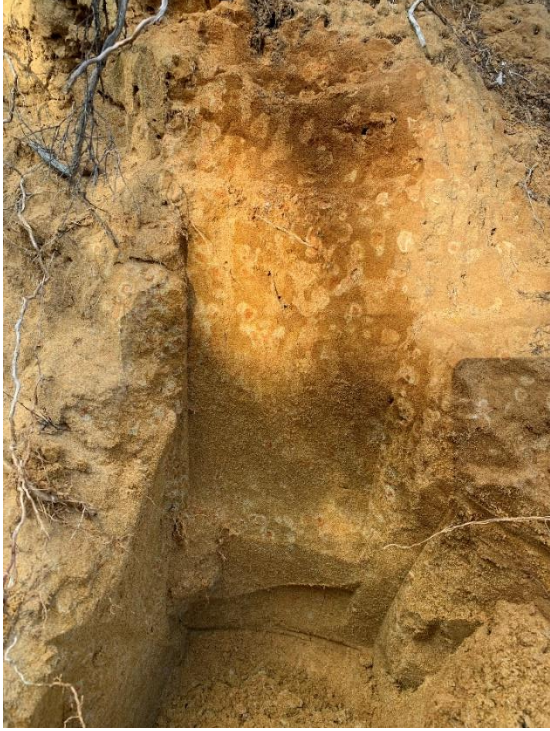
| <p>Sand</p> <p>A 0-10cm Top Soil Very friable No mottling or gleying</p> <p>B 10- 50cm Red yellow sand Vary friable No mottling or gleying</p> <p>B²50cm-95cm Consolidated sands More compact Signs of sandstone</p> <p>Note: Distinction between horizons difficult to see.</p> <p>Site 3, 13, 15, 16, 17, 18, 19, 20</p> | |

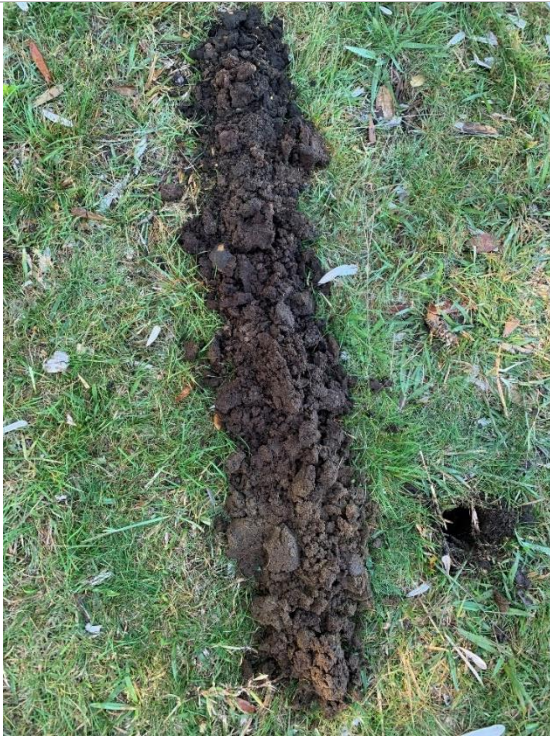
| <p>Sandy loam</p> <p>A 0 -15cm Top Soil Very friable No mottling or gleying</p> <p>B 15 – 80cm High silt content Brown loam Course textured No mottling or gleying Friable</p> <p>C 80 – 95cm Large silt aggregates No mottling or gleying Courses textured</p> <p>Site 5,8</p> | |
