Project Number: 1-14129.03

Kaipara Moana

KDC Marine Asset Assessment Pouto Point

21 April 2020

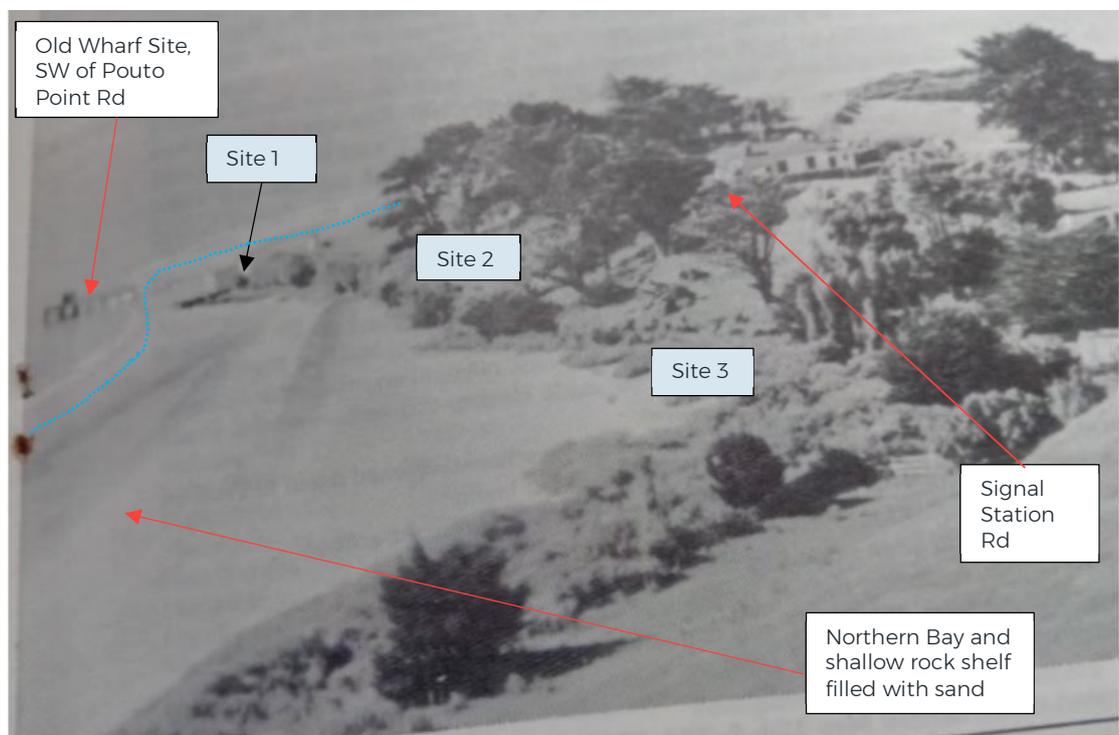
Figure 4: Pouto Point Circa 1936 (looking South)

A jetty previously existed at the end of Pouto Point Road (Site 1). Its position is understood to have been Southwest of the Fisherman’s rock and the current beach entrance. No sign of the old piles was visible at low tide during the day of the WSP site inspection, but locals recall seeing them at that approximate location. A boat house can be seen on Fisherman’s rock in below, and evidence of its foundations are still present on site.

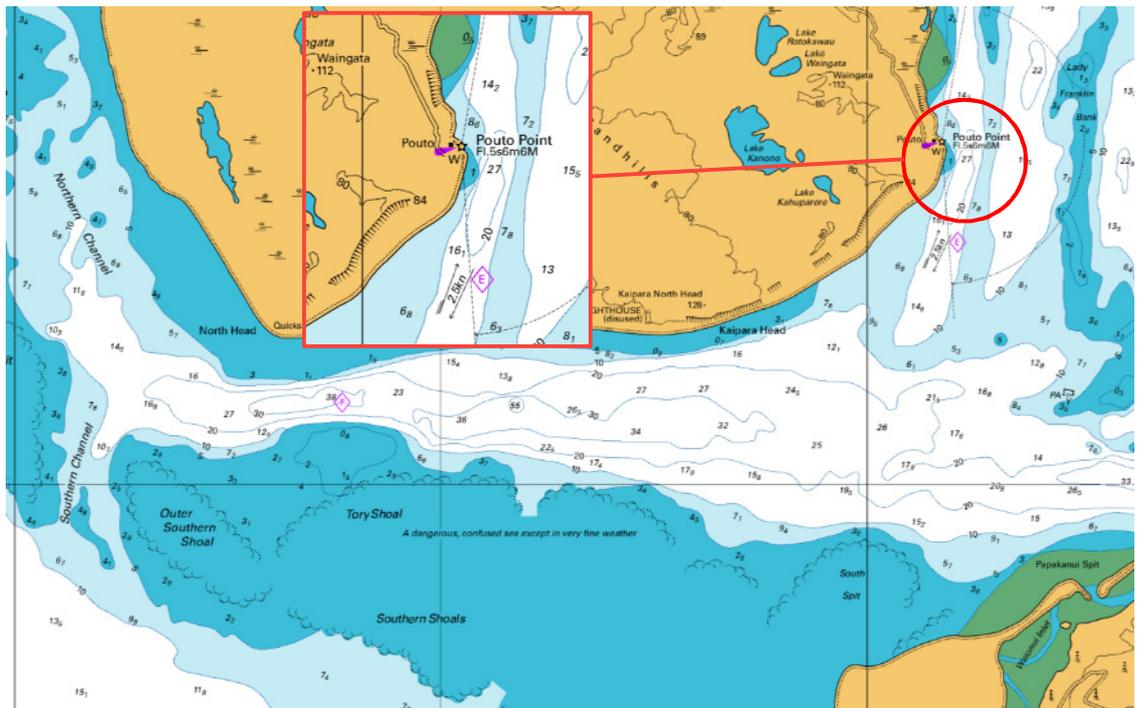
Figure 9: Extract from Chart NZ 4265 Kaipara Harbour showing Pouto Point (LINZ, 2018)

A desktop review of publicly available information indicates tidal current flows of up to 3.1 Knots in the adjacent deep channel during spring tides (Figure 9).
