Geotechnical Assessment

Kaiwaka

Kaipara District

28.03.2019
15601.000.001_02

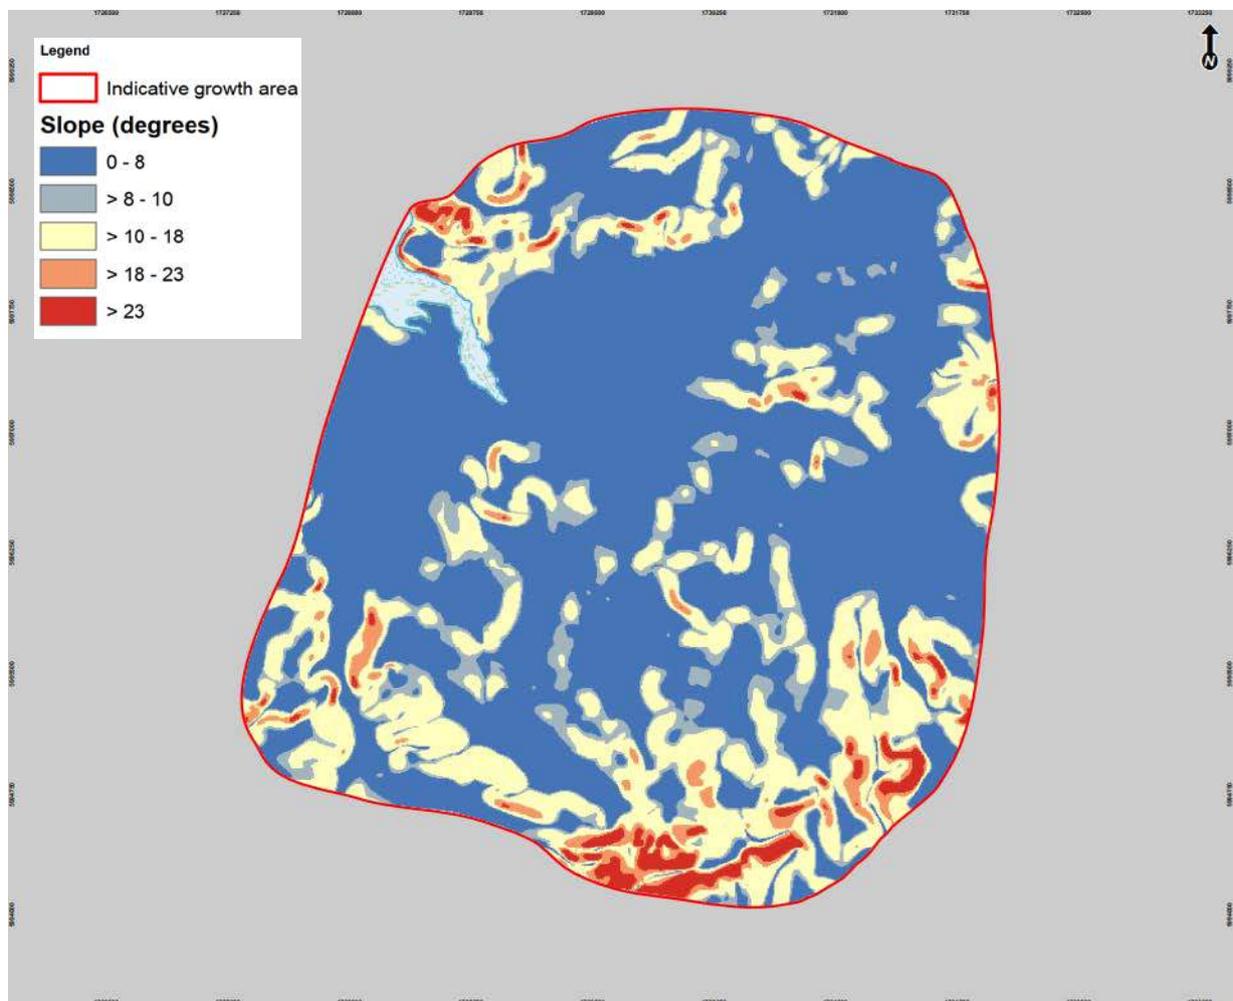
Figure 4: Topographic Slope Angles

A profile of existing slope angles was created using LINZ Topo50 20 m contours (vertical accuracy ≤ 10 m). From this, a digital elevation model (DEM) was generated, and then a Slope Profile (Figure 4) was produced to show relative steepness within the study area.

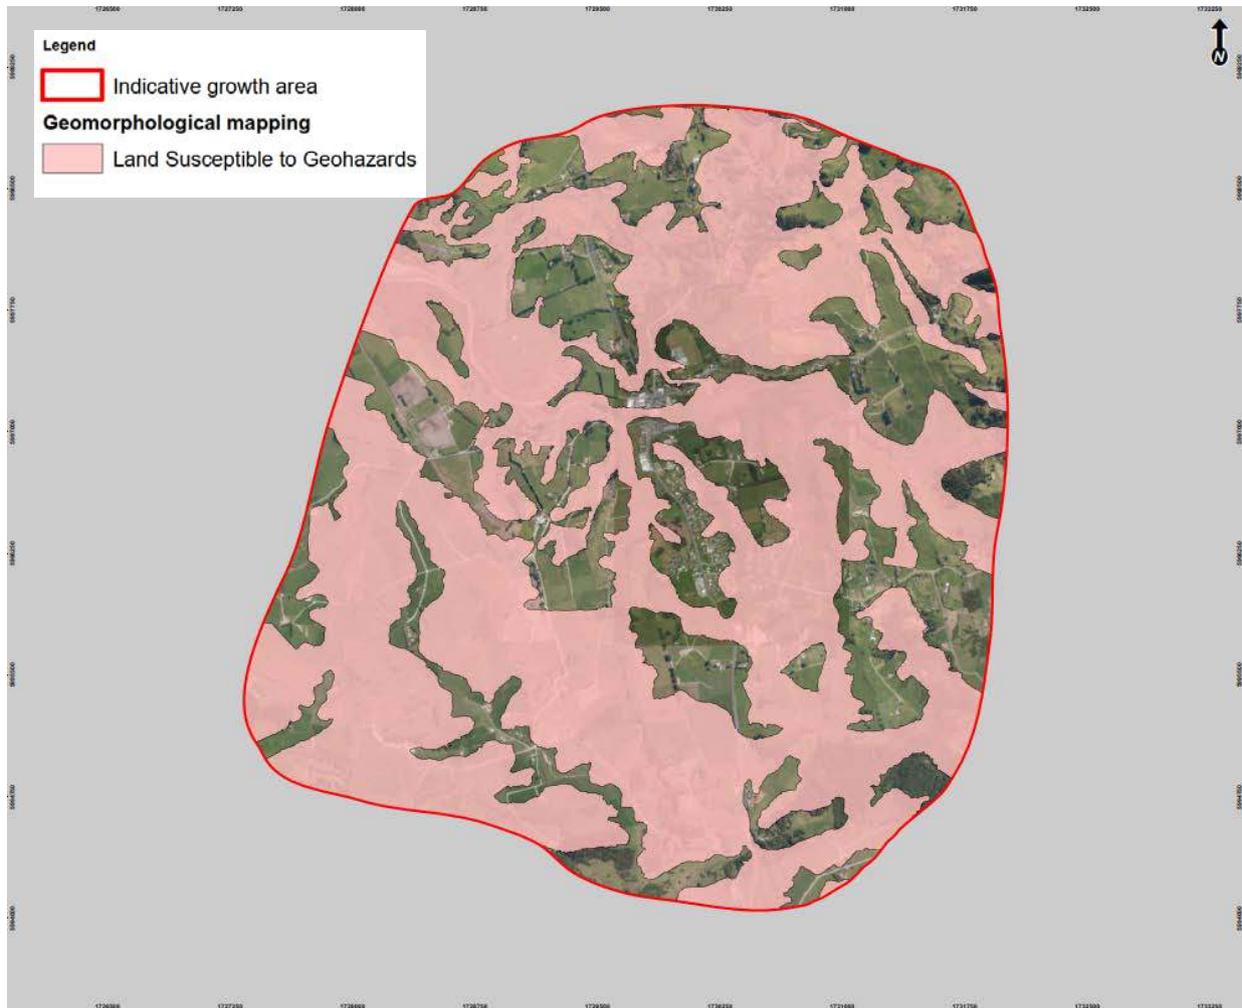
Figure 5: Geomorphological Mapping

We assessed the images to identify geomorphic features such as headscarps, hummocky and irregular-shaped landscapes, displaced blocks, and debris lobes that may be indicative of recent or historic landslide activity. Based on subtle inflections in topography, we mapped the approximate limits of interpreted land instability areas as depicted in Figure 5. We also mapped the approximate limits of alluvium and colluvium deposits in hillside gullies and valley areas, which are considered to be susceptible to liquefaction and consolidation settlement. Interpreted land instability (deep seated and surficial), colluvium, gully fill, and alluvial soils were not differentiated in our mapping, which was intended to identify land susceptible to geotechnical hazards.

The geomorphic mapping performed for this study should be considered a reconnaissance-level effort, and is intended to provide a generalised delineation of geotechnical hazards for planning-level site evaluations. The accuracy was limited by the scale of the aerial images and other factors such as vegetative cover, farming, and urban development. The mapping depicted on Figure 5 should be supplemented by detailed site-specific geomorphic mapping for design-level studies.

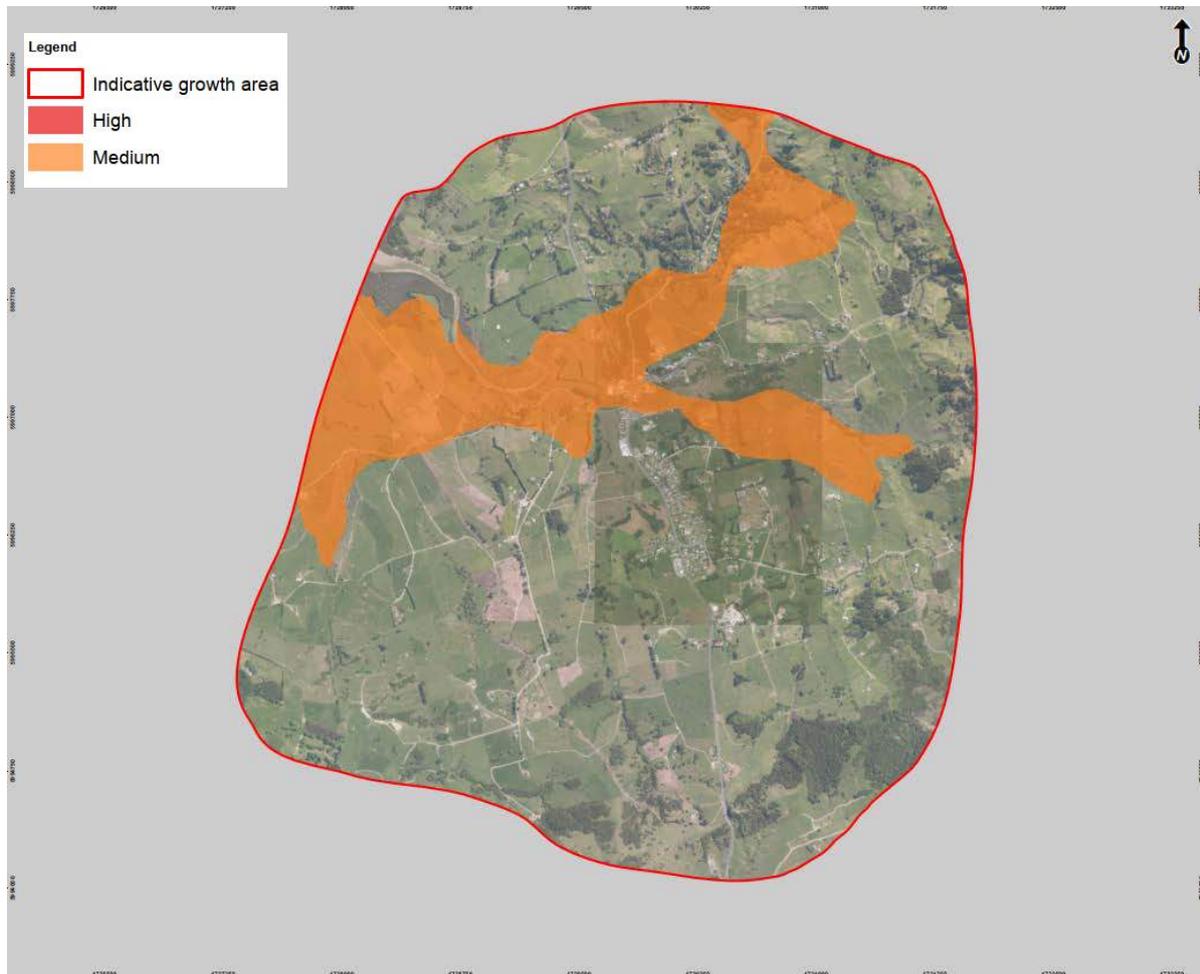
Figure 7: Liquefaction and Lateral Spread Susceptibility Plan

Northland Allochthon rock is not considered liquefiable. Residual soils of Northland Allochthon and Waitemata Group typically comprise moderately plastic clays and silts with variable amounts of sand. Due to the nature of these soils, we consider the liquefaction and lateral spread potential to be low. Areas having a low liquefaction potential are unshaded in Figure 7.

Given the potential for poorly consolidated, coarse-grained soils to be present below groundwater within the Pleistocene Alluvium, we consider liquefaction and lateral spread potential within this unit to be medium (Figure 7).

We consider the liquefaction and lateral spread potential of the Holocene Alluvium to be high. Due to the isolated areas which these deposits were observed, Holocene deposits have not been included on Figure 7.

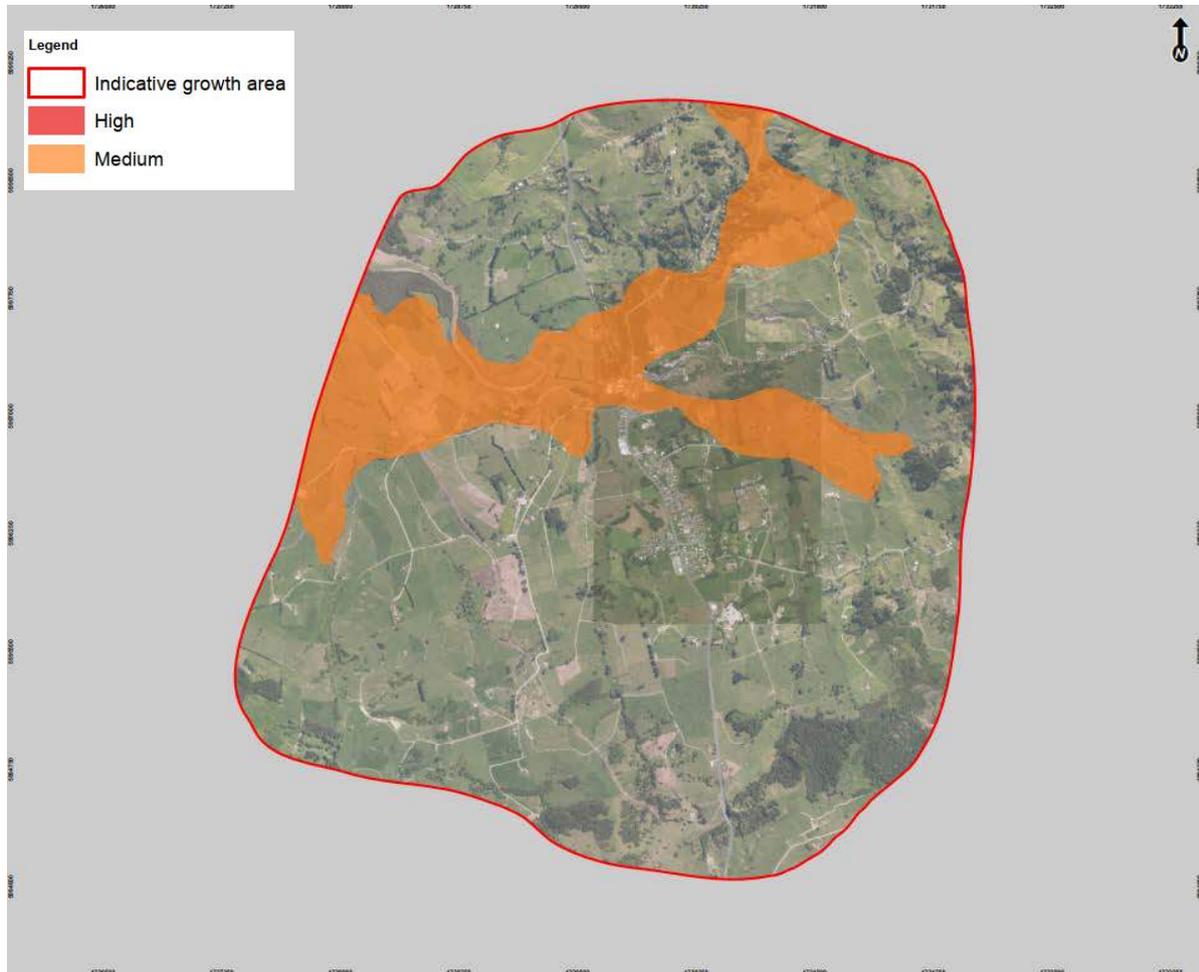
Figure 9: Settlement Susceptibility Plan

We consider these areas to have a high potential to experience consolidation settlement under loading. Due to the isolated areas which these deposits were observed, we have not included Holocene deposits on Figure 9.

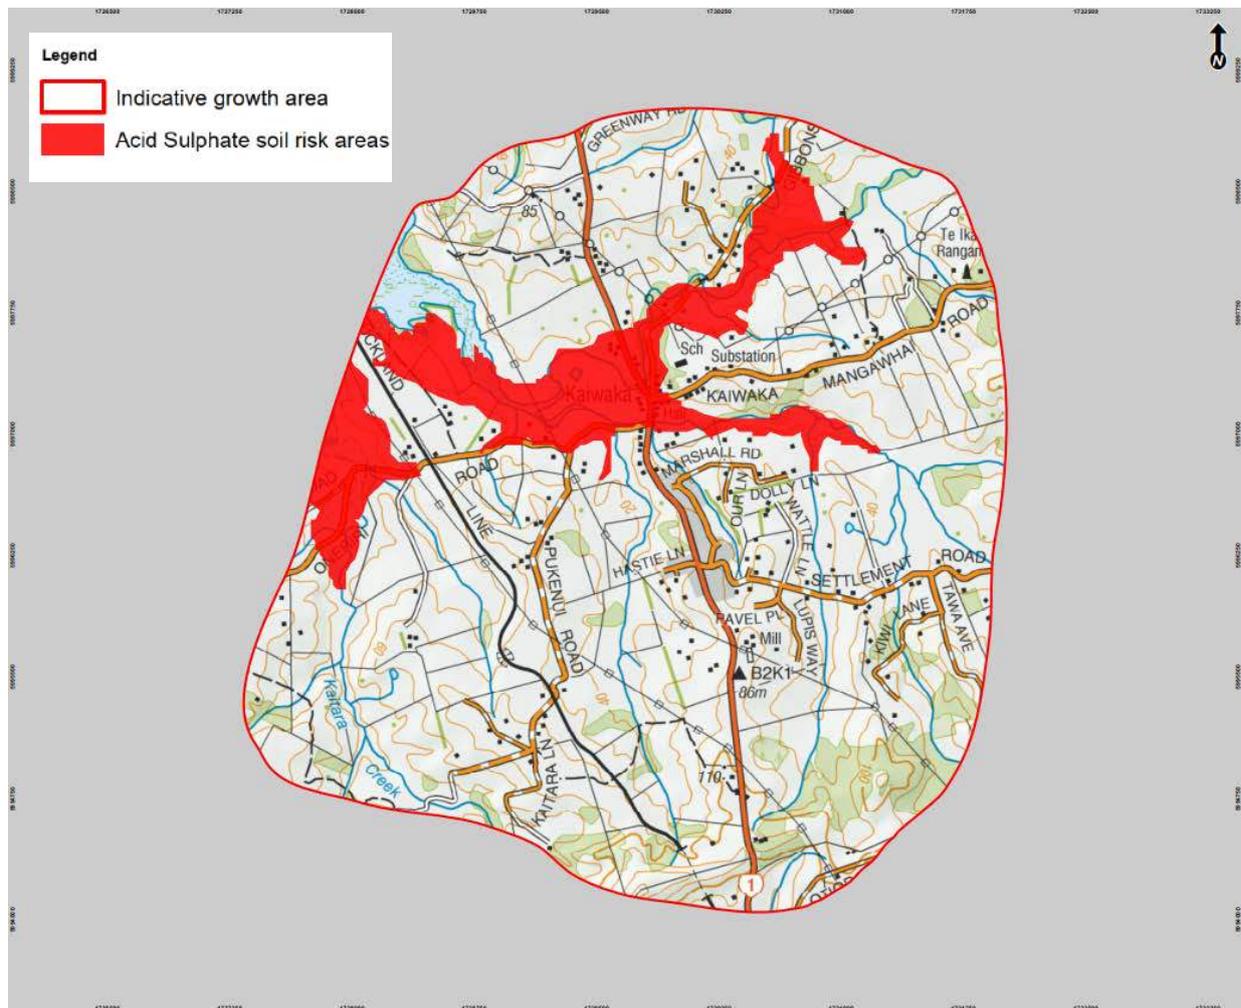
Figure 10: Acid Sulphate Soil Risk Plan

A draft joint Council submission (Acid Sulphate Soils – Northland) was recently undertaken (Opus 2017). Included in this report is an Acid Sulphate Soil Risk plan that was developed using historic sea levels, current surface elevations and mapped sedimentary deposits. Kaipara District Council have provided focussed areas of the plan for use in this study, which includes the Kaiwaka study area (Figure 10).

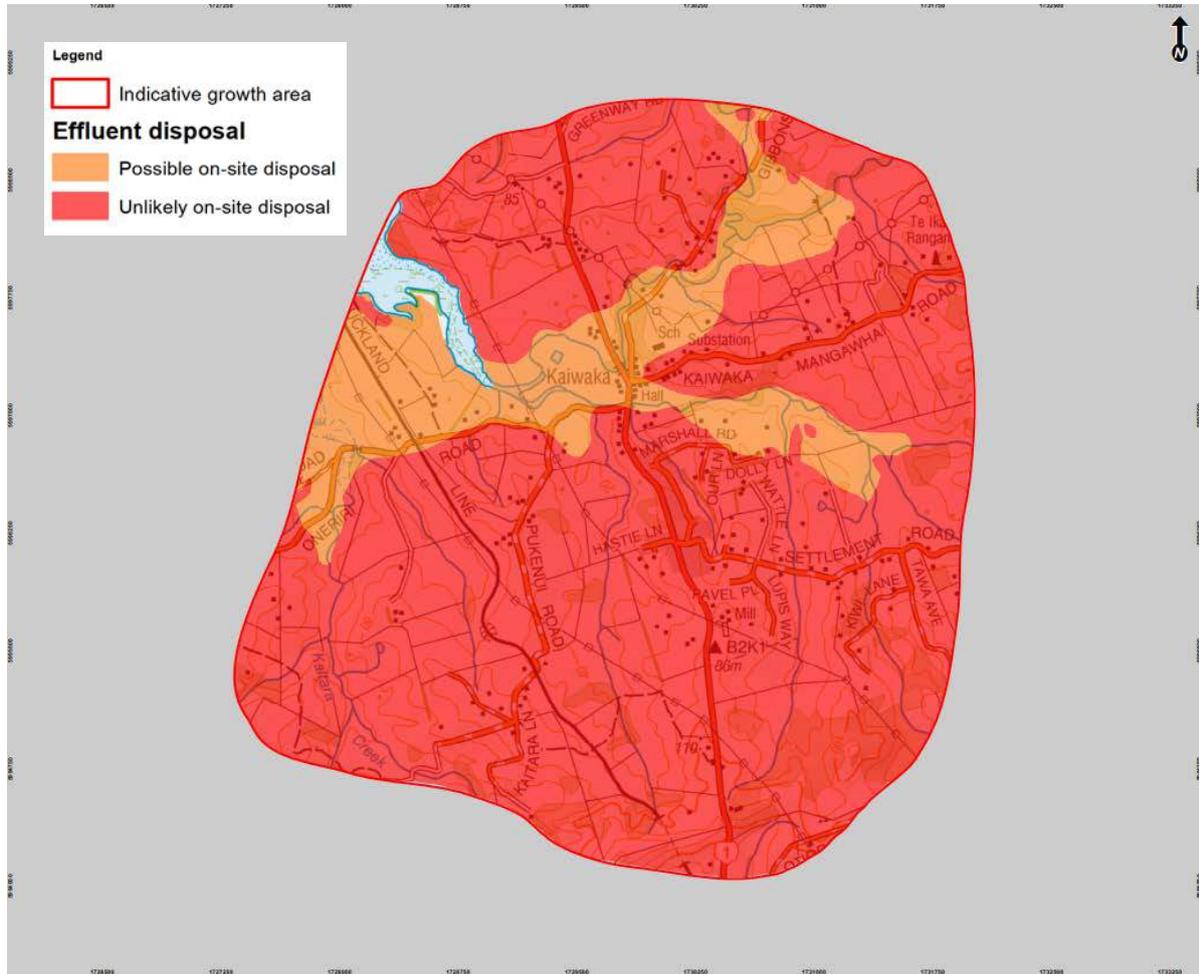
Figure 11: On-Site Effluent Disposal Potential Plan

Without site-specific assessments, the potential for on-site effluent disposal can be considered as a function of anticipated soil type, topography, and mapped geotechnical hazards for any given area. We have prepared a plan depicting the potential for on-site effluent disposal in the Kaiwaka study area (Figure 11) based on these factors, as summarised in the following sections.

Due to its low-lying topography, typically near-surface groundwater table, and mandatory setback requirements from clean water sources, effluent disposal potential within Holocene Alluvium should be considered unlikely.
