# Geotechnical Appraisal for Proposed Plan Change at

# 159 Awakino Road, Dargaville

Rev A

5 May 2022 Job No. NL220026

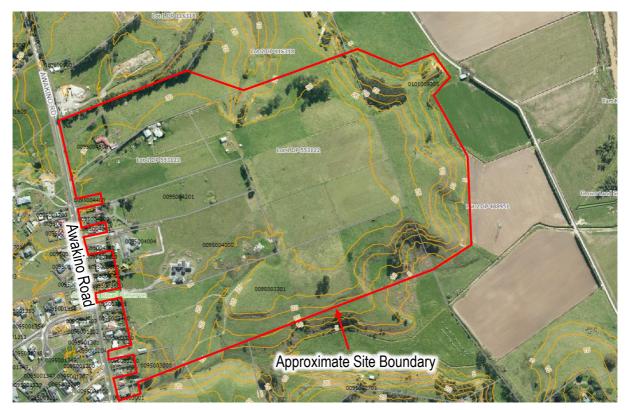
Figure 1: Aerial photograph with contour lines (Source Kaipara District Council GIS Viewer)

The site covers 14 properties as summarised in Table 1 below and presented in Figure 1. The property is occupied by dwellings, sheds and ancillary farm buildings and infrastructure (eg: fences and troughs etc).

The site is located on an alluvial terrace, above the plain of the Awakino River to the east. Mapped contour lines indicate the site is generally near level to gently sloping with moderate to steep slopes at the edge(s) of the terrace in the southern and eastern portions of the site. Erosional gullies are located to the north and south of the site.

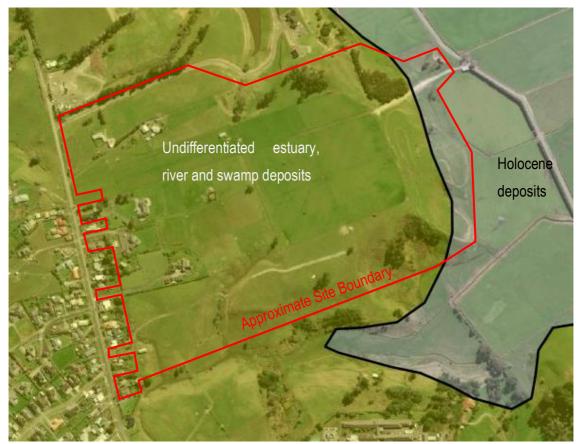
Figure 2: Geological Map with aerial photograph (GNS Science Web Map)

The contact between the two deposits, as mapped by GNS, is at the toe of the terrace and indicated by the black line in Figure 2 below. Such contacts are mapped at large scales and should be considered approximate at best.

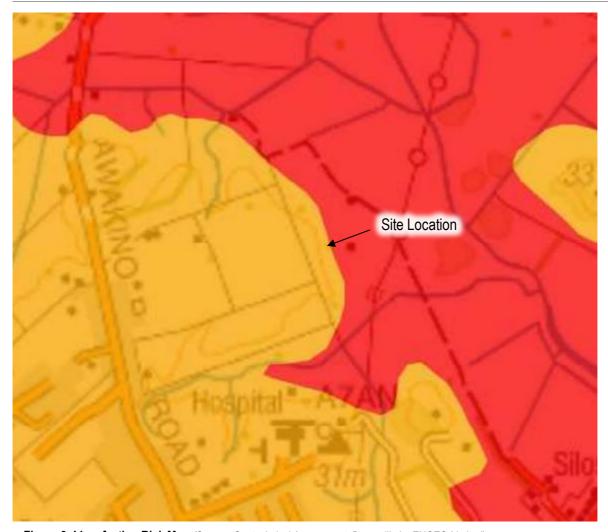
Figure 3: Liquefaction Risk Map (Source: Geotechnical Assessment: Dargaville by ENGEO Limited)

Liquefaction mapping prepared for Kaipara District Council by Engeo Ltd indicates that the site is located within areas of medium and high liquefaction risk, as shown in Figure 3 below. The Holocene deposits underlying the eastern (lower) portion of the site are mapped as having high liquefaction risk, whereas the elevated portion of the site is mapped as medium liquefaction risk.

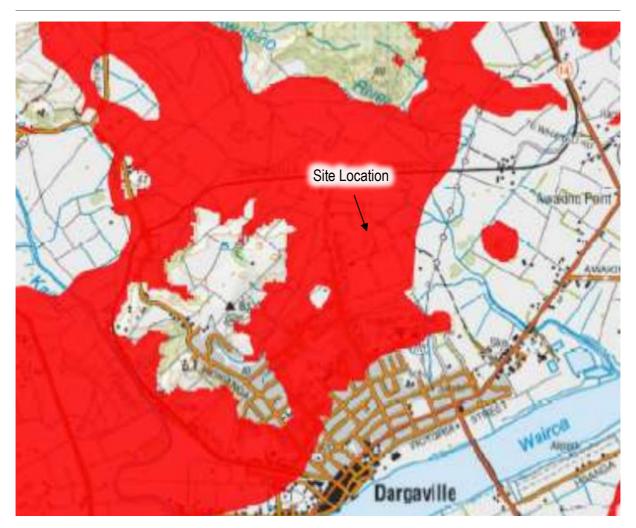
Figure 4: Acid Sulphate Soil Risk Map (Source: Geotechnical Assessment: Dargaville by WSP-Opus Limited)

A draft map prepared by WSP-Opus (2017) indicates the subject site within the Acid Sulphate soil risk area (see Figure 4).
